**Lyddington Manor History Society  
Historic Building Survey**

**24 Main Street & 1 The Green  
Lyddington, Rutland**

## 24 MAIN STREET & 1 THE GREEN, LYDDINGTON, RUTLAND

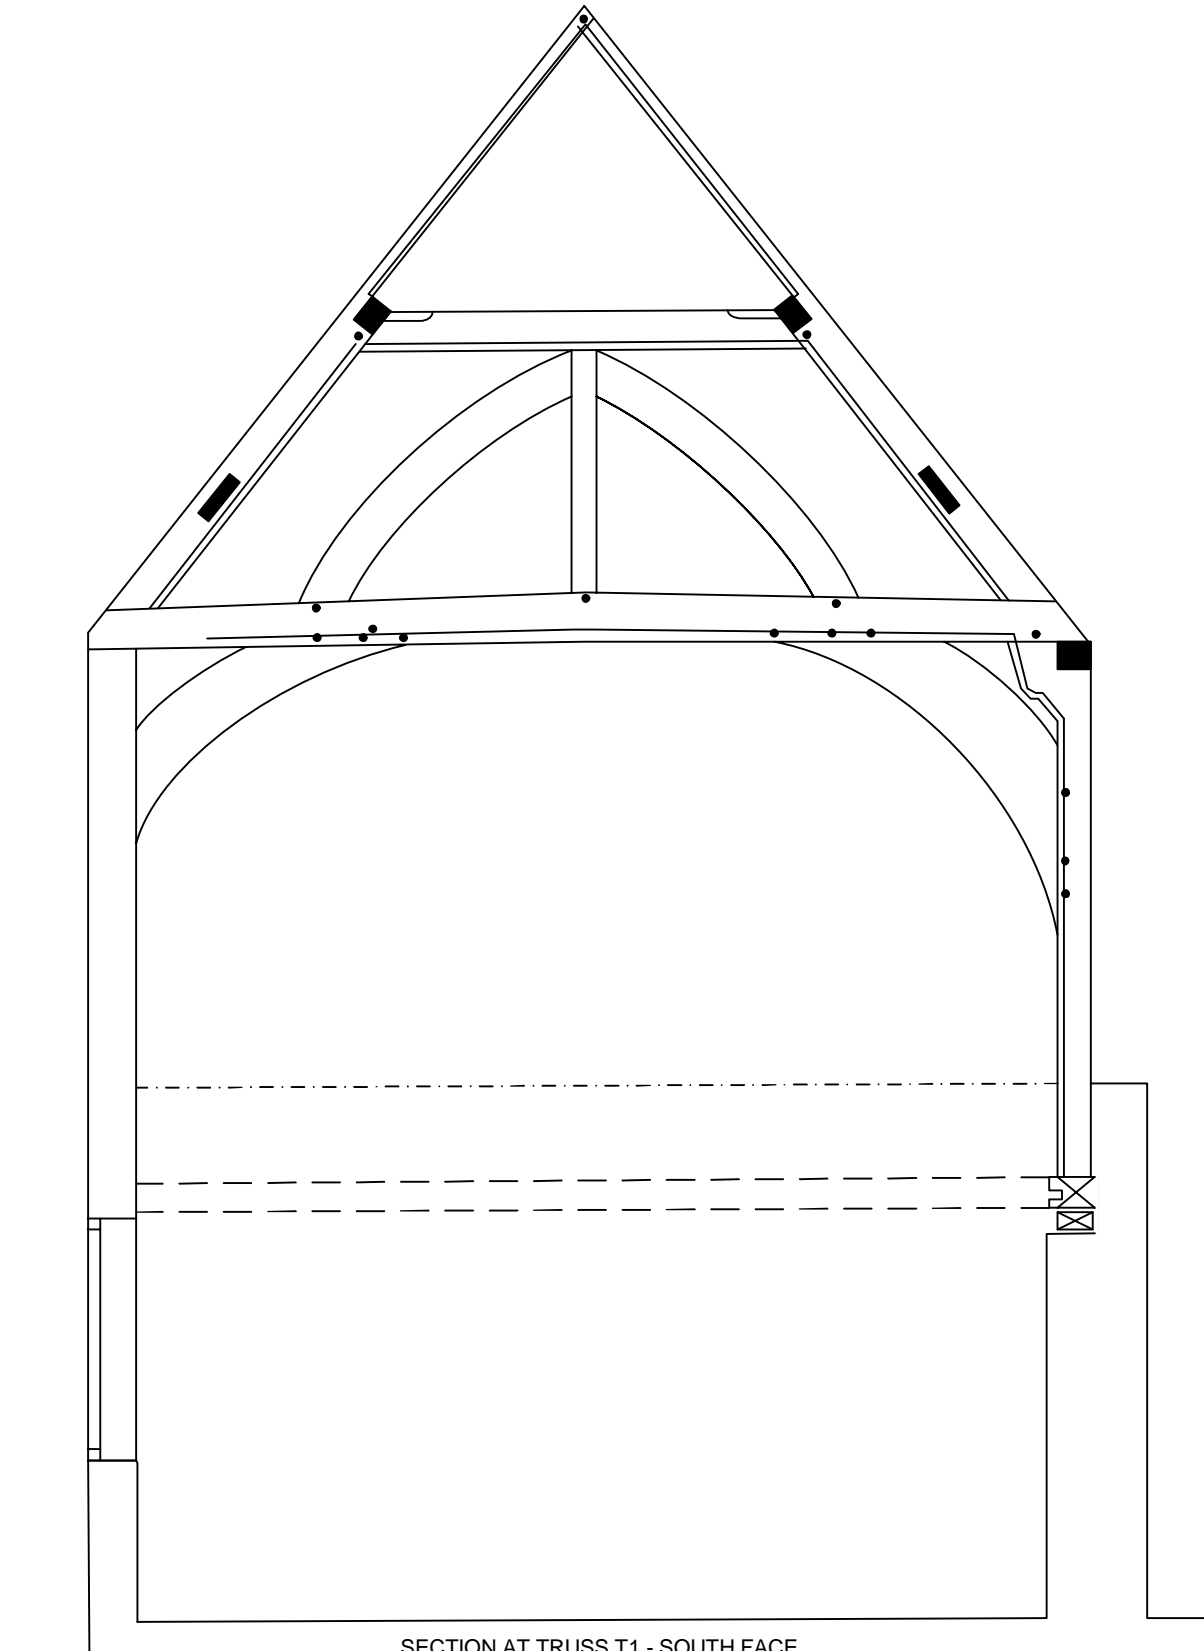
SECTION AT TRUSS T1 - SOUTH FACE  
 MARKET HOUSE, 24 MAIN ST, LYDDINGTON

Truss T1 to N is the best preserved, also has fancier decorative post and braces from tie to collar. Slightly cranked tiebeam with heavy curved arch-braces, jowled post to E survives. Clasped purlin roof, principal rafters diminish at purlin height. Straight collar. Unusual vertical post and braces. Post is tenoned and pegged at foot, but has only a small stub tenon and no peg at top. To lower part, the post has 2 pairs of 2 pegholes running from face to face W-E. Unclear what these could be – perhaps to attach some decorative detail. The curved braces are pegged at the foot, but the top joints are covered by later timber, so not clear if pegged. Chamfer (both sides where visible) to the post, jowl, underside of tie, inner side of principal and underside of collar. Also a smaller chamfer to inner side of principal right up to apex. The braces are square-edged.

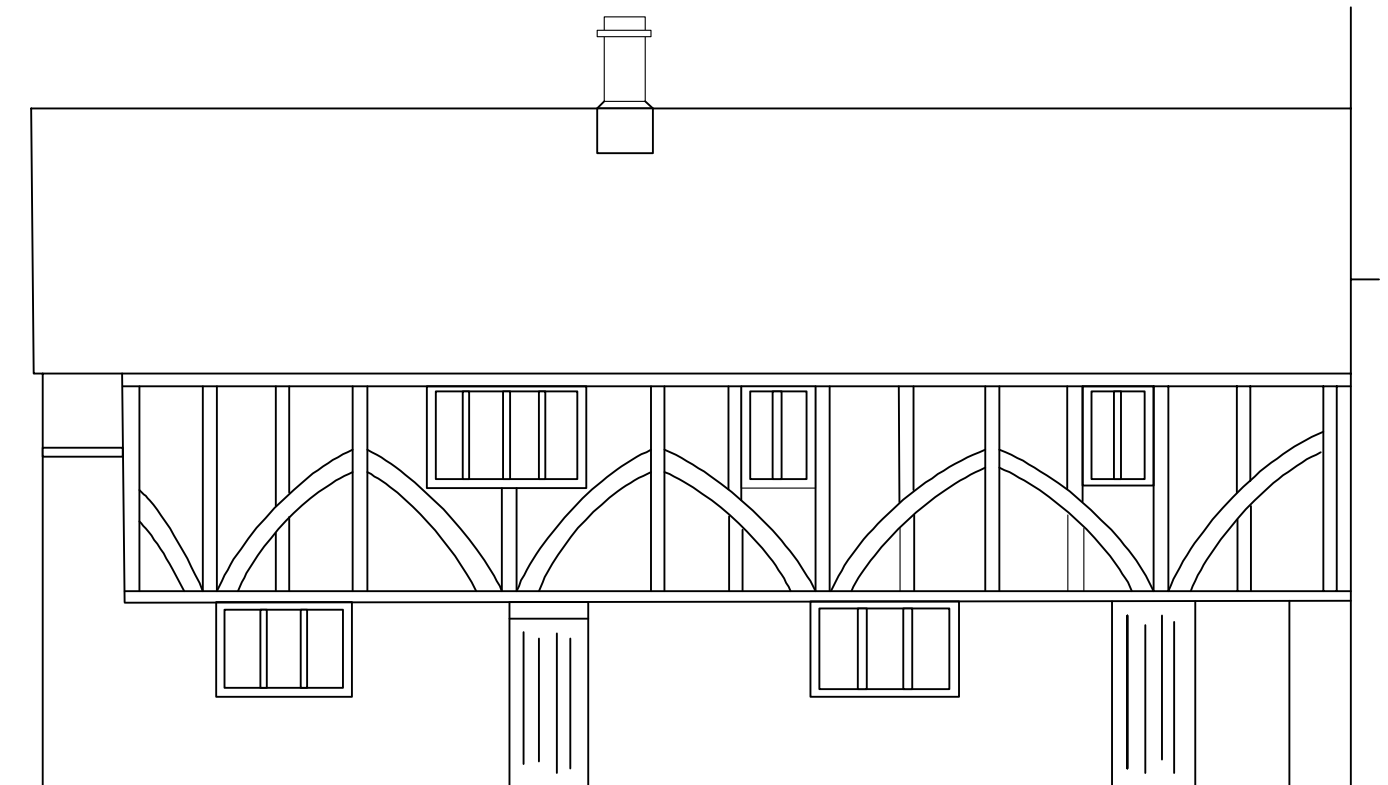
RECONSTRUCTION OF FRONT ELEVATION  
(From a photograph of c1900)

The front W wall frame can be reconstructed from the two c.1900 photos and surviving evidence. The studs are slightly closer-spaced than on the rear wall, with regular down-braces (though the bay spacing and brace length varies somewhat). No evidence for original window positions – it seems there were no good framed-in cill members.

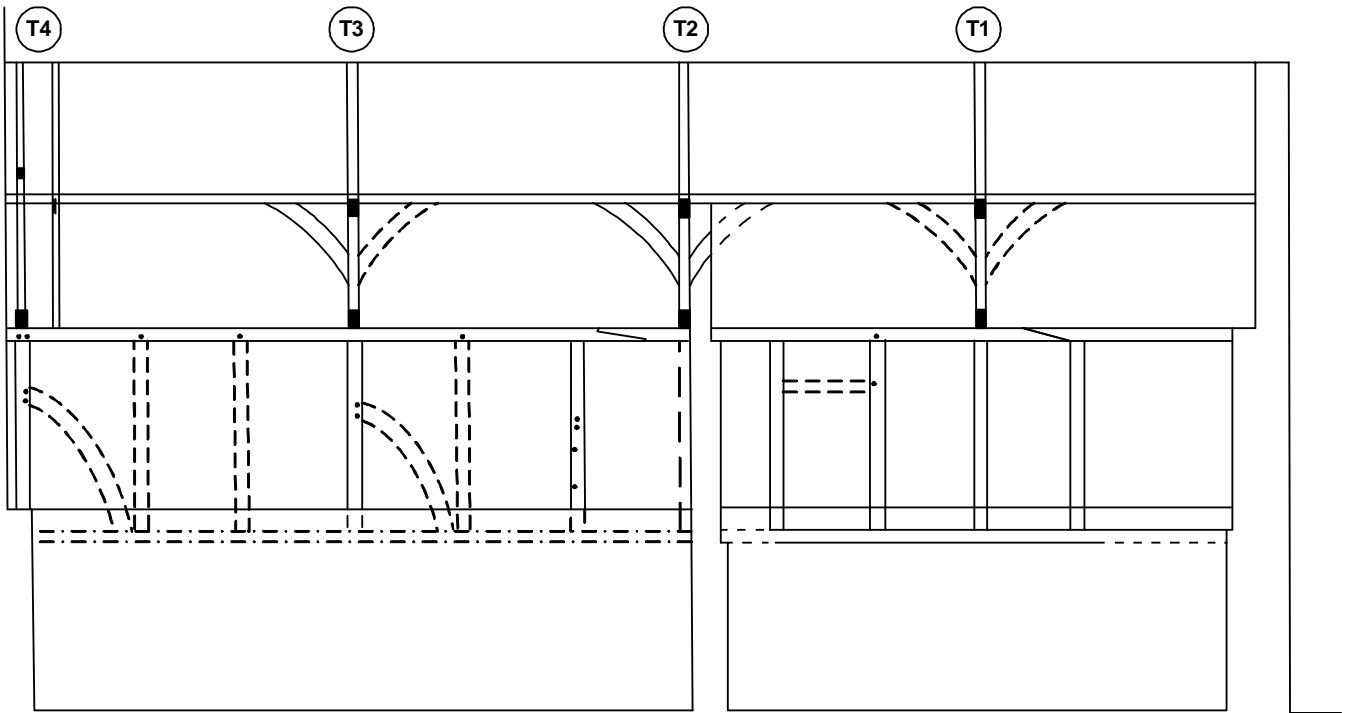
REAR (EAST) ELEVATION

Enough remains of the rear E wall frame to piece together most of its original pattern. 4 posts remain to No 1, including that of T1. The posts are c.140mm wide, with panels of c.1m width between. One section of original infill survives to N of T1, with solid mud infill, mixed with hay, and an outer coating of lime plaster. On the exposed S face of T1's wall post there are two lengths of V-gouging, which would have provided a key for the infill. The top wallplate has a scarf joint around mid-way, splayed scarf with under-squinted butts. Another straight-splayed scarf towards N, but this may be a later repair. The wallplate is chamfered, with a step stop visible by truss T1, though the chamfer runs on past the intermediate studs.

No regular pattern of bracing to posts, unlike the front W wall. Post T1 has no brace to S side, evidence not visible to N. Post T2 not visible. Post T3 has 2 pegs for presumed brace to N side, but no mortice or pegholes to S side. Post T4 has mortice and 2 pegholes for brace.

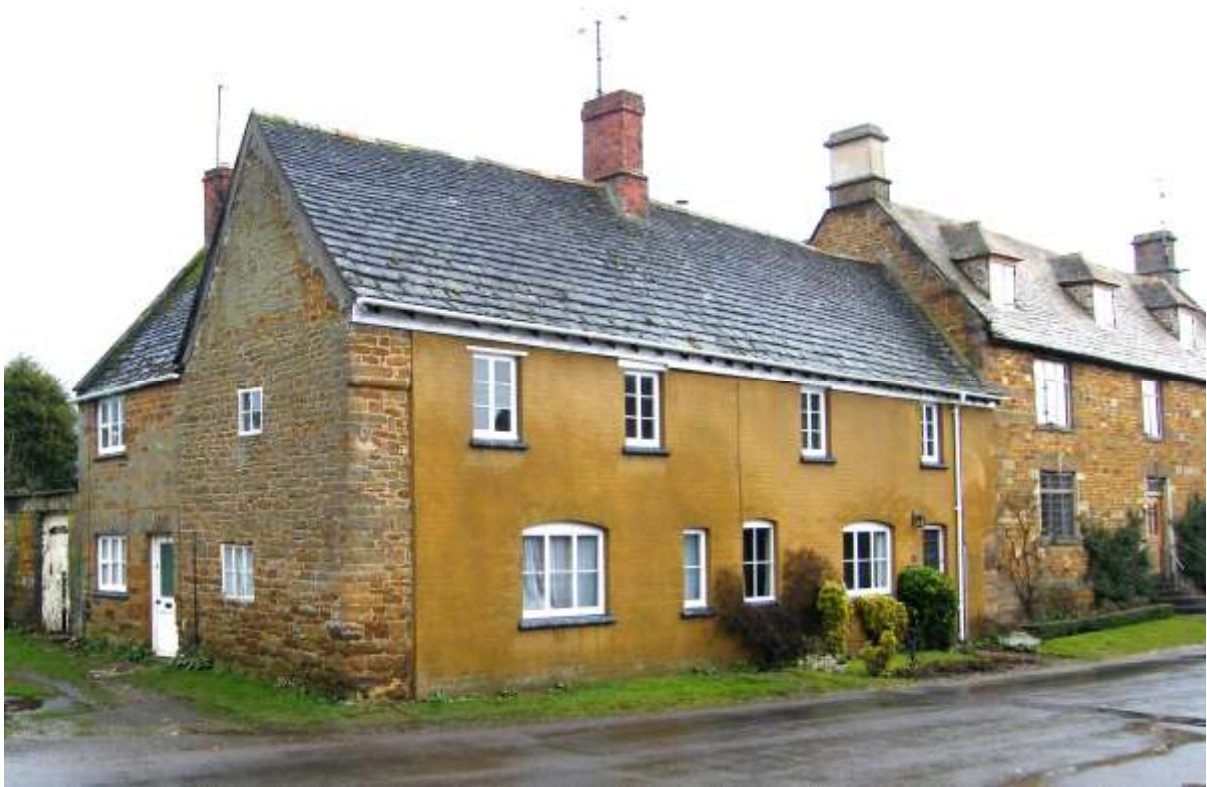
View from north-west, with No 1 to left and No 24 to right

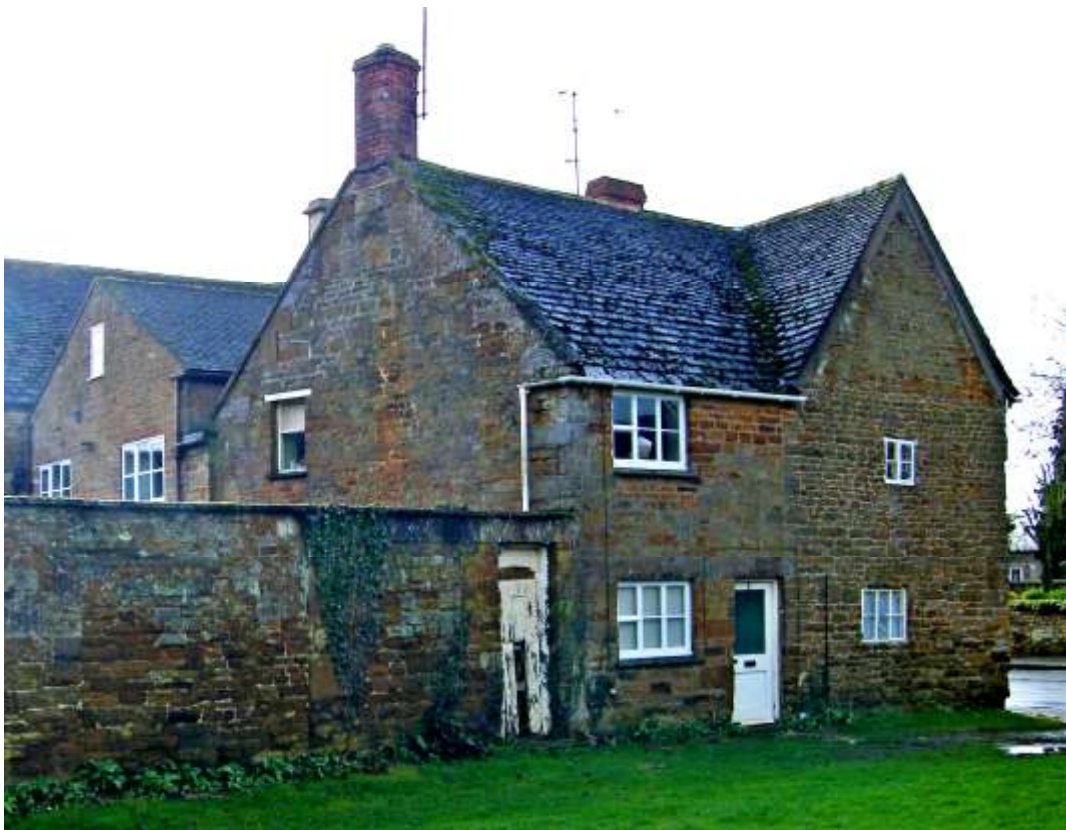
External walls of well-squared neatly coursed ironstone and good quoins. N front has continuous ashlar band over door and window. Gable has gable parapet with plain kneelers, plain squared coping and seating for single stack, of C19 brick. Door and window openings here have plain timber lintels. Windows and doors C20. Collyweston roof.

North-east wing (1 The Green)

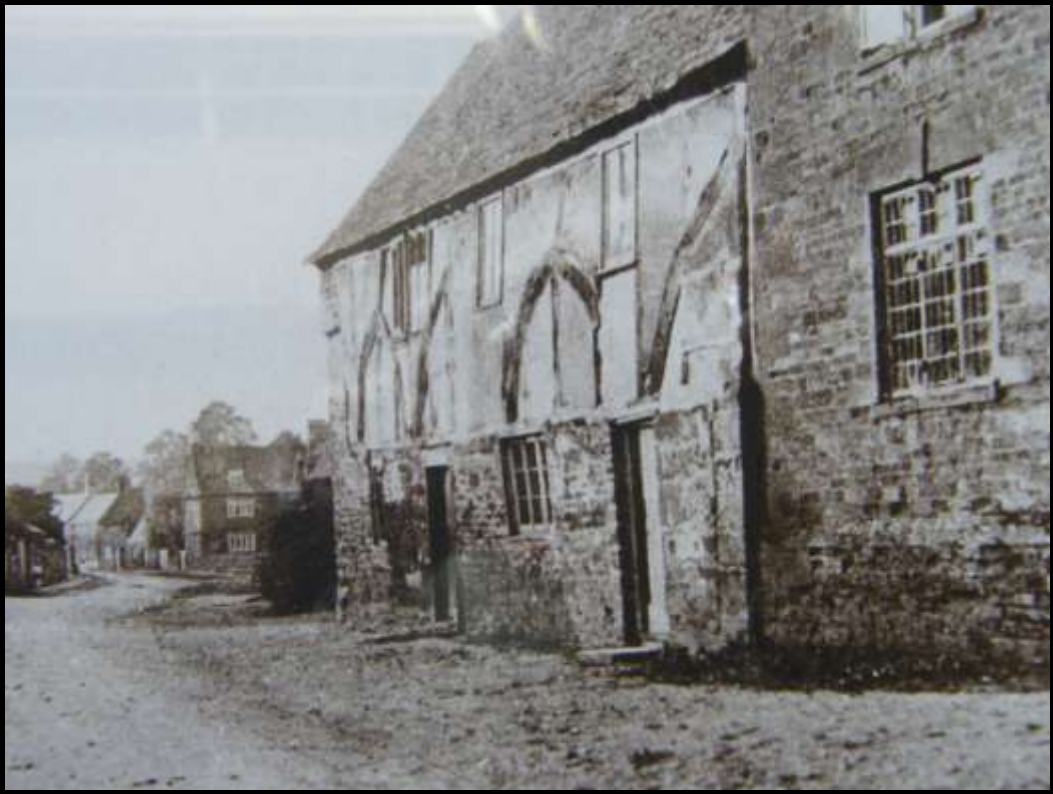
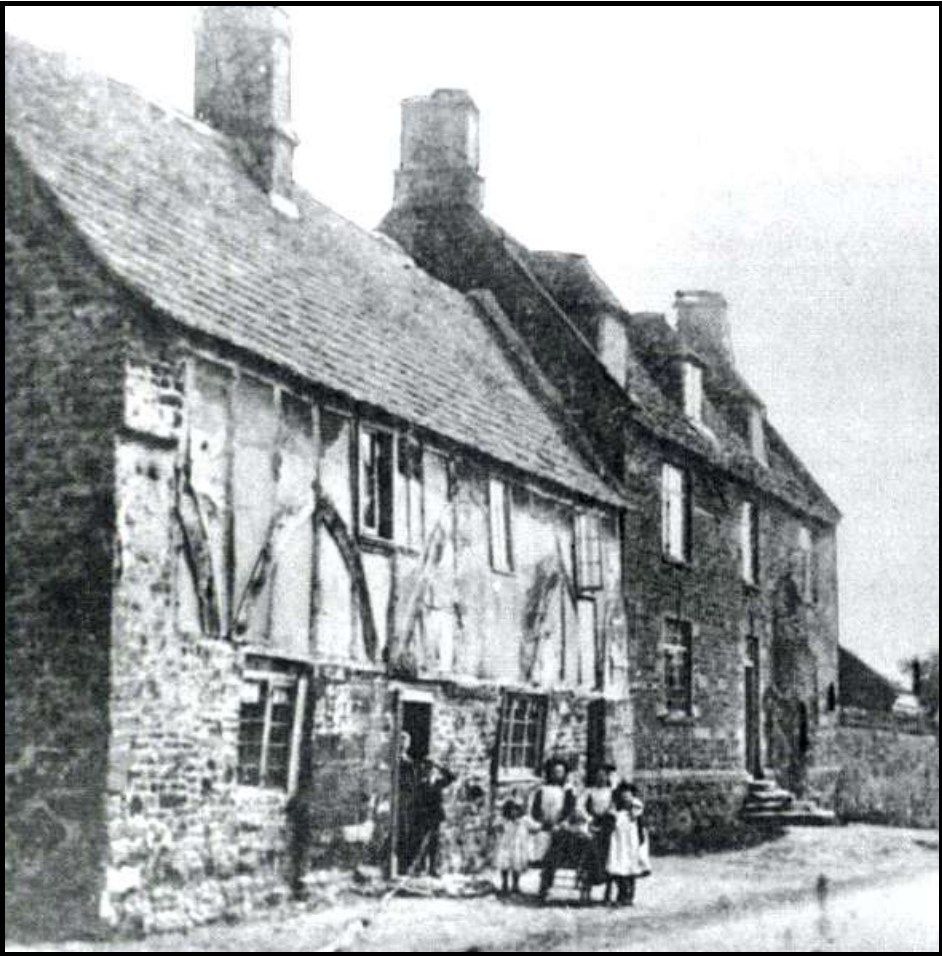
As seen in photographs of c.1900, the front wall formed an impressive feature. Set above a ground floor wall of stone, there were four bays of timber framing, with heavy braces running from high up on the posts down to the cill beam. When examined closely, the pattern of braces is not as regular as it first appears, as the bays differ slightly in length. Unlike other examples of timber-framing in the area, the wall is not formed of closely set studs, but with quite widely spaced posts. The rear wall, of which enough fragments remain to discern the arrangement, was of similar type, with slightly wider spaced studs and only occasional down-braces, rather than a full matching set. The infill to the panels, of which a small section survives to the rear, was of mud mixed with hay, probably with light vertical timber and wattling in the middle. No evidence for the arrangement of windows survives, though these must have been fitted in around the bracing, rather than having major horizontal members.

Photograph of c.1900

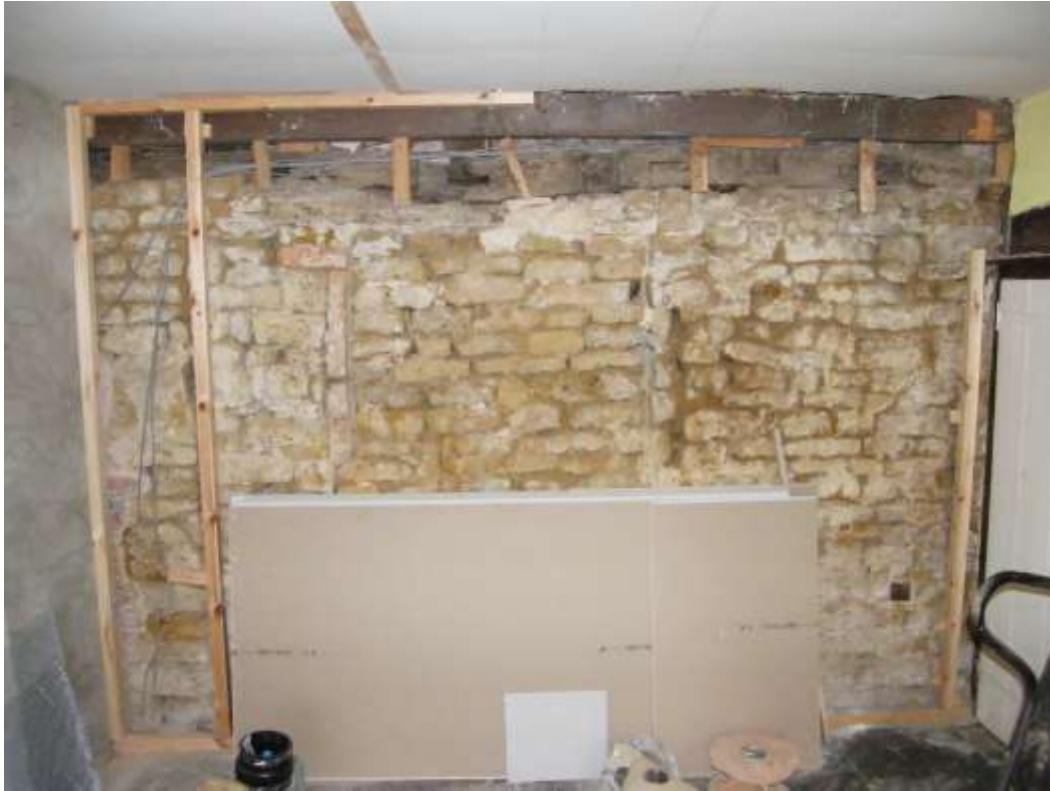
No 1 has main has single main room with inglenook fireplace. In E wall, exposed during current building works, is a remaining section of timber plate, still in situ, set on top of the rear stone wall. Pegs and tenons for 2 posts to first floor. Regular mortices for heavy flat-set floor joists (140mm wide), now missing, with vertical pegs. No pegs or mortices for any timber posts to ground floor – always set on a stone wall. Various other notches etc from later alterations.

Rear east wall of No 1, with timber plate on top of stone ground floor wall

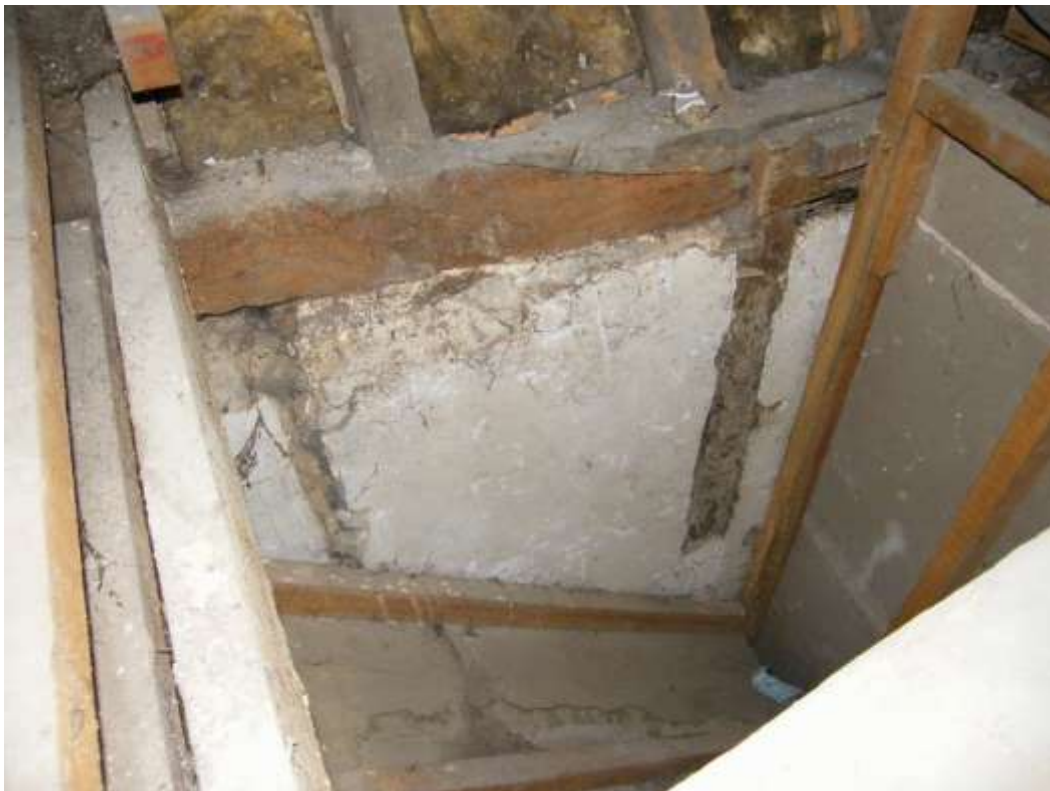
Surviving original infill panel to rear wall of No 1

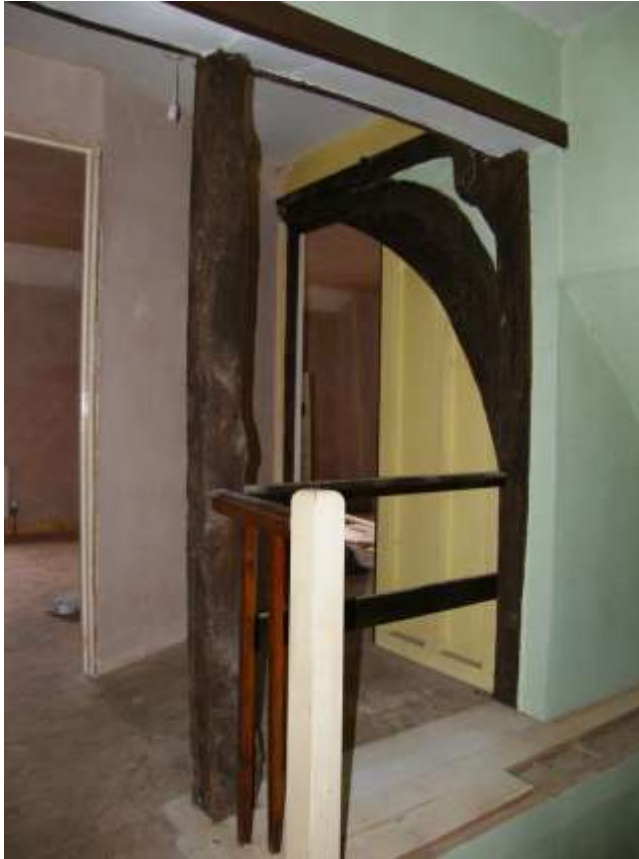
View from north-east wing  
towards Truss T1

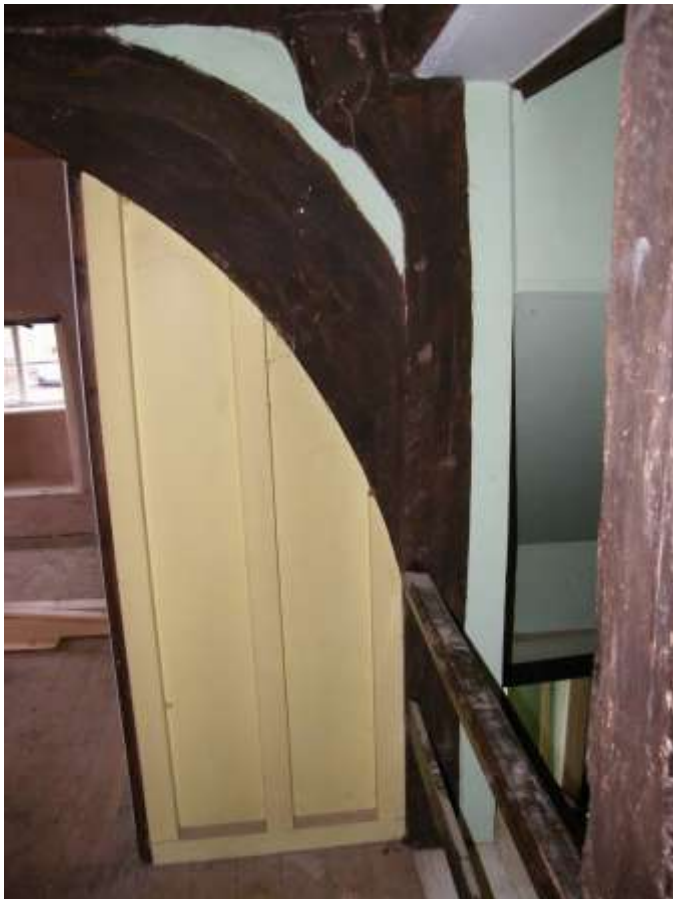
Lower part of Truss T1 with jowled post  
and heavy arch brace

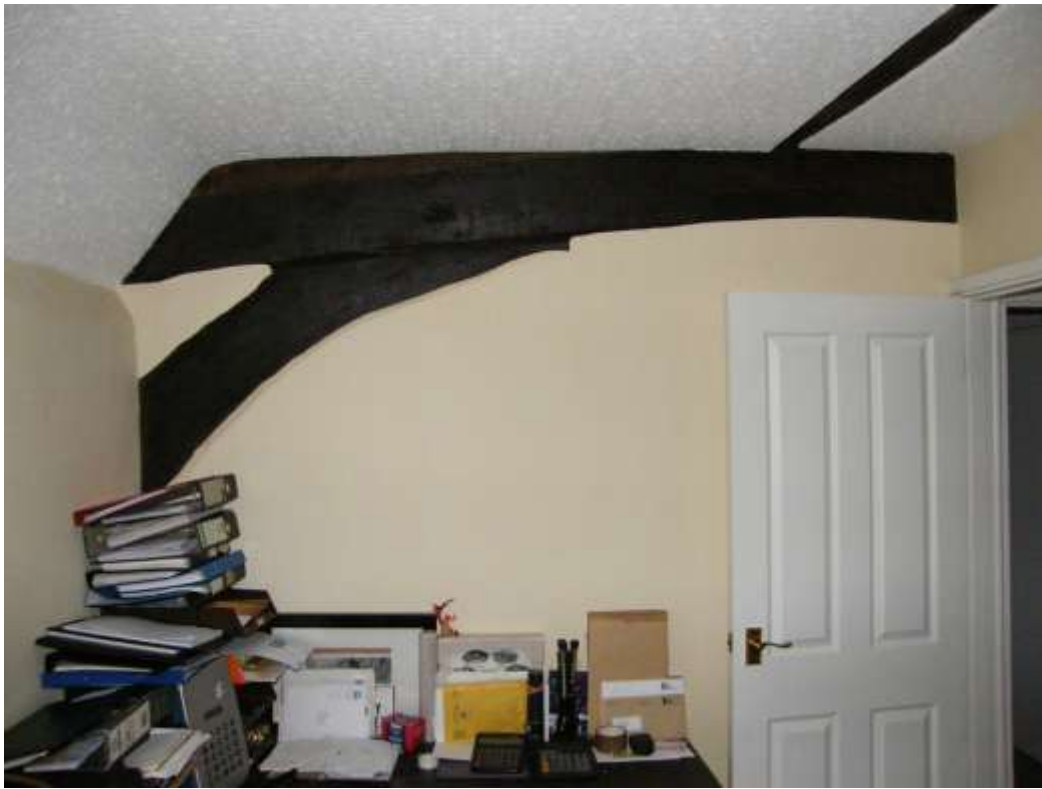
Truss T3 is similar, except that it never had the post/braces detail between tie and collar – no pegholes to the top part of the tie, no mortice to underside of collar. Knife-cut setting out marks to S face of E principal, also a big scribed carpenter's mark VV. The collar has 3 small mortices to the top edge, unpegged – perhaps a later alteration. The purlins are both jointed at this truss, with bridle joint set on edge to E but on flat to W. Surviving E wall post has jowl cut back.

South face of Truss T3 in No 24

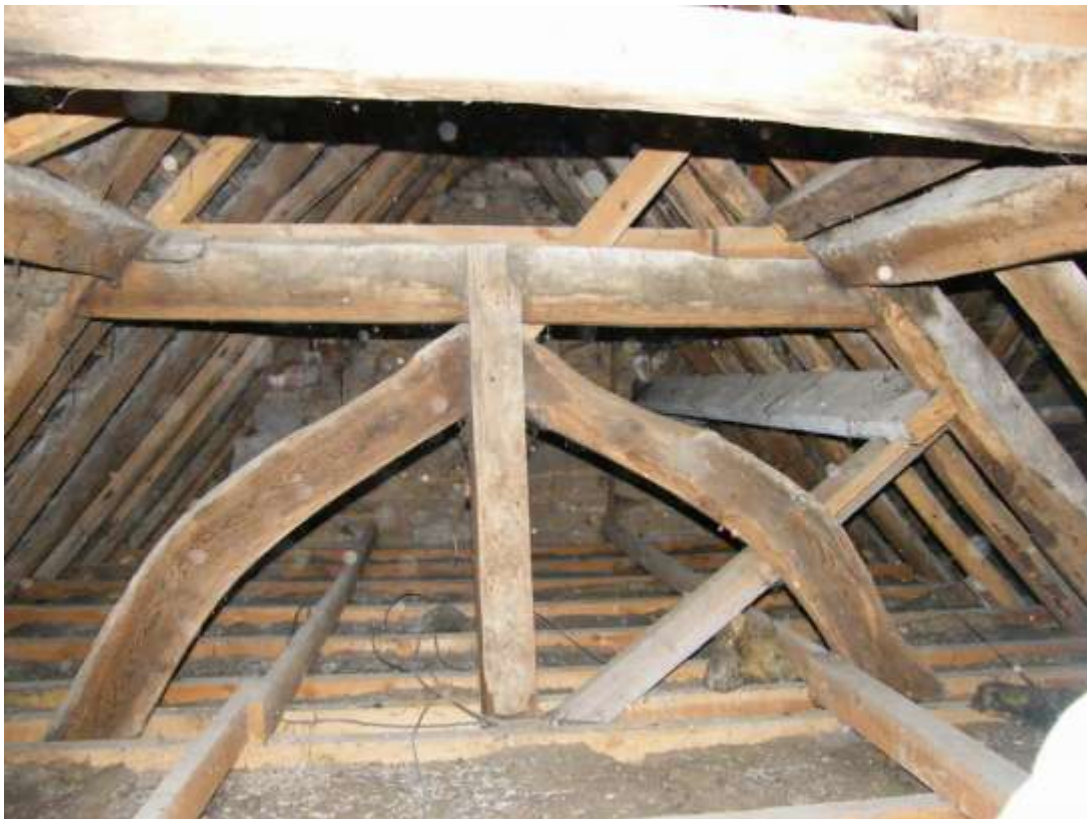
South face of Truss T1 with decorative bracing between tie-beam and collar

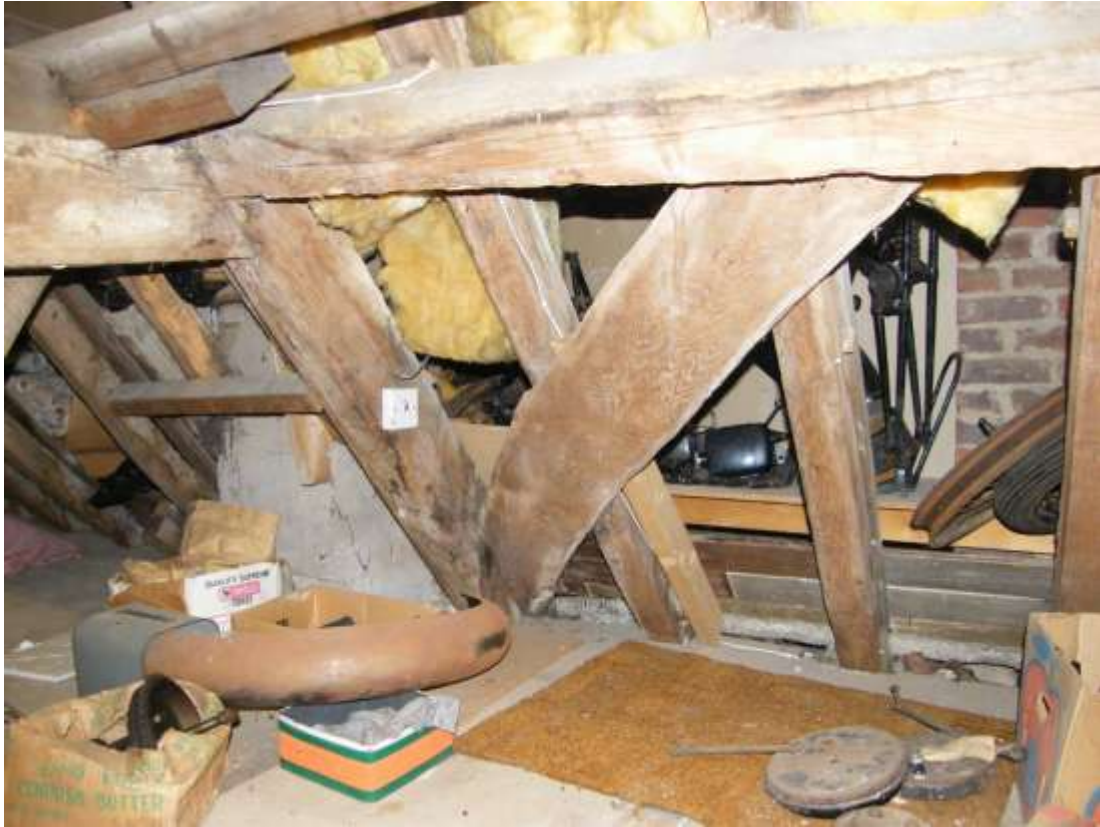
South side of Truss T3 with purlin and wind-brace

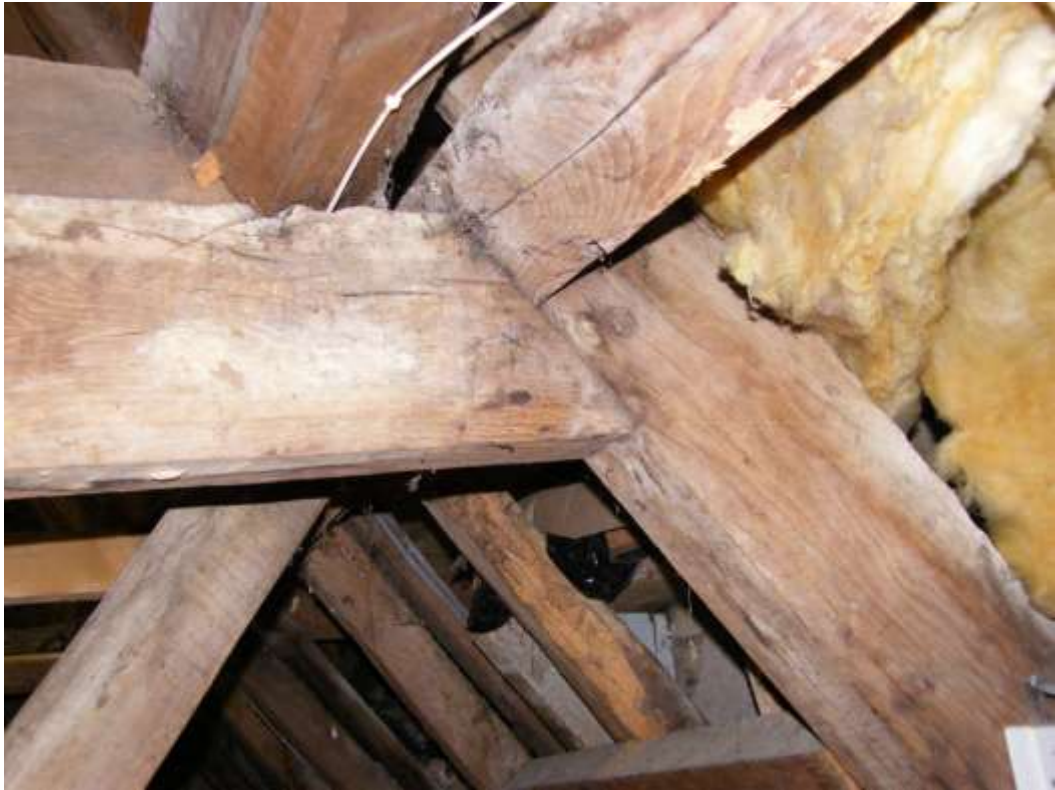
Detail as above, showing clapped purlin joint

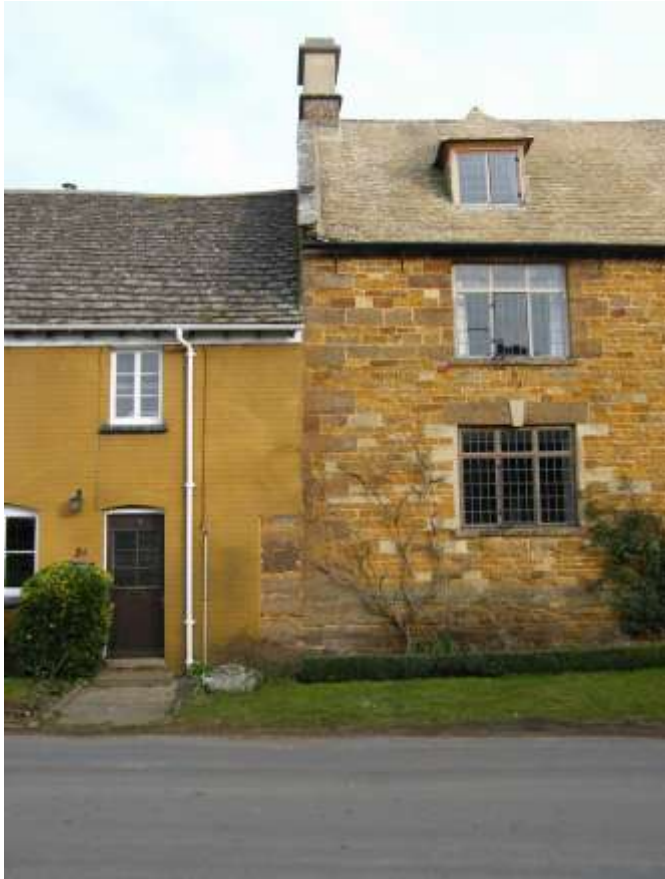
Junction to the Manor House, showing stone wall to ground floor

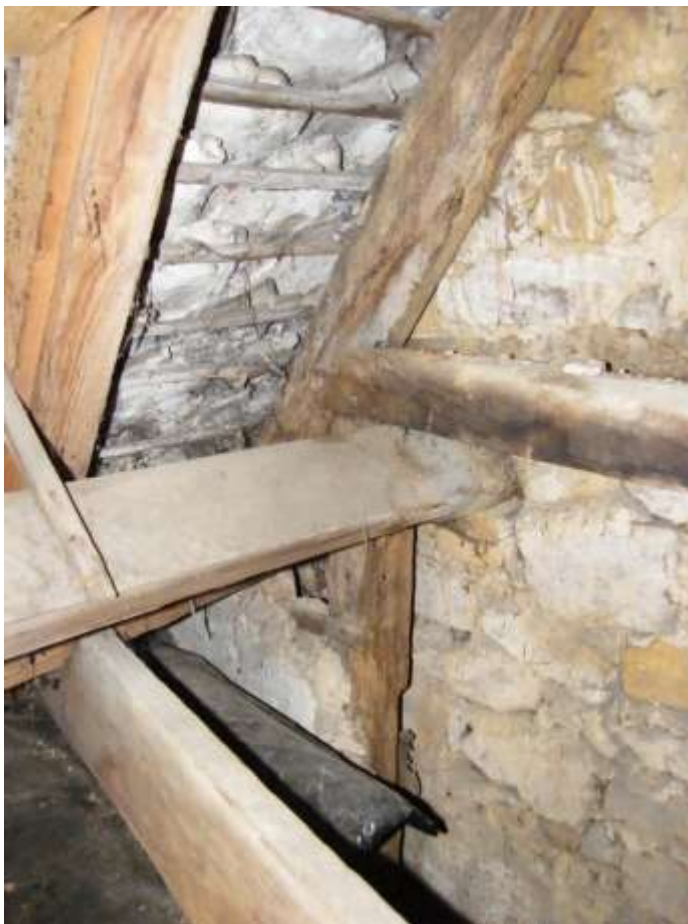
Bay 4 has original purlins and 7 rafter couples. Wind-brace to NE survives in situ, elsewhere evidence not visible. At the S end of this bay there is a hybrid construction, with the gable neither fully timber-framed nor fully masonry. Rafter couple 7 has a thin (200 x 40mm) dovetail-lapped collar, with 1 peg, which clasps and supports the purlin. Truss T4 is not a full truss, having principals only slightly larger than normal rafters. There is a tiebeam and there were probably arch-braces (peghole visible to underside of tie to SW) as elsewhere, but the structure above the tie is different. Thin collar, morticed and pegged to rafters. Rising to this are vertical queen struts, morticed and pegged at the top to the collar. The purlins, which are clasped and supported by rafter couple no 7, simply pass through T4 without contact or support from timbers. They run on into the stone gable wall. One curving down-brace visible from strut to tie, with crude lapped joint at top, nailed. Two small mortices (with cut-off tenon) but no pegholes to underside of collar for missing studs, but not normally spaced. No mortices or pegholes to top of collar. Mud infill survives to SE, with a finished face to outer side, though this is only 100mm away from the adjoining stone gable. The stone gable has rough rubble in clay mortar and is roughly finished, not flat – clearly always an internal face here. So: Truss T4 must have been built first, and the outer face of its mud infill finished. However, it seems likely that the stone gable was constructed shortly afterwards, as it is integral to the construction and supports the purlins. Why bother with the mud infill and external finishing? Maybe it was a temporary closure, with the full stone gable to follow on in the next season's building?

Junction to the Manor House, showing Truss T4 against the Manor House gable. The rafter couple to the left has a thin collar which clasps the purlin
