**Lyddington Manor History Society
Historic Building Survey**

**Pageant House, 47 Main St,
Lyddington, Rutland**

HISTORIC BUILDING SURVEY REPORT

PAGEANT HOUSE, 47 MAIN ST, LYDDINGTON

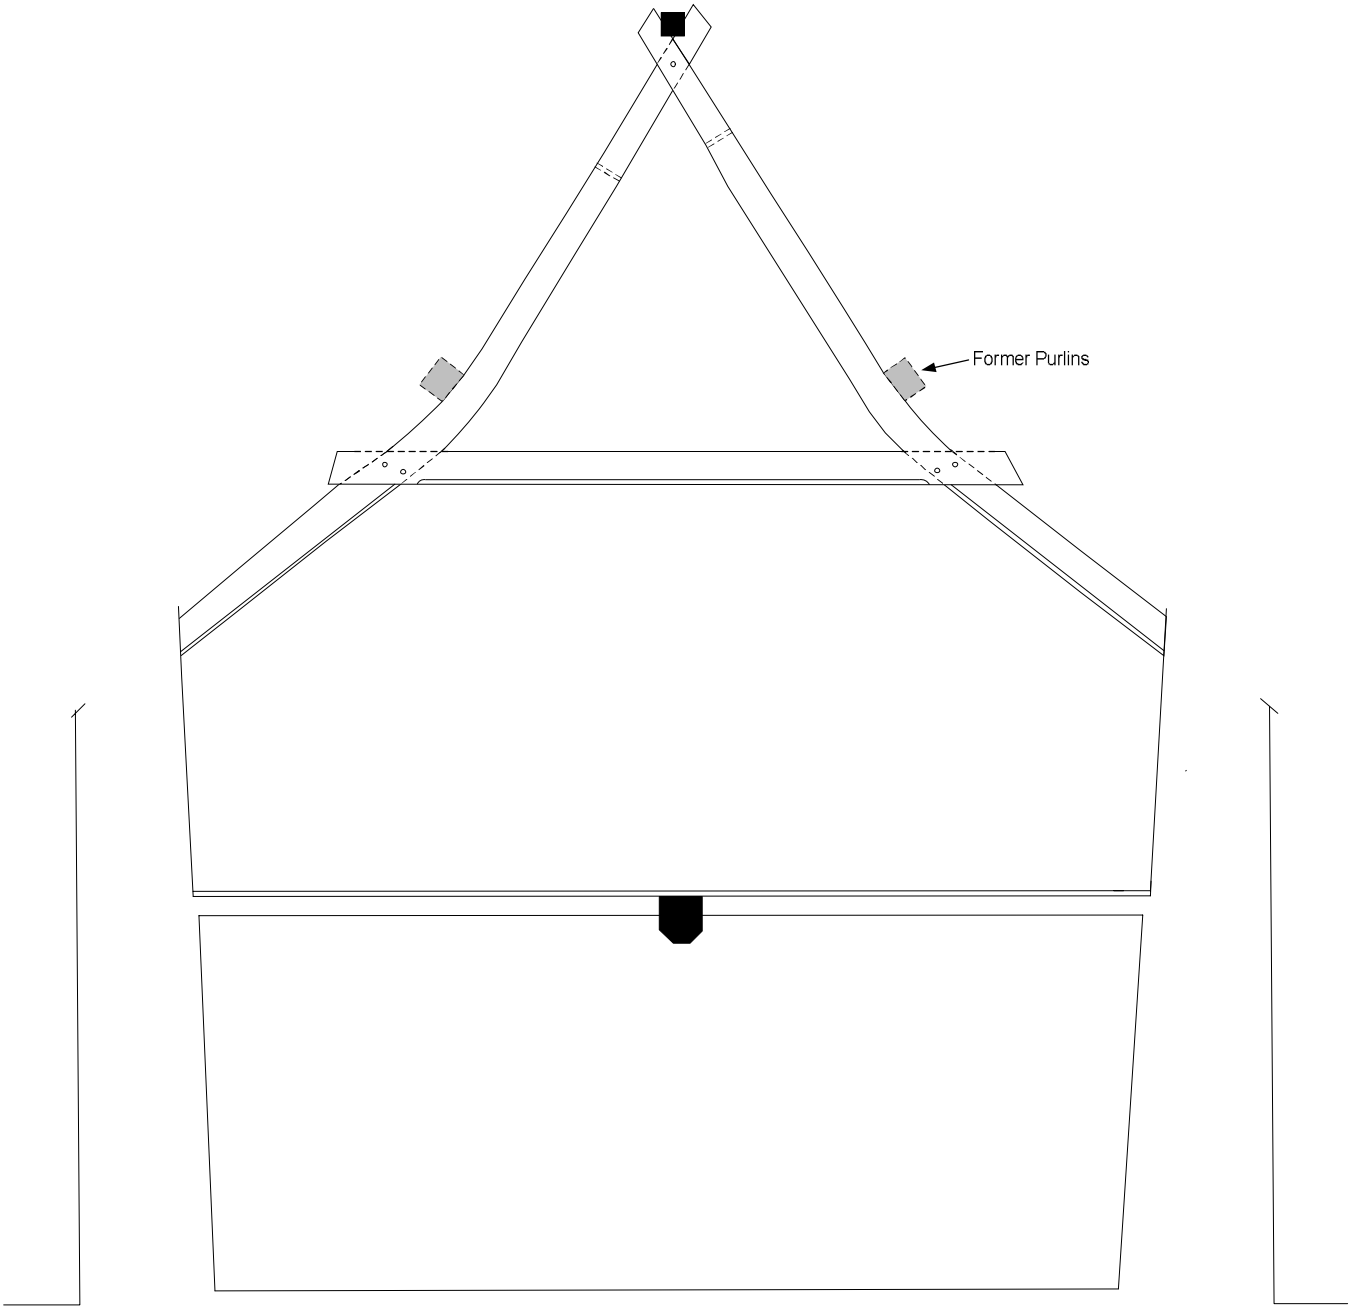
SECTION - TRUSS T1 - SOUTH FACE
 (Later additions omitted)

Truss T1 has thin, inward-curving and rather irregular principal rafters. There has been some distortion, which emphasises the inward curve. There is a straight, lapped collar, fixed with pegs. It is unclear if this is simply half-lapped or dovetail-lapped, as the upper part of the joint is concealed. The apex has a scissors crossing, fixed with a single peg, with cut-out to support the ridge. The E principal rafter is 175 x 65 mm towards the lower end and the W one is 180 x 125mm. The lower part of the principals is chamfered on both sides, though the S side of the E principal also has waney edge. Above the collar, most of the S side of both principals is waney-edged, though the N side is chamfered. The underside of the collar is chamfered to the S side, but mainly waney-edged to the N. There are remains of smoke-blackening to various parts of both principal rafters, and also to the peg of the apex joint (which therefore seems to have been undisturbed). It can be seen that the sooting is deposited onto the surface of the original timber, and is not charring, which would erode the surface. There was more sooting before the major roof repair and renewals of 1988. A little below the apex there are through-pegs for fixing of timbers to the outer face of both principal rafters. These pegs may have been the fixing for a smoke louvre, though they are at slightly different heights. Alternatively, they could be for wind-braces rising from purlin to the upper principal, though this would be an unusual configuration. The distorted section of the W principal has been reinforced with an applied oak plate on the S face and an iron strap on the opposite side, fixed with a forelock (wedged) bolt and large nails (probably an 18th century repair). It was seen in 1988 that an upper, lapped collar and a king strut had been added for further reinforcement, though these were removed during repairs. These timbers were simply lapped and nailed/bolted on, and were clearly not original.

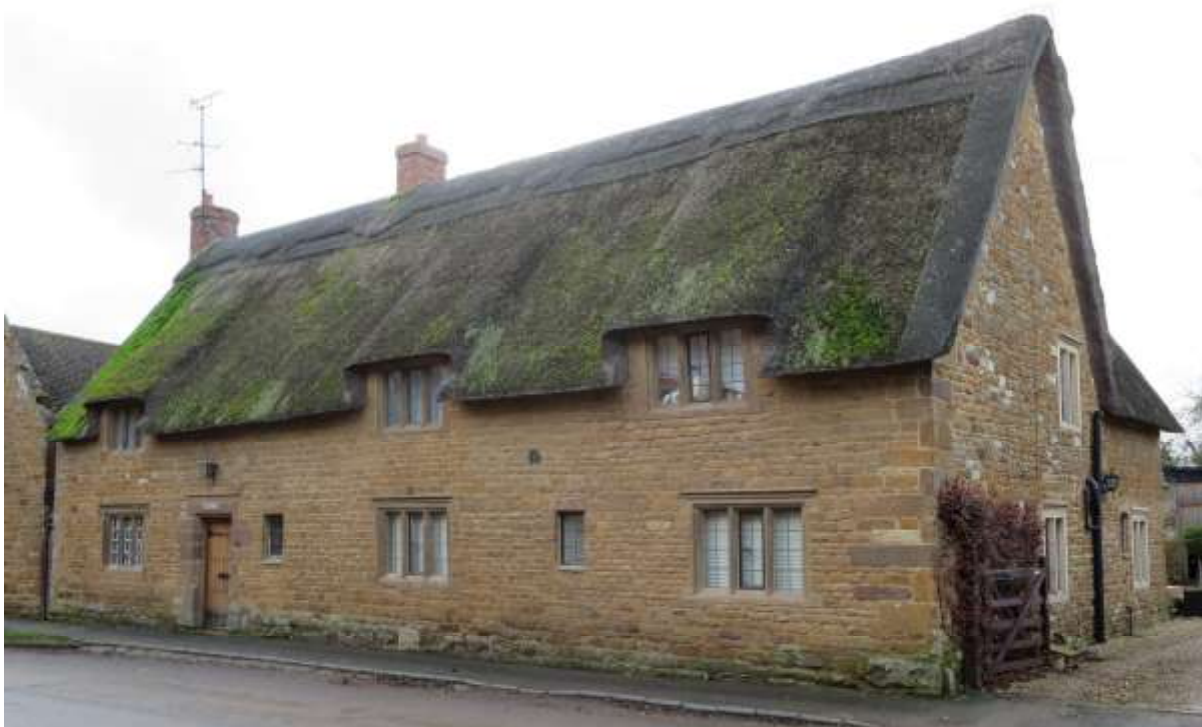
View from north-east

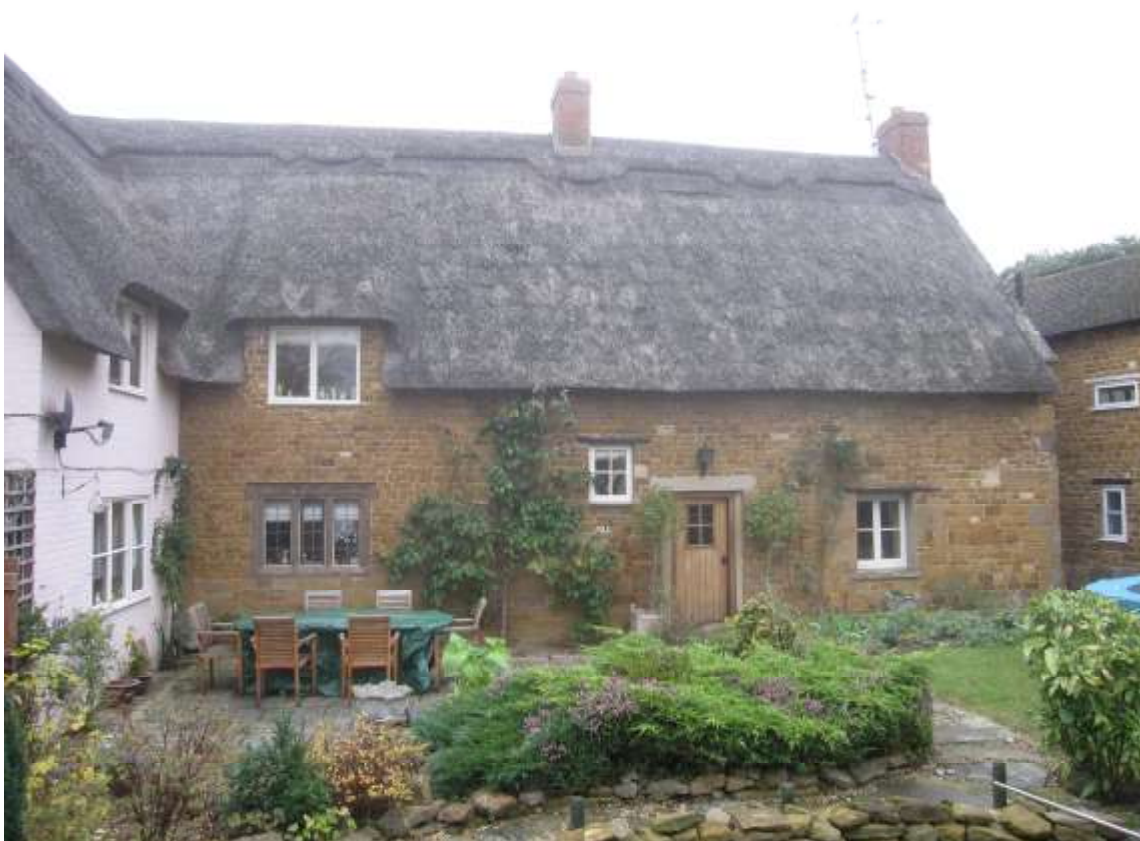
The rear W side has coursed ironstone rubble, with quite a few blocks of re-used, scorched ironstone. Considerable re-facing at lower level of 1988. To the N is a good 3-light mullioned window like those to the front, with a cavetto-moulded cornice. Above this is a timber dormer window, an insertion of 1988. The rear doorway has some early plain ashlar jambs, but the head is rendered. Set between ground and first floors to the N of the doorway is a stairs window, with some older jamb stones and an old oak lintel. This may be an 18th century re-working of an original, smaller stairs window. The S end has a timber window set in deep reveals, with some old large ashlar jambs to the S side, and an old oak lintel. A straight joint to the N suggests this was originally a window, but it was later altered to form a doorway, with square reveals.

The rear west side

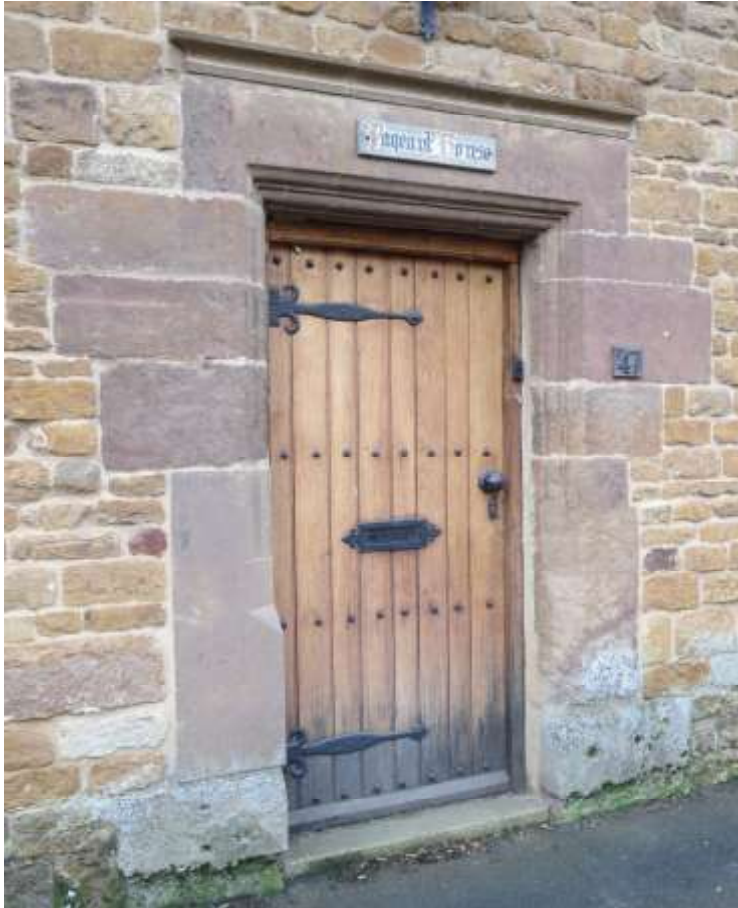
The front doorway

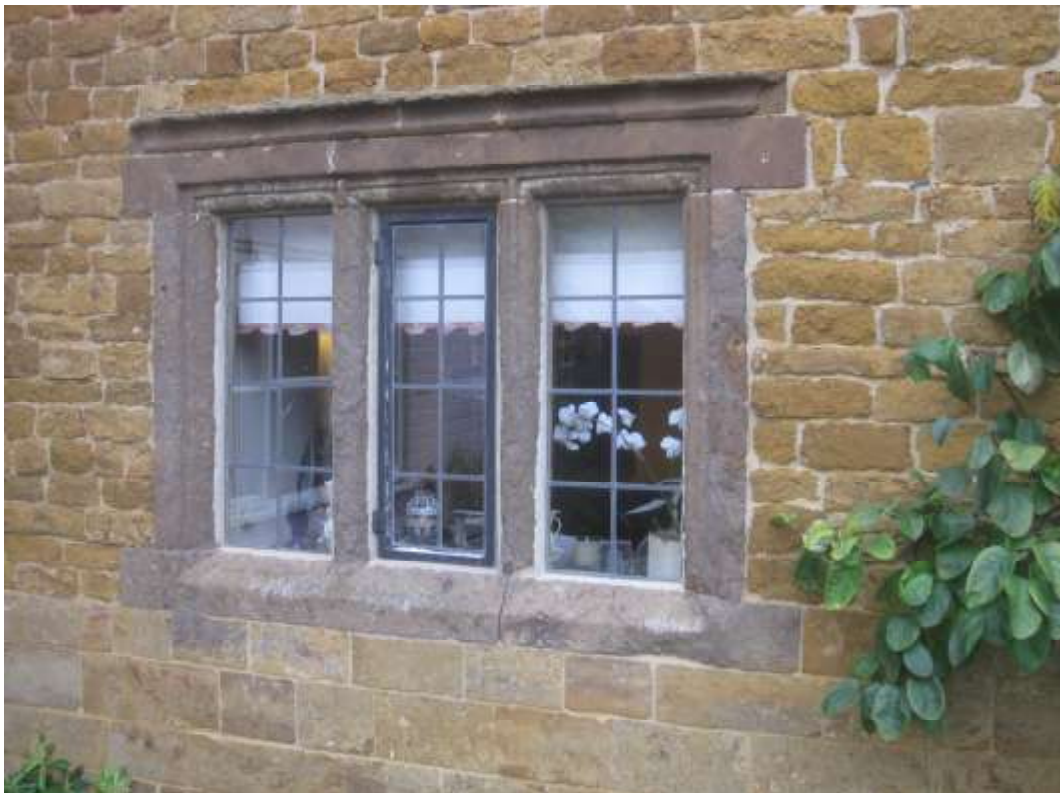
Stone mullioned window to east front

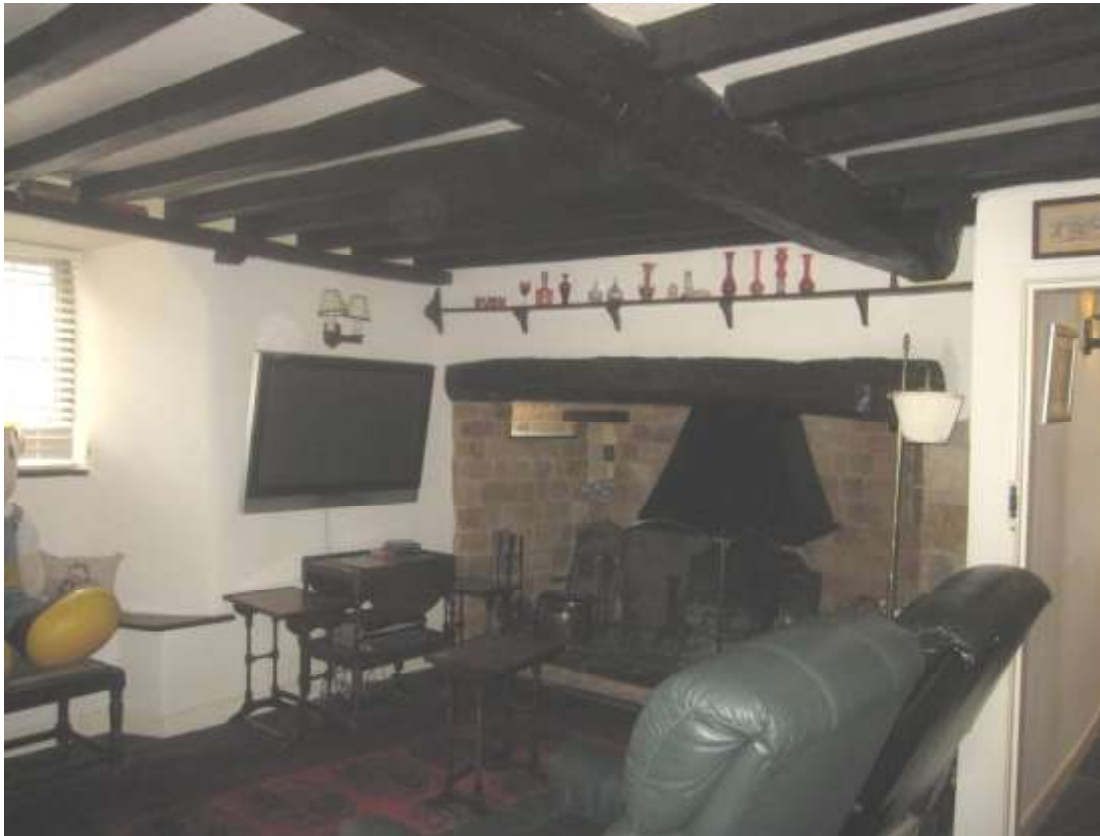
The central room would have been the hall. It has a spine beam with big, slightly irregular chamfers. At the N end are two pyramid stops, the W one damaged but the E one surviving in good condition – a rare and early type of stop. At the S end the chamfers run on without stops into the chimneybreast. Large inglenook fireplace, chamfered beam with crude run-out stop to right, ironstone cheek wall. Floor joists are modern, but are supported along the E wall by an old oak plate, chamfered with no stops, sitting on two oak corbel timbers, to either side of the window. There is no similar plate to the W wall. In the SW corner is the stair, rebuilt in 1988. There was formerly a tight winder stair here (as in listing description of 1985), of which holes for the bearer timbers were observed in 1988. The new stairs has an under-stair cupboard door, a re-used single oak board, moulded around all four edges, with old strap hinges – probably from an old oak chest. A recess in the N wall indicates the location of the earlier doorway.

The central room (hall) looking south

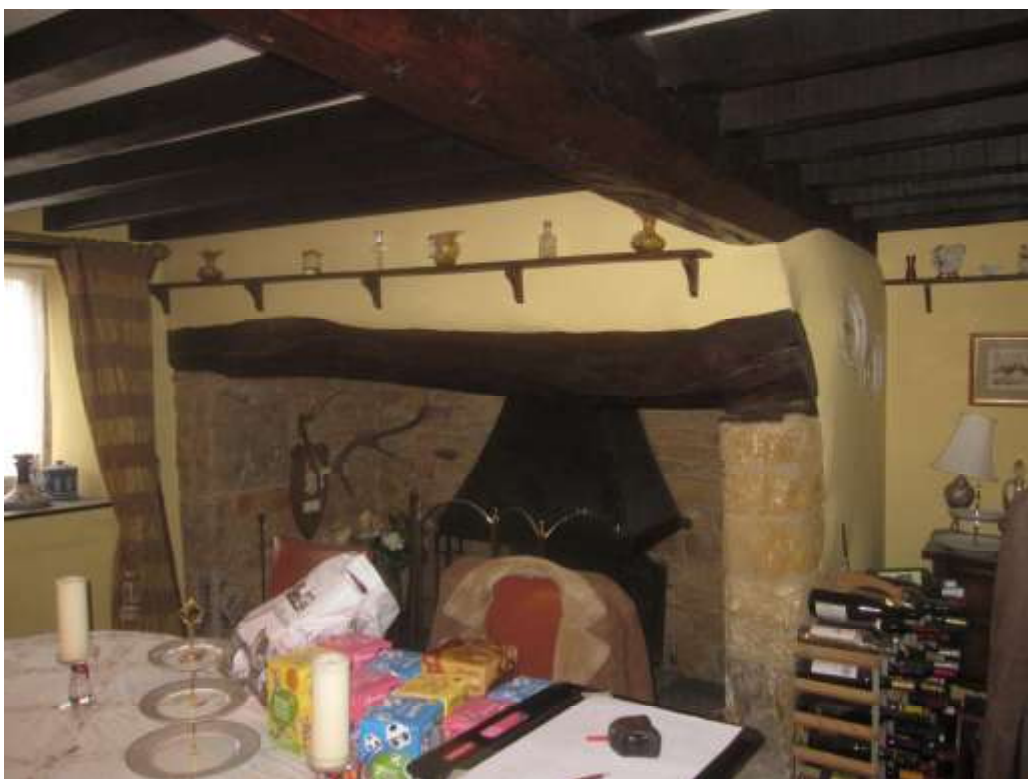
Inglenook fireplace in the south room

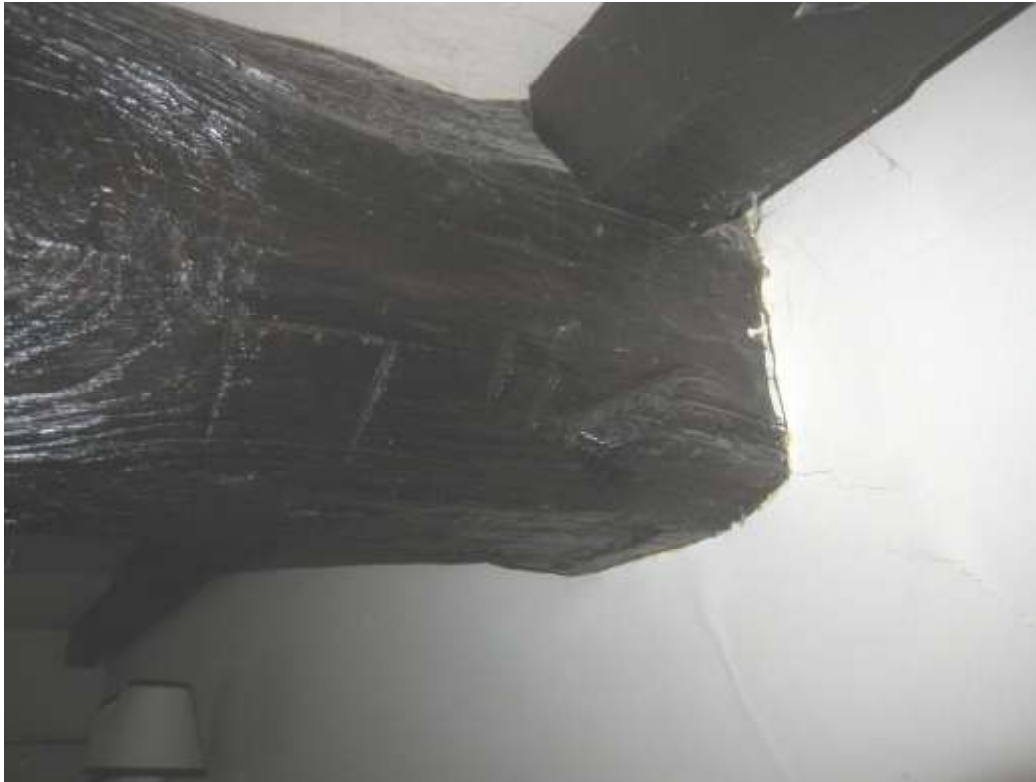
Pyramid chamfer stop of early type to ceiling beam of central room

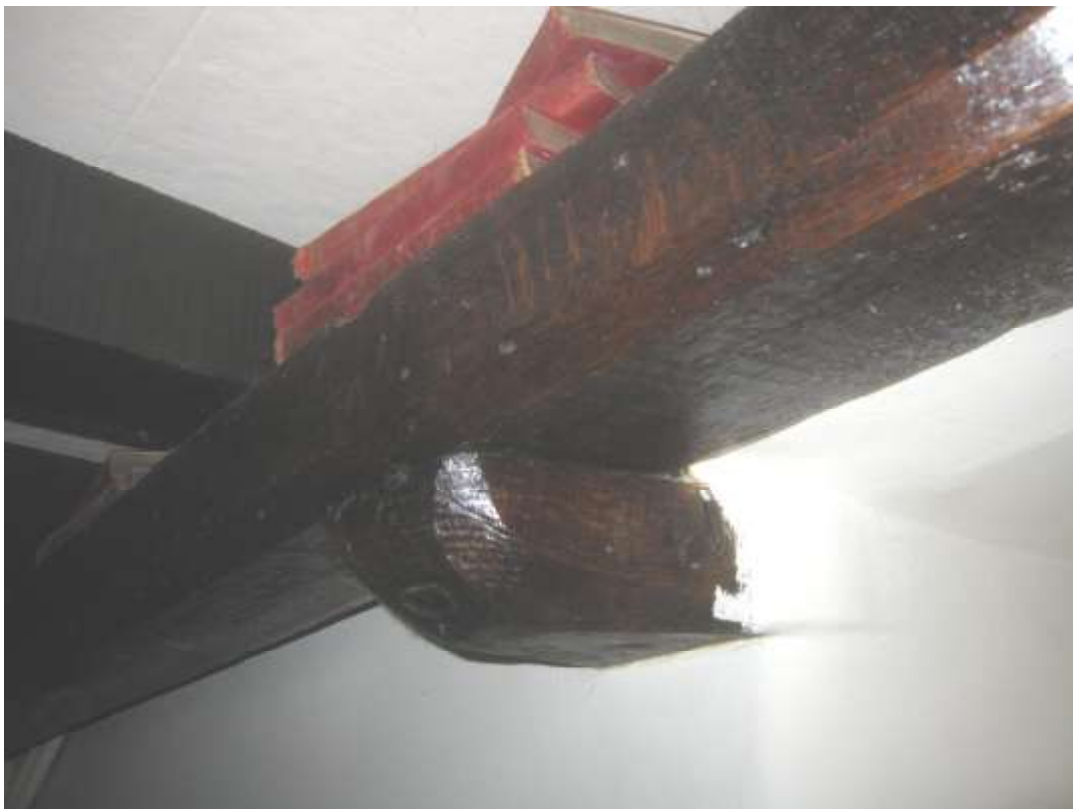
Oak plate on corbels, supporting ceiling joists to east side of central room

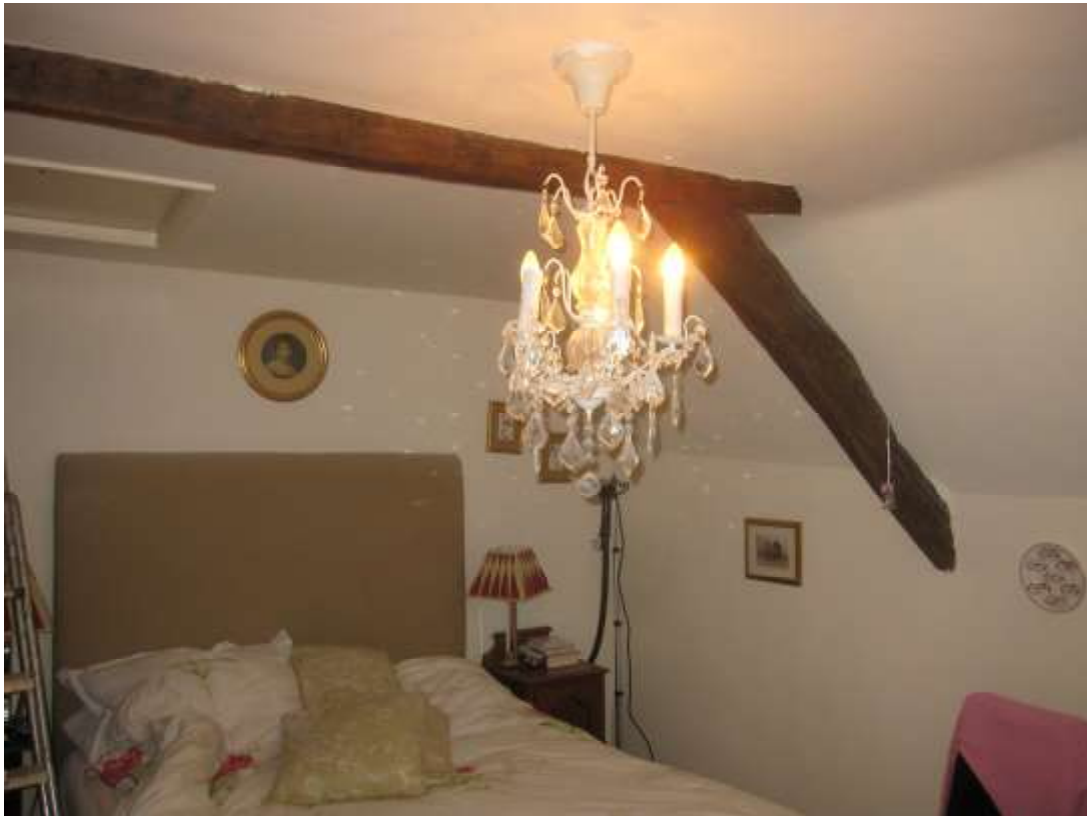
Truss T1, south side

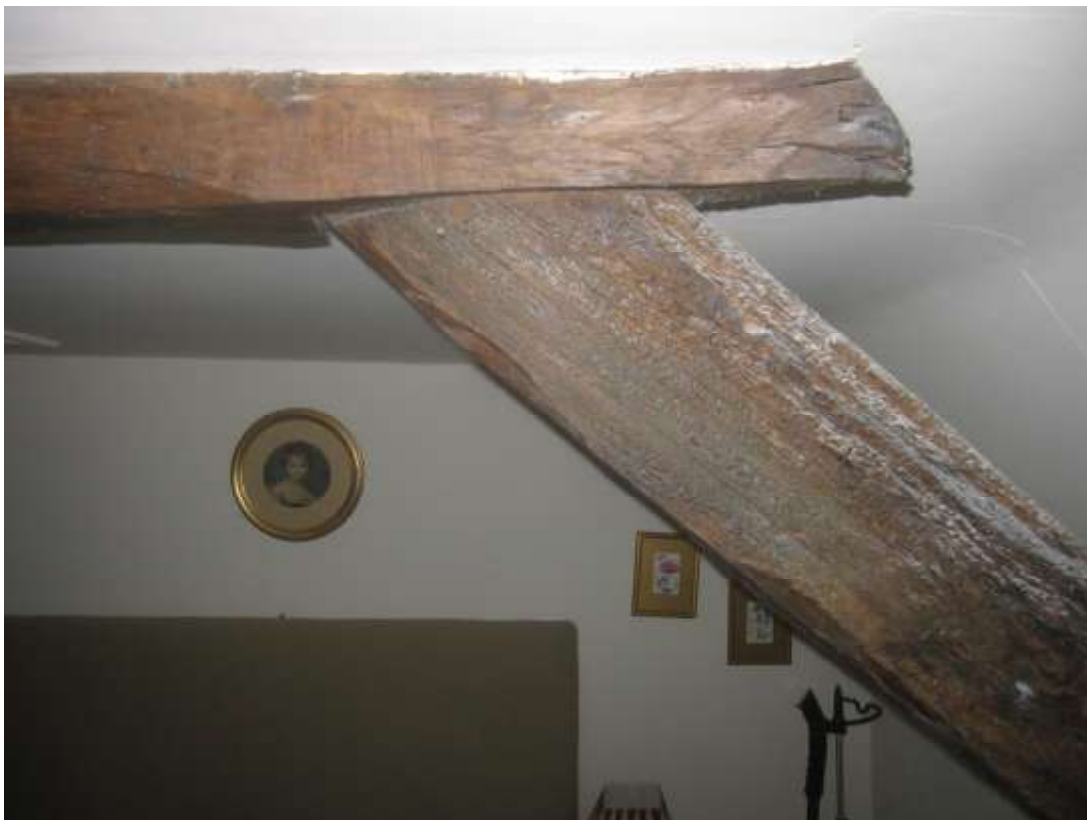
Lap joint to collar/principal rafter of truss T1

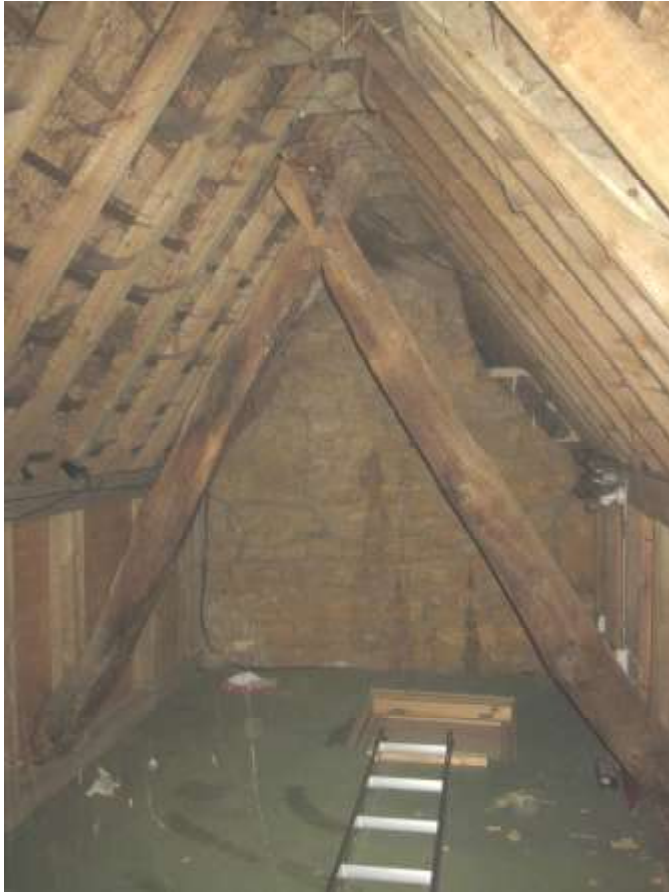
Truss T1 south face

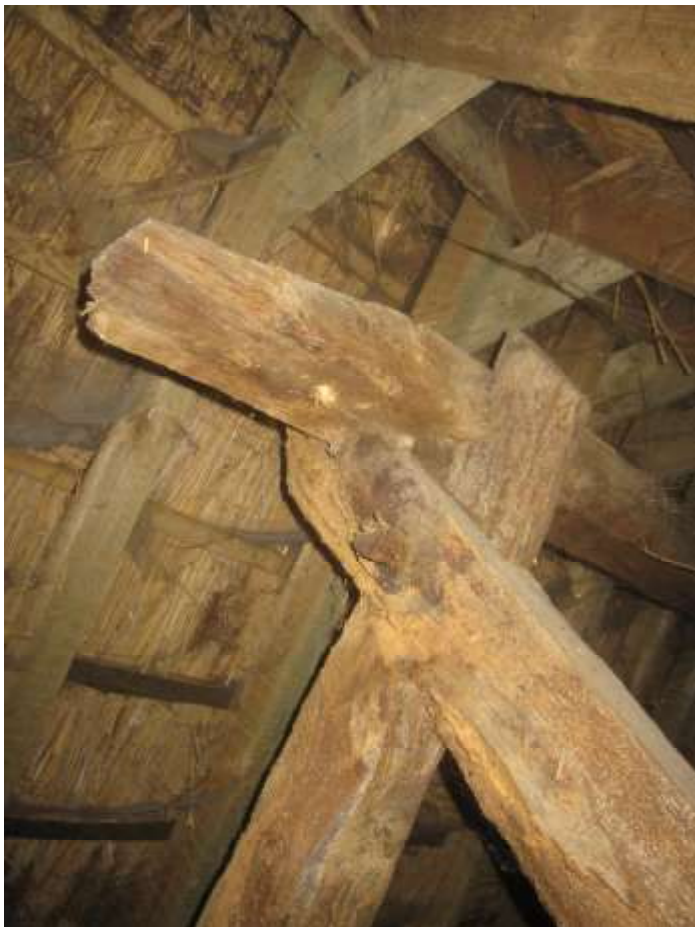
Apex of truss T1

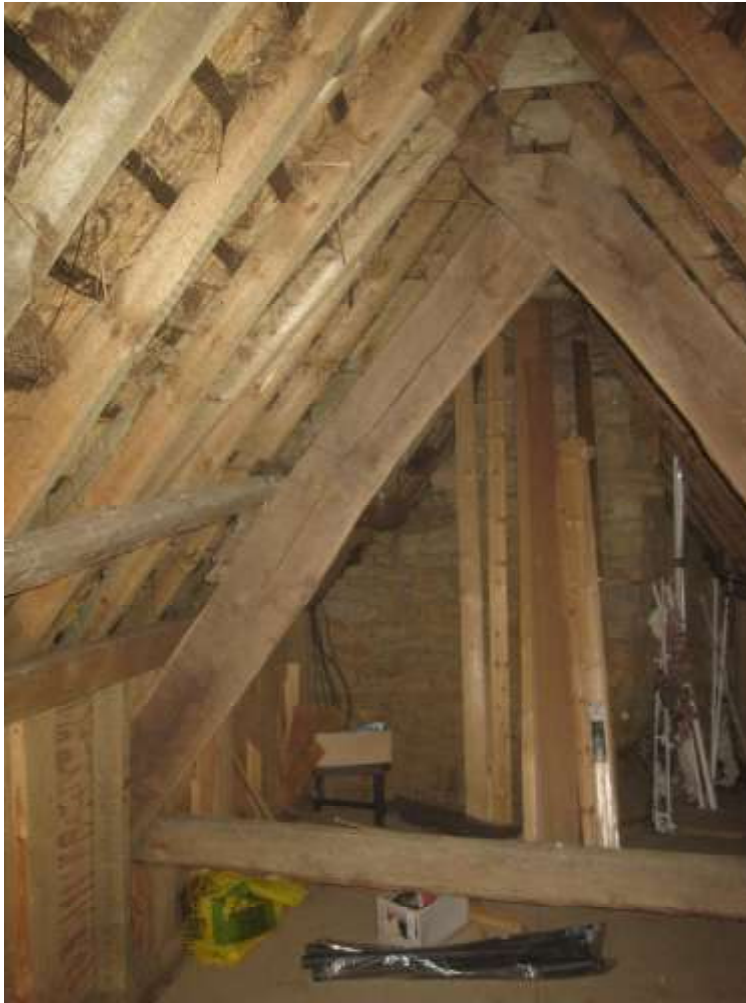
Truss T2, though also of A-frame form, is of different character. It has quite large-section, straight principal rafters, with a thinner, lapped collar and a scissors apex. There were two sets of purlins, the lower ones supported on the collar. The upper purlins to the E side can still be seen, one a re-used timber with an empty lap-joint matrix. All the timbers are clean, with no smoke-blackening.

Truss T2, north side

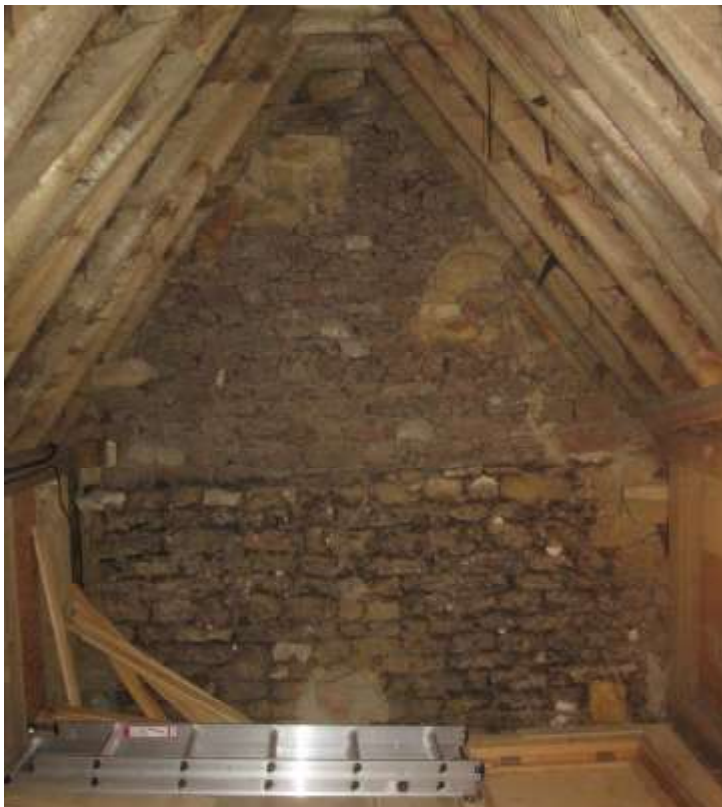
The S side of the cross-wall to the S of T2 (on the hall/parlour division) has the remains of quite heavy sooting on the lower half of the masonry in the roof void. Above this, the wall is built of reddened fire-scorched ironstone, with no sooting. Evidently, the upper part must have been rebuilt later, using fire-scorched stone; if the scorching had occurred in situ, the lower part of the wall would also be scorched. The roof void over the N end has been lined with boarding and cannot be seen. The hall stack and cross-wall have ironstone rubble, without sooting or fire-scorching, except for one stone on the upper S side. The internal face of the S gable in the roof void also has ironstone rubble, with a stone chimneystack and later additions in brickwork.

The south side of the cross-wall separating the central room from the north room, with sooting to lower part and upper part rebuilt in fire-scorched stone.
