Lyddington Manor History Society
Historic Building Survey

Fern Cottage, 43 Main Street
Lyddington, Rutland

HISTORIC BUILDING SURVEY REPORT

FERN COTTAGE, 43 MAIN ST, LYDDINGTON

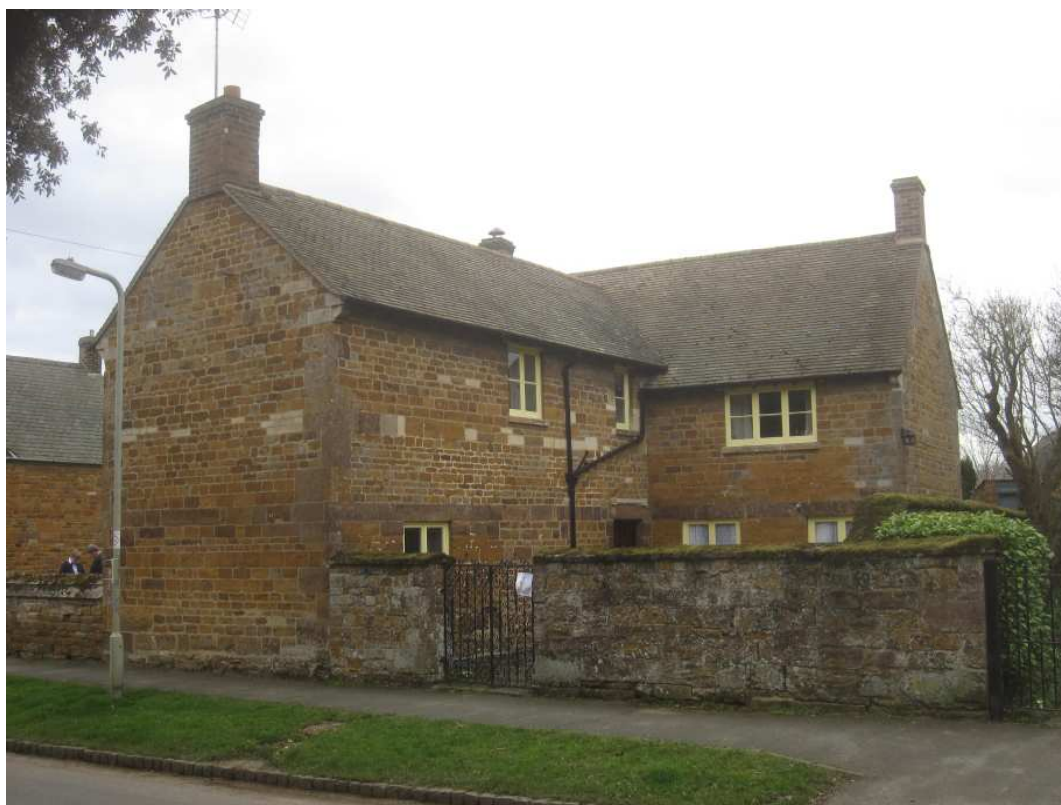
View from the north-east

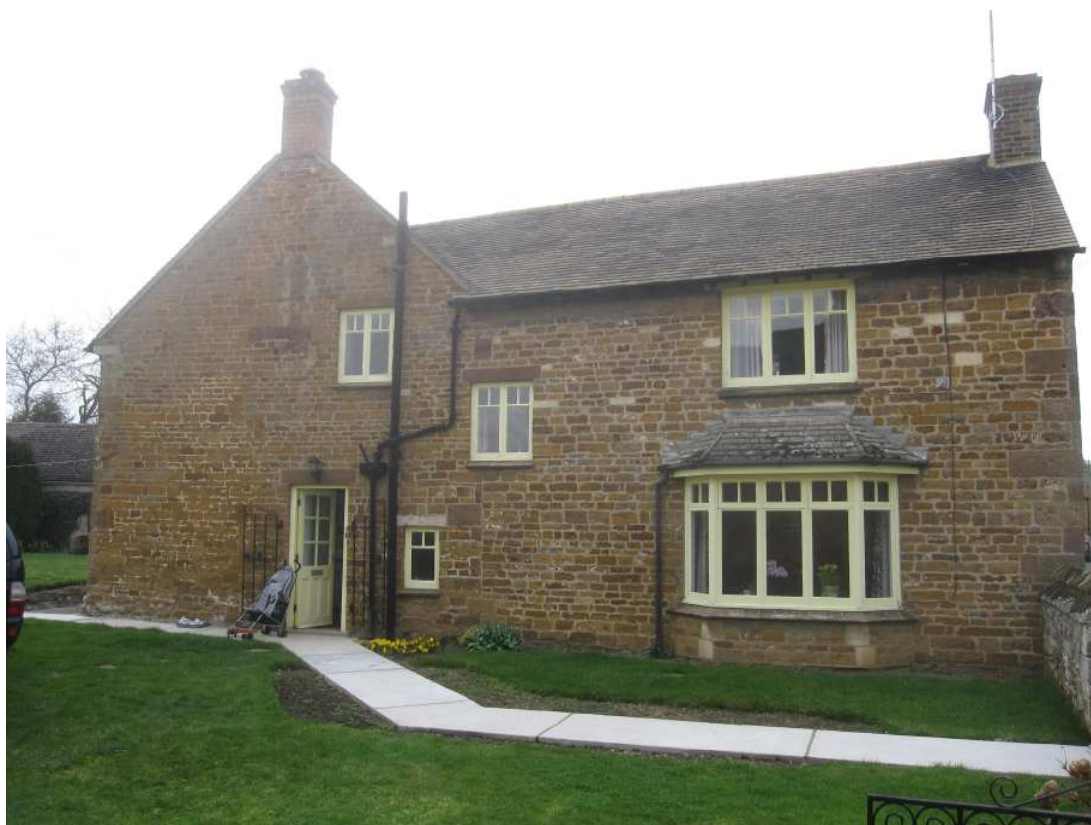
The main block S gable has a doorway, 1st floor window and gable kneeler all probably of 20th century date. The roof eaves to this range was also raised in the 20th century. There is a blocked window to the former first floor height with a characteristic large brownstone chamfered lintel – probably 19th century. The rear W

View from south

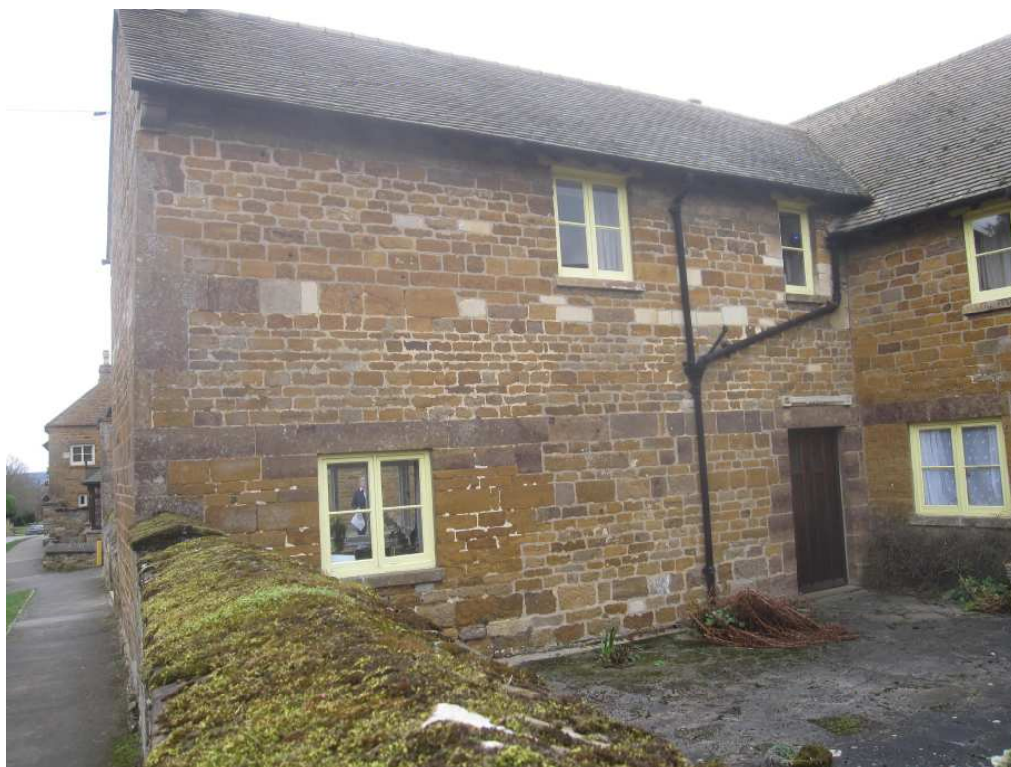
The front wing N elevation has an ashlar brown/purple stone band at first floor height, and another irregular band around 1m above, of larger blocks with some limestone – probably representing an earlier eaves line, as the upper part of the building has had the roof eaves raised in the 20th century. Doorway with large plain brown/purple stone blocks and flat head to W end, perhaps moved here from the centre of the wall in the 20th century (area of disrupted masonry to the centre). Above the door is the name 'Fern Cottage', carved in limestone with a fern leaf decoration, in earlier 20th century style. The front E gable has good quoins, with the ashlar band carried also across the gable. The gable has distinctive limestone (or cast stone?) ovolo-moulded kneelers of 20th century date. The S elevation has a large 20th century bay window, and a stair window with a flat ironstone head of similar date. There is a straight joint at the junction with the main range, indicating that the front wing is a later addition.

The north side of the front wing

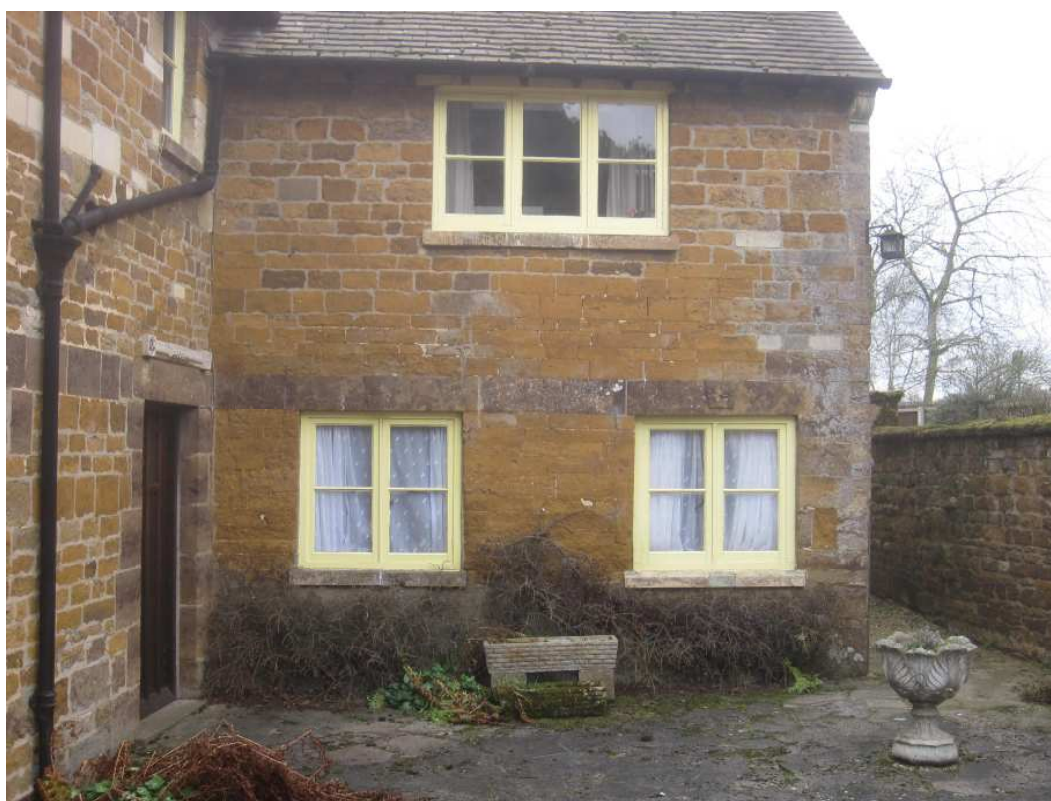
The front wing was probably added around the later 18th or early 19th century, with the E wall of the main block refaced around the same time. Both areas have a matching band of ashlar stone at first floor level, with keystone lintels over the window openings of the main block, typical of this period. The front wing was non-domestic, but its use is not clear. It seems it had a single doorway of normal width to the N front, windows and no first floor. It is unclear if it contained a chimney, the existing chimneystack being modern. Given its intimate location beside the upgraded frontage of the main block, it seems more likely to have served as a workshop or for other ancillary service purposes, rather than being for agricultural use.

The east front of the main rear range

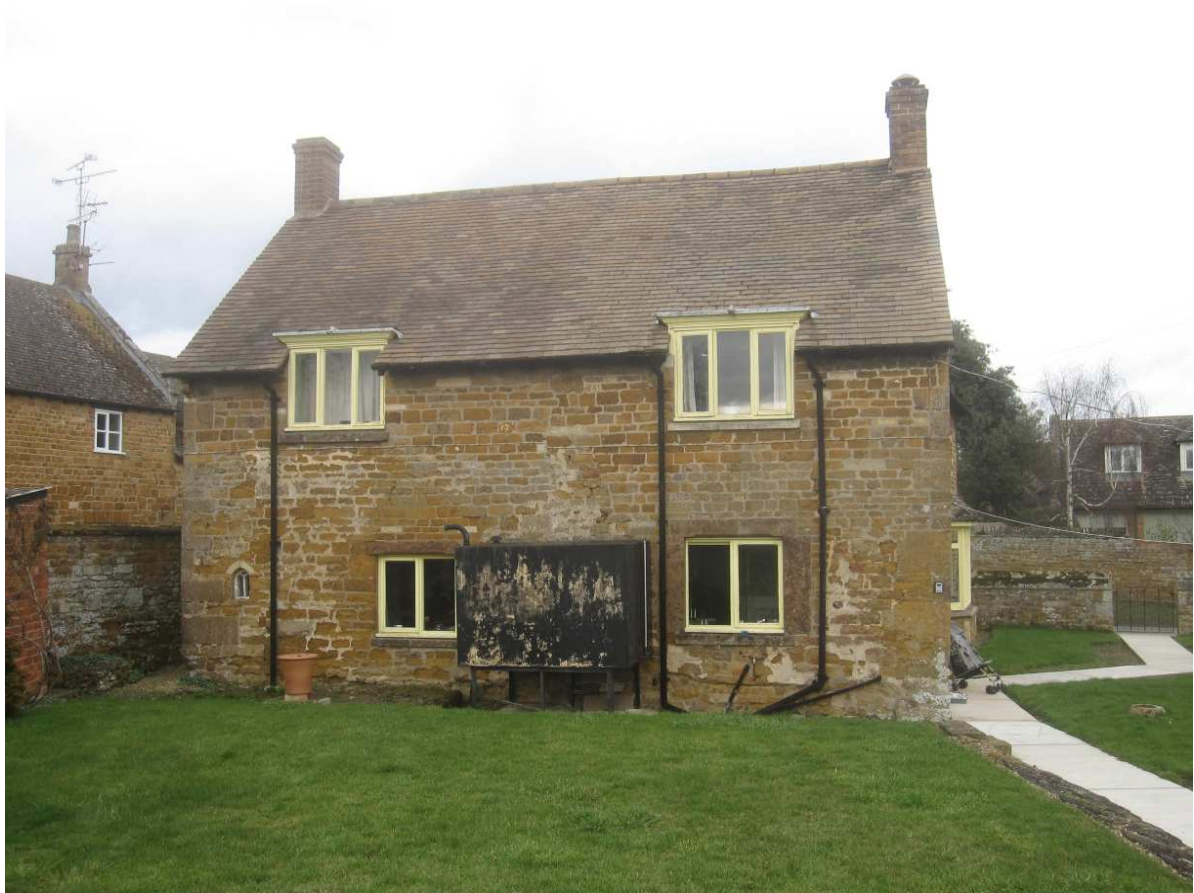
wall has rather irregular masonry coursing in places, with an area of rebuilding above the S ground floor window. The two main ground floor windows have chamfered brownstone lintels of the same 19th century type as the S gable. At the N end is a small single window which has a highly unusual detail – a 2-light inner window with delicate ogee-headed tracery of alabaster. This is presumably a later insertion, probably of the 19th century, re-using a feature salvaged from elsewhere. The first floor has two large dormer windows. The n gable is blank, and has the same ovolo-moulded kneelers as the front wing, for the 20th century roof raising. The front E wall of the main block has a brown/purple stone ashlar band at first floor level, like the front wing, but with finely jointed ironstone walling. The two ground floor windows here have flat lintels with a slightly projecting false keystone. Three 20th century brick chimneystacks.

The rear west side of the main range

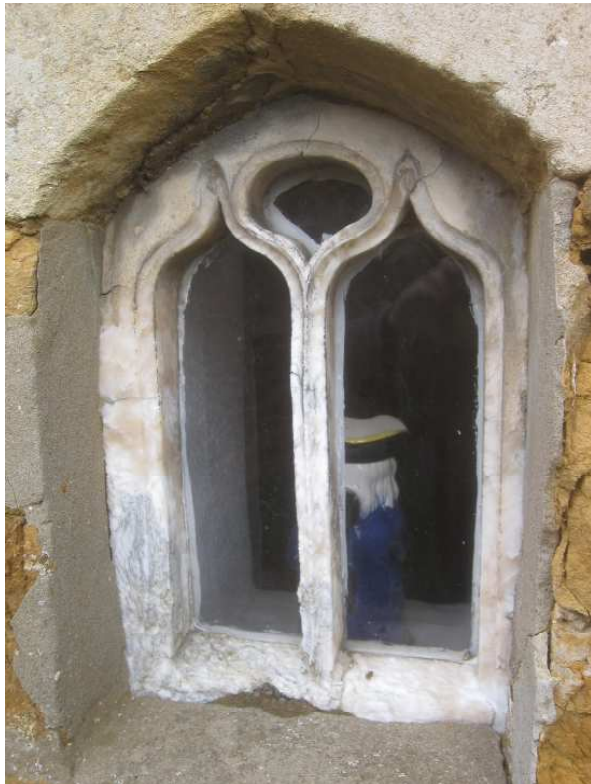
It seems there was a further phase of alteration in the 19th century, when three windows with large, chamfered ironstone lintols were inserted (one to the first floor is now blocked). This may also have been the time when the salvaged features of the alabaster angle window tracery and the Jacobean panelling were imported, indicating an antiquarian interest. By the later 19th century, it seems that the front wing was in use as a laundry, servicing Uppingham School. In 1962 further major changes were made, with the front wing converted to domestic use, the connecting area between the front wing and main block re-worked with a new staircase, the insertion of various new doors and windows under plain ironstone lintels, and the raising of the roof eaves, replacing the lower-pitched thatch.

The re-used alabaster window in the west wall of the main range

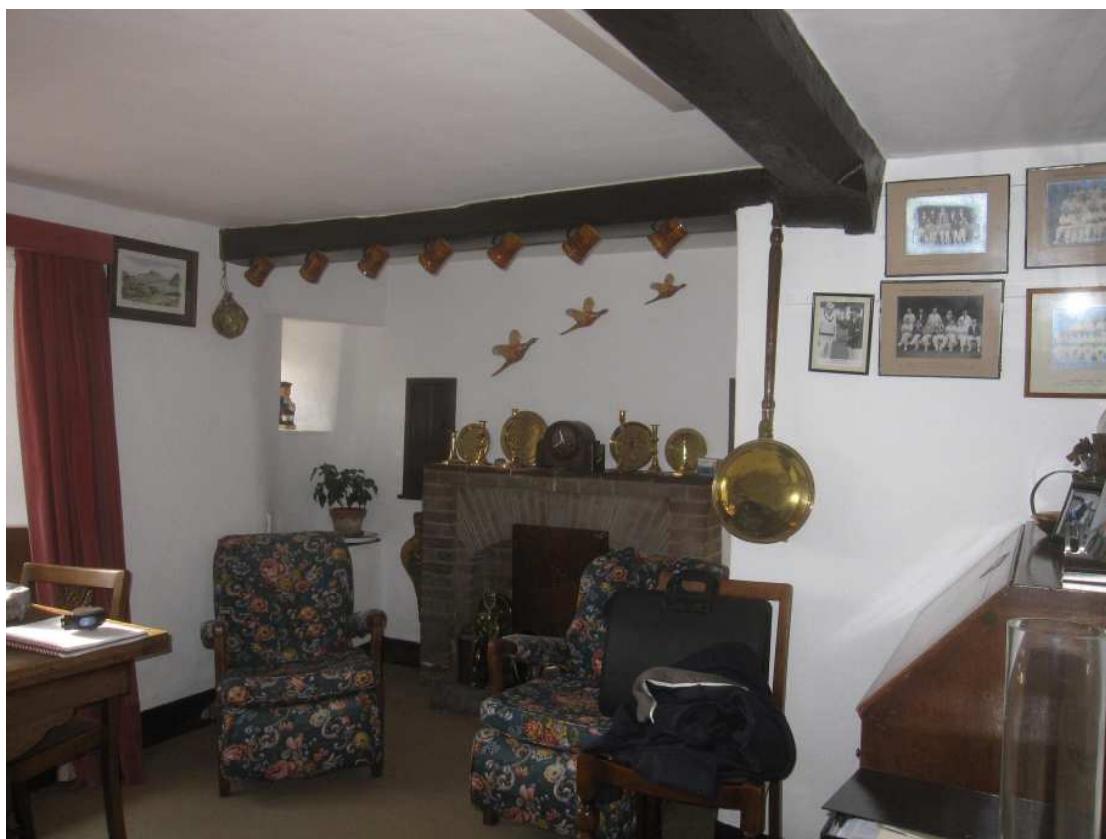
The N room has a good spine beam with finely formed ogee stops to the N end, at the inglenook chimneybreast, but no stops at the S end. The inglenook has a high-set beam, cased in boarding. A partition wall now divides the room, with a narrow room to the east. A rounded corner at the N end, beside the inglenook, is said to have been the location of a former winder stair.

The S end of the house was altered at a later date, but before the addition of the front wing (which abuts the main block with a straight joint). This alteration may have occurred in the 18th century, and the work may have included the central roof truss. The inglenook fireplace had its original, lower-set beam raised and cased in pine boarding around this period.

The north room in the main rear range, with ingle fireplace

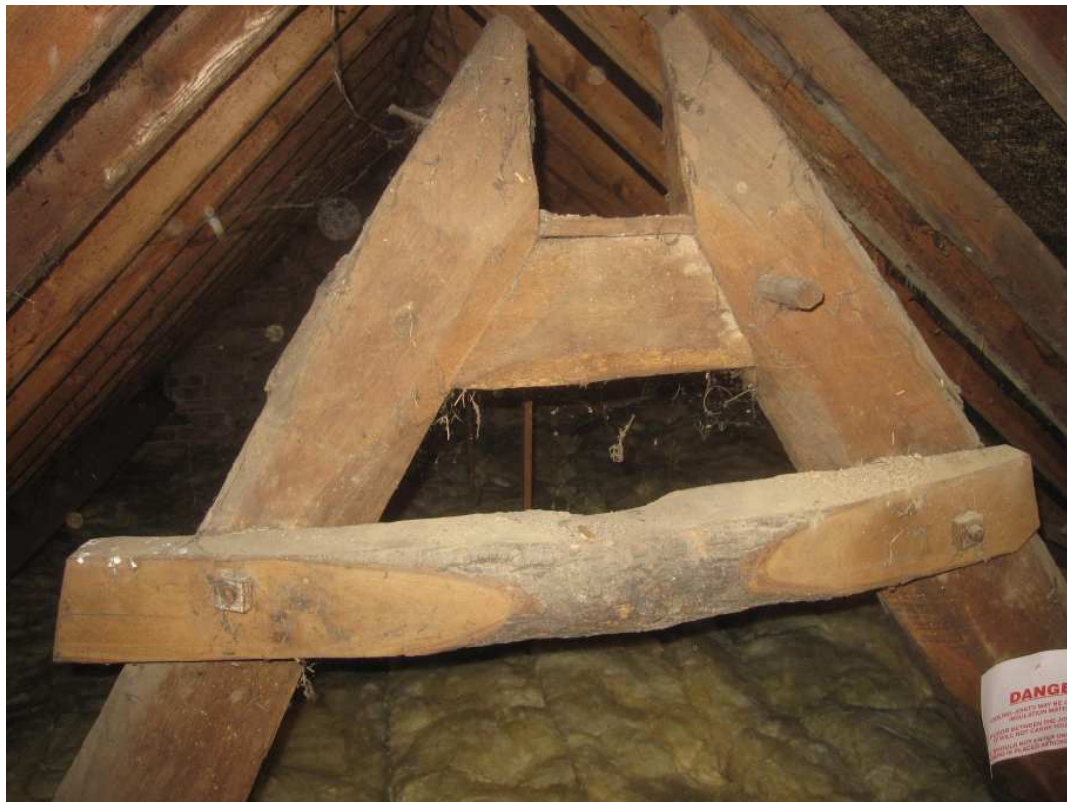
Single roof truss at centre of main block, of A-frame type with dovetail-lapped collar. At the apex, the principal rafters are joined by a short saddle piece, and rise above this to hold a ridge beam, now missing. The purlins and rafters have all been replaced when the roof was raised in the 20th century. The S room has an irregular projecting chimneybreast, probably a later addition for a ground floor fireplace.

The apex of the roof truss to the rear range

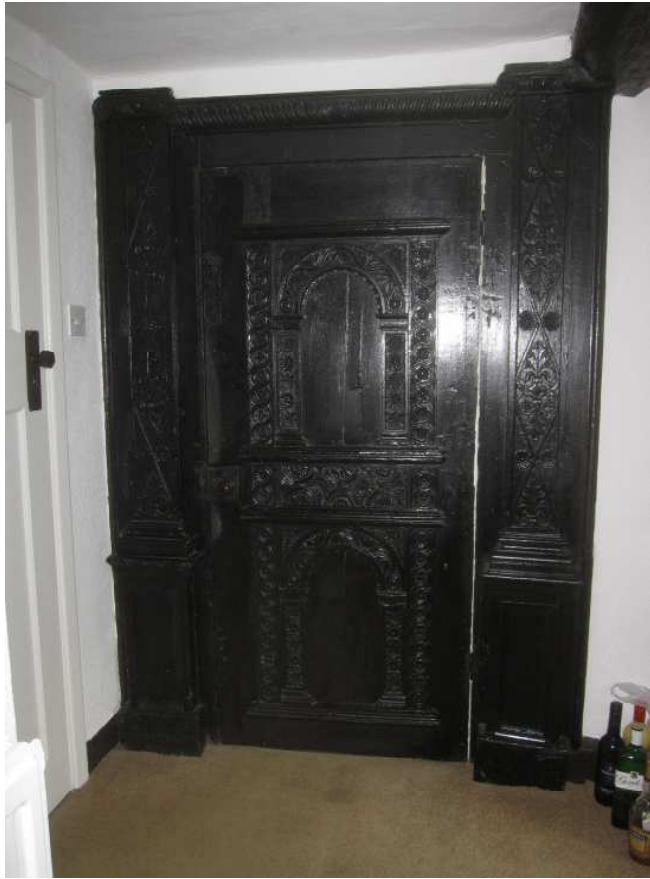
The door in the N room leading to the kitchen, with pilasters to either side, is made of re-set Jacobean panelling. The panelling is of very high quality, a very unusual feature which must have come from a building of considerable status, probably of earlier 17th century date. The door has two arched sections, one above the other, with intricately carved guilloche borders to each side. The pilasters have panelled pedestal bases, shafts with leaf and floral carving, and Ionic capitals. Over the door, between the pilasters, is a finely carved gadrooned cornice.

The re-set Jacobean
panelling in the north room
of the main rear range

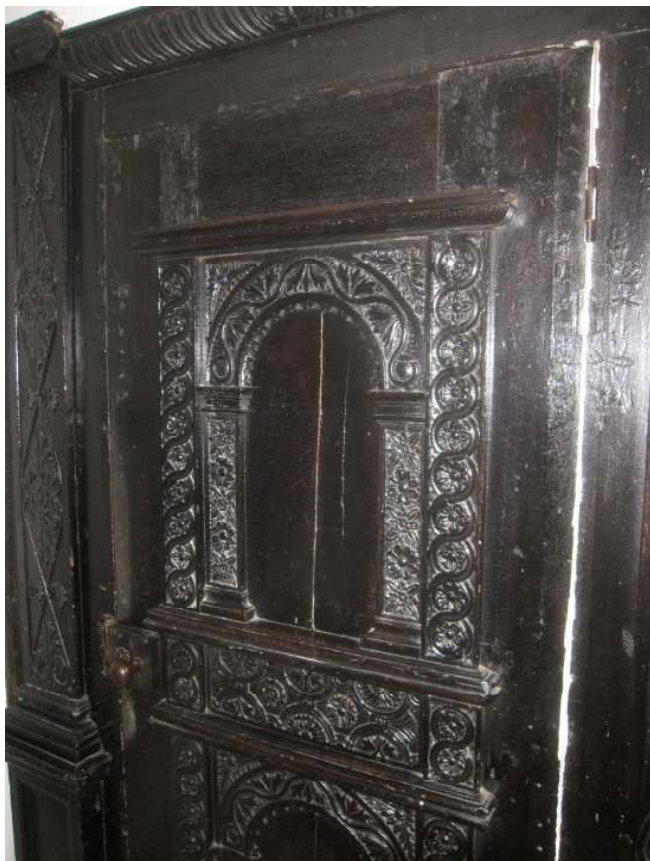
Detail of the panelling

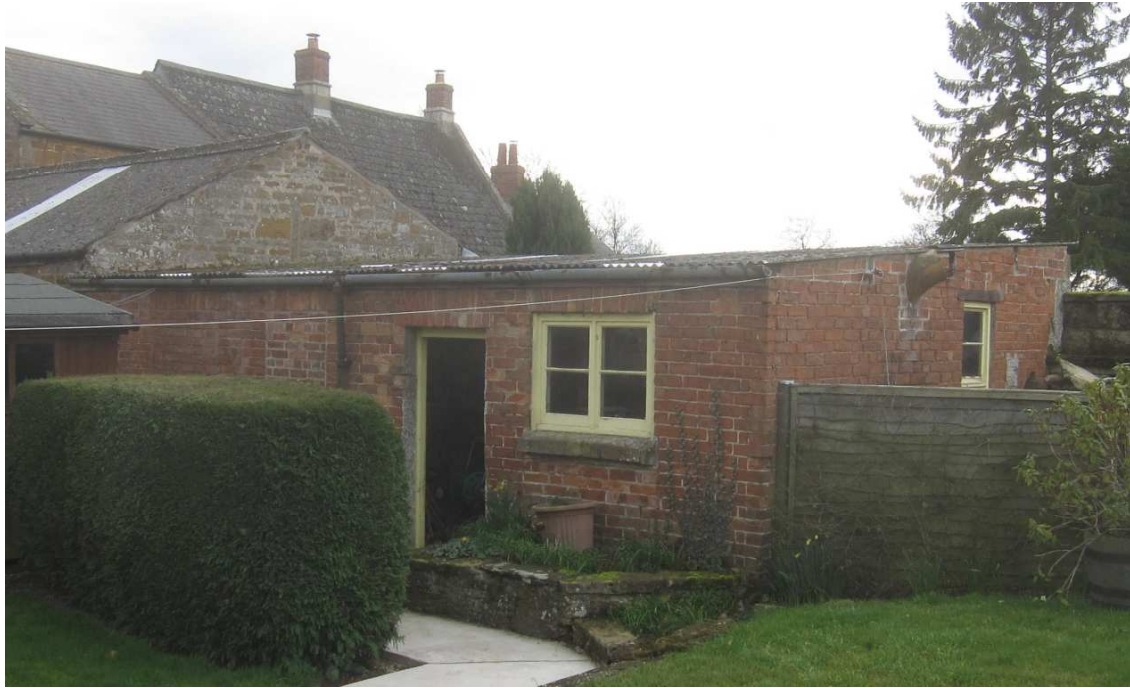
The 1886 map shows two very small houses at the SW of the two plots adjoining to the S. These survive as the ground floor only of a pair of brick-built 19th century cottages. Each cottage had a single room on the ground floor with a front door and window in the E wall, under flat brick arch heads. The rear W wall and S end walls are older, of stone. The front E wall and N external wall are of 9 inch brick, but the dividing wall between the two cottages (of which only the base course remains) was of half-brick thickness. The N cottage had a fireplace with chimneybreast on the N wall, though evidence for a chimneybreast to the S cottage is unclear. Brick-paved floors, modern profiled sheet roof, with no remains of the former first floors. .

The surviving ground floor of the pair of 19th century cottages at the rear of the plot

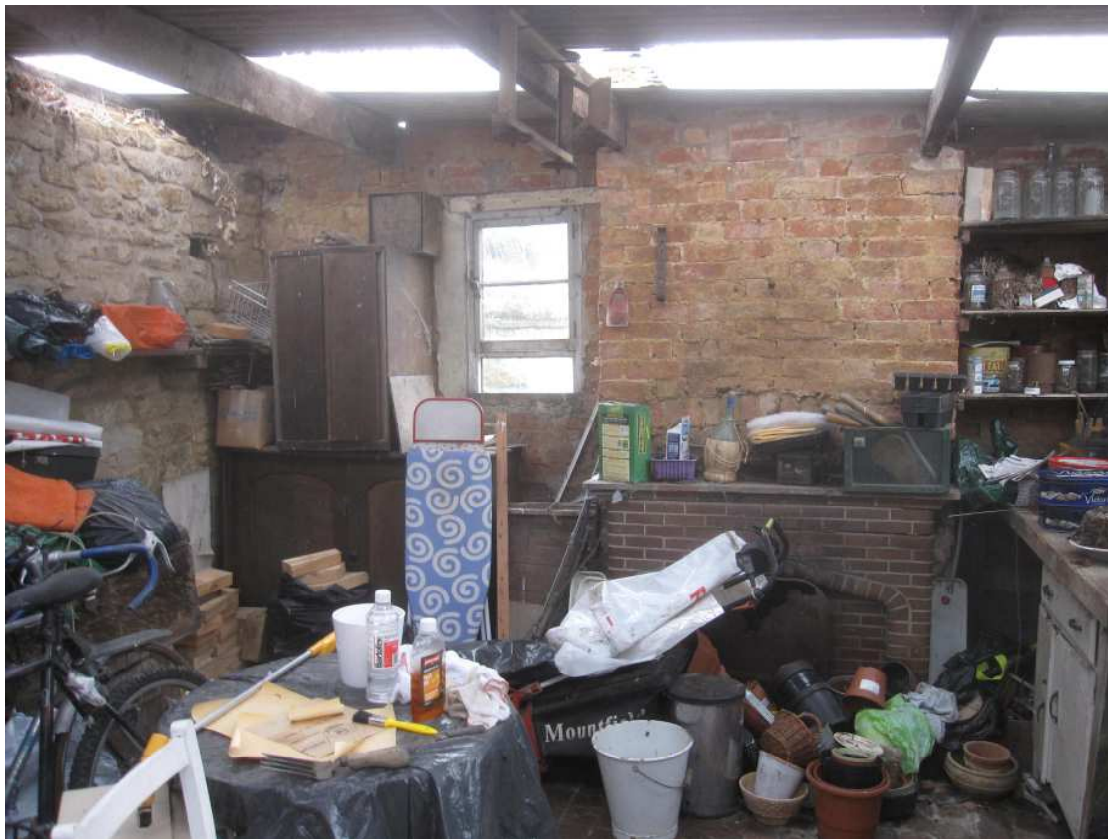
Interior of the west cottage, looking west

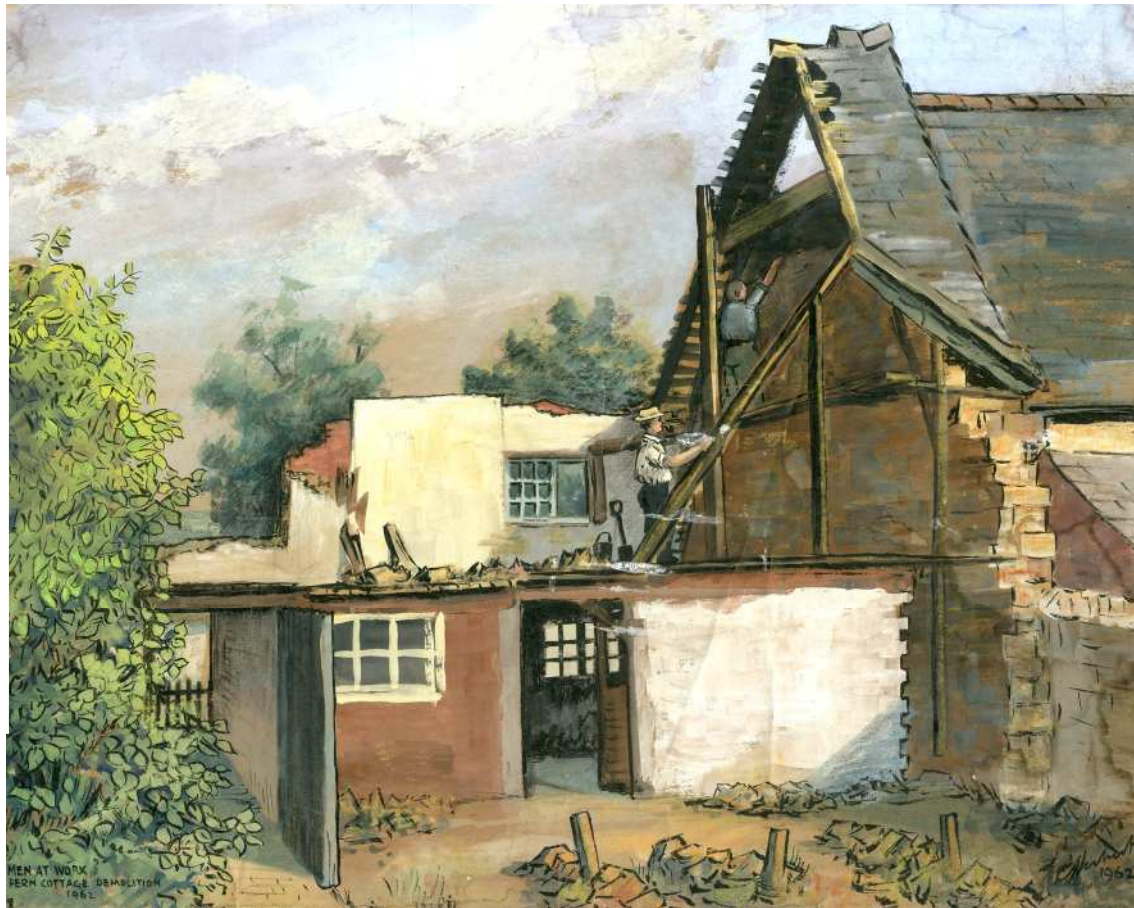
A painting of the demolition and building work being carried out on Fern Cottage in 1962

The linking hall/stairs area between the main block and the front wing has a W-E beam of vertical rectangular section, with some chamfering, and exposed joists – all probably a late re-working. The large room in the front wing was converted from a former laundry in 1962, with an inserted first floor.
