**Lyddington Manor History Society
Historic Building Survey**

**Little Park Barn
Lyddington, Rutland**

HISTORIC BUILDING SURVEY REPORT

LITTLE PARK BARN, LYDDINGTON

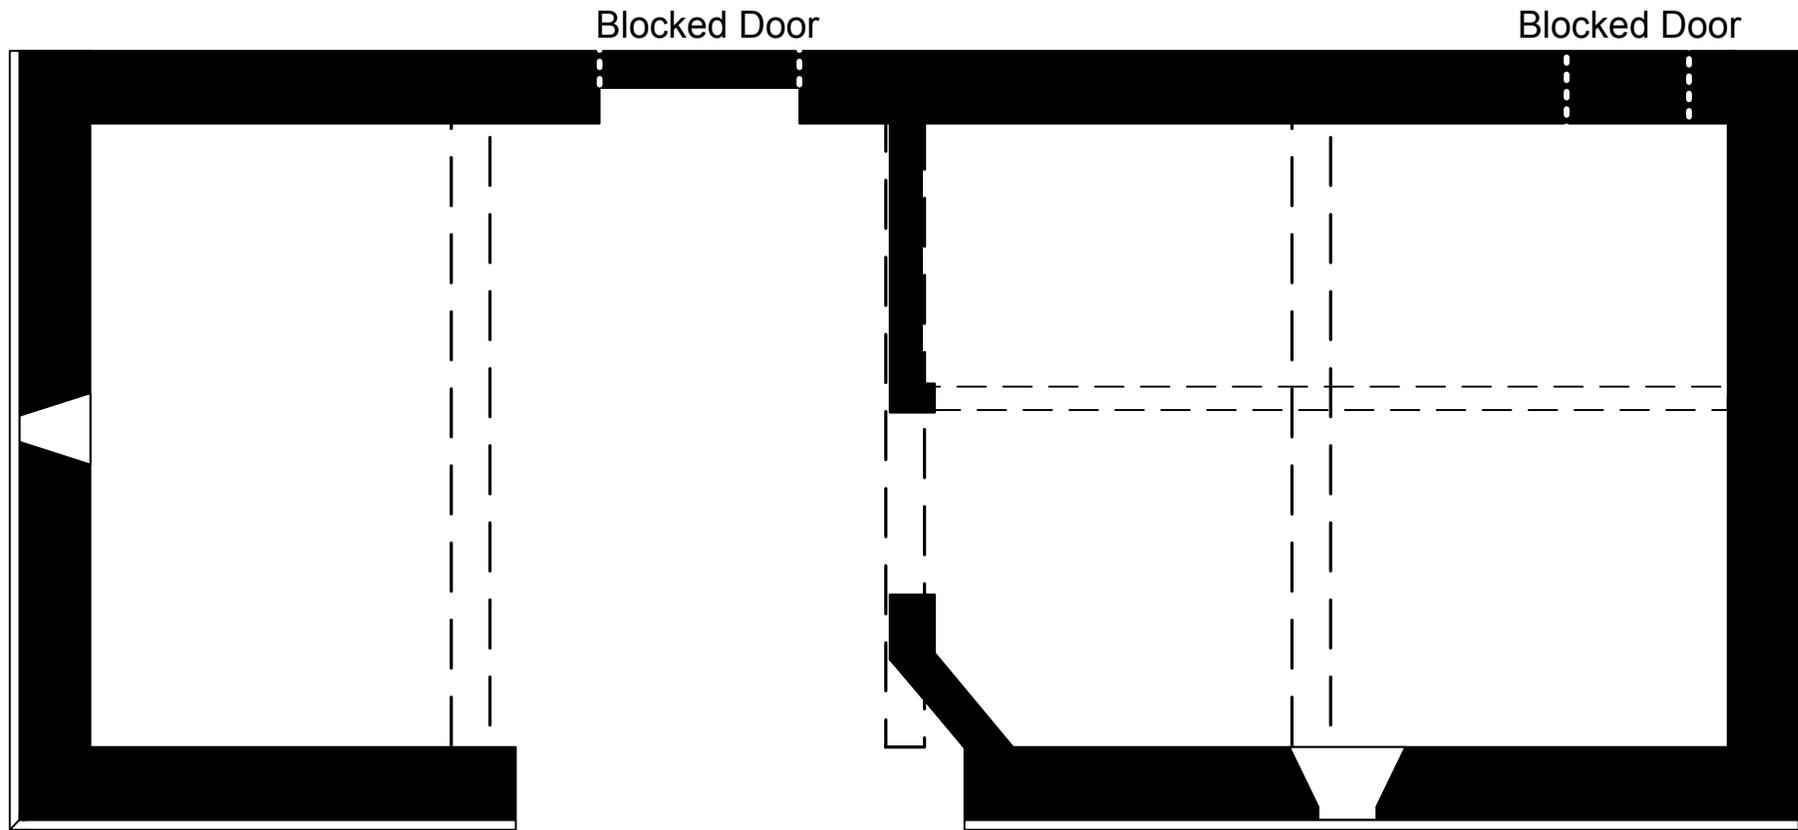
T1

T2

T3

The roof, all of oak, has 3 trusses with tie-beams, principal rafters and tenoned collars. Tenoned purlins and heavy rafters (mostly in one length, running from eaves to ridge), now meeting at a ridge board – but there would have been no ridge originally. Much of the roof timber is re-used, as detailed below. But some of the timbers (some principals, purlins and rafters) are probably new-cut for the C18 roof, often rather crudely, and of cleaner timber. A number of chisel-cut carpenter's marks are visible, on both new and re-used timber, clearly related to the construction of the C18 roof: T1 N principal/tie joint is marked 'I'; bay 1 N purlin/T1 principal joint is marked 'II', with 'III' to bay 2 S purlin and 'IIII' to bay 2 N purlin. T2 N principal/tie has a square-cut 'X'; T2/bay 3 N purlin has a shallow cut 'V', with an 'I' alongside; T2/bay 3 S purlin has 'X' again. On T3 principal W face a knife-cut 'W' is visible, with an 'X' type 'face' mark further up. There are probably other marks to be found. Although only part of the sequence follows a clear logic, the pattern is enough to confirm that the roof was probably framed in a single operation, using both new and old timber.

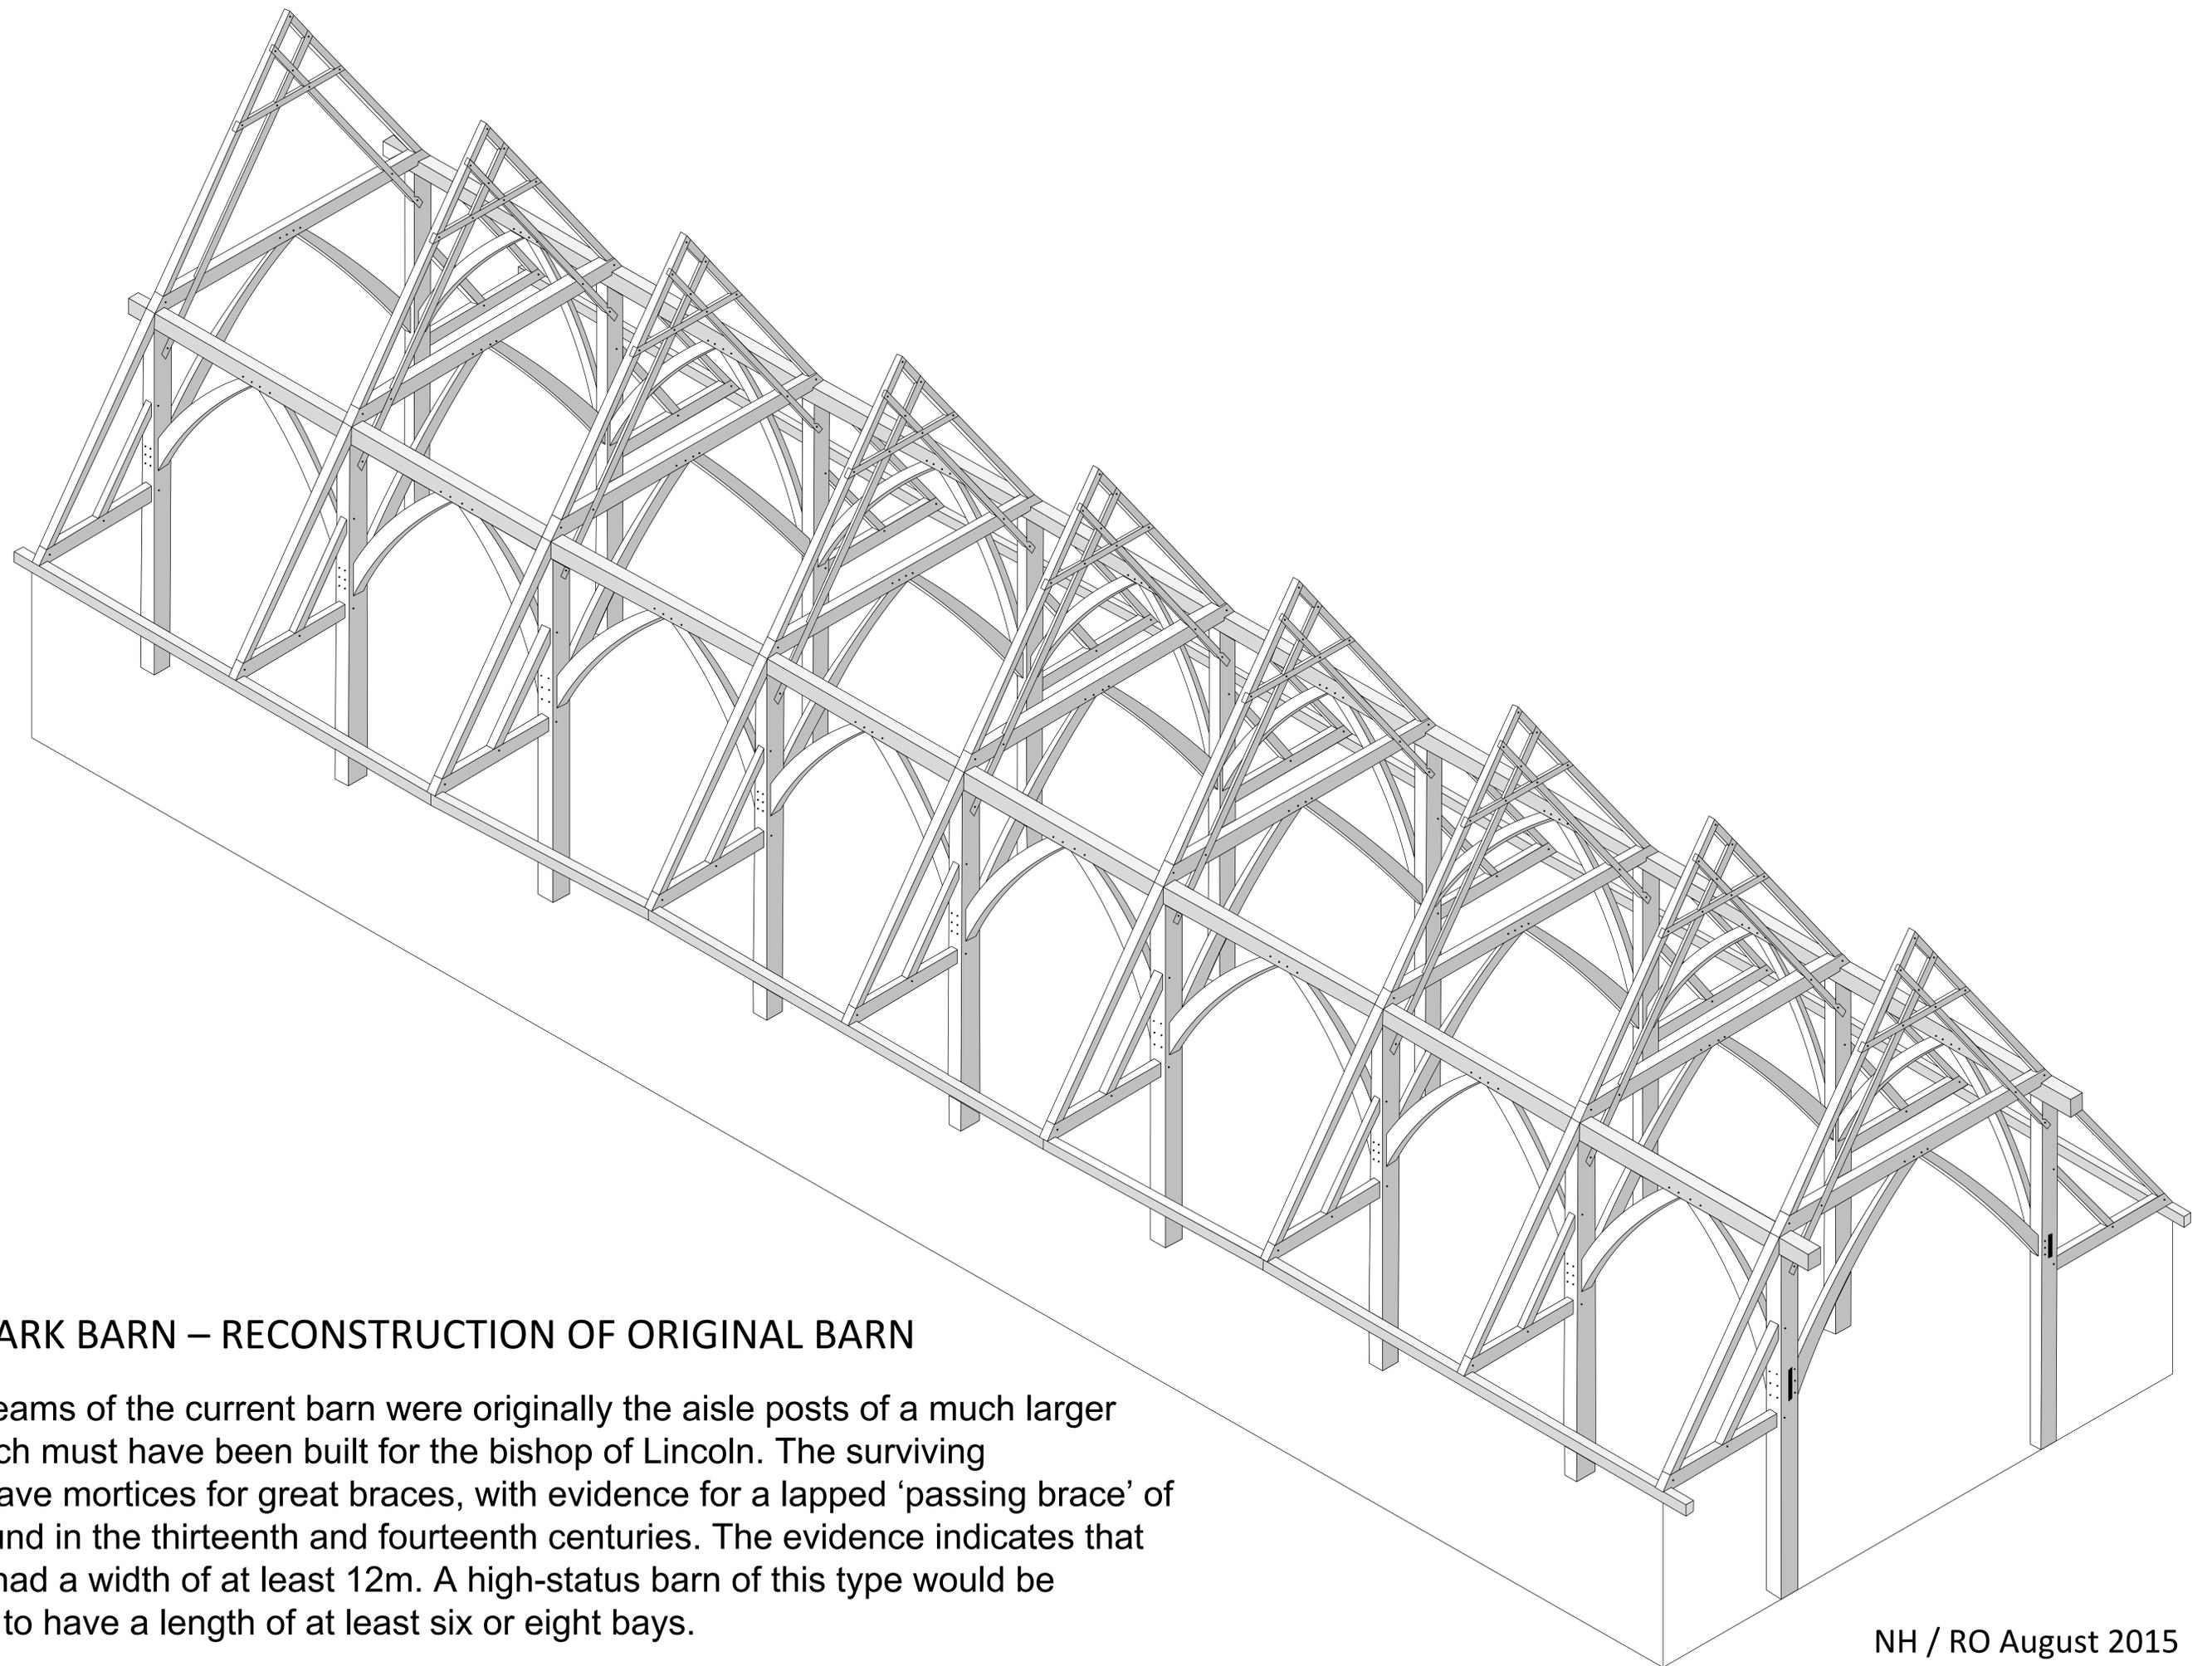
LITTLE PARK BARN – RECONSTRUCTION OF ORIGINAL BARN

The tie-beams of the current barn were originally the aisle posts of a much larger barn, which must have been built for the bishop of Lincoln. The surviving timbers have mortices for great braces, with evidence for a lapped 'passing brace' of a type found in the thirteenth and fourteenth centuries. The evidence indicates that the barn had a width of at least 12m. A high-status barn of this type would be expected to have a length of at least six or eight bays.

A convincing reconstruction of the original structure can be assembled from this evidence. The beams were originally aisle posts. A large brace rose to a tie-beam, and two other braces rose to the arcade plates. The lower horizontal mortice was for a horizontal aisle tie, extending out to the aisle wall-plate. A brace above angled down from the post to meet the aisle tie. The angle of the braces can be measured from the splayed mortices. The notch-lap joint housed a passing brace, which rose from near the head of the post and crossed over the tie-beam. The angle of the passing brace would have followed the roof pitch, and was similar (though not necessarily identical) to the lower raking line of the joint matrix. The passing braces would probably have crossed over each other near the apex, in the usual scissors pattern. The foot of the post can be estimated from the location of the burn marks, as noted above. The top of the post can be judged from the length of the surviving timbers (max.5.9m to the NW wall-plate) and the space needed above the passing brace (which could be more than drawn, though could hardly be less). A roof pitch of 50-55° is indicated by the angle of the dovetail joint across the rafter (for a horizontal collar) – which would be typical for any traditional building in the area. There were probably two horizontal collars providing extra bracing to the rafters, though the location of these is unclear. The aisle

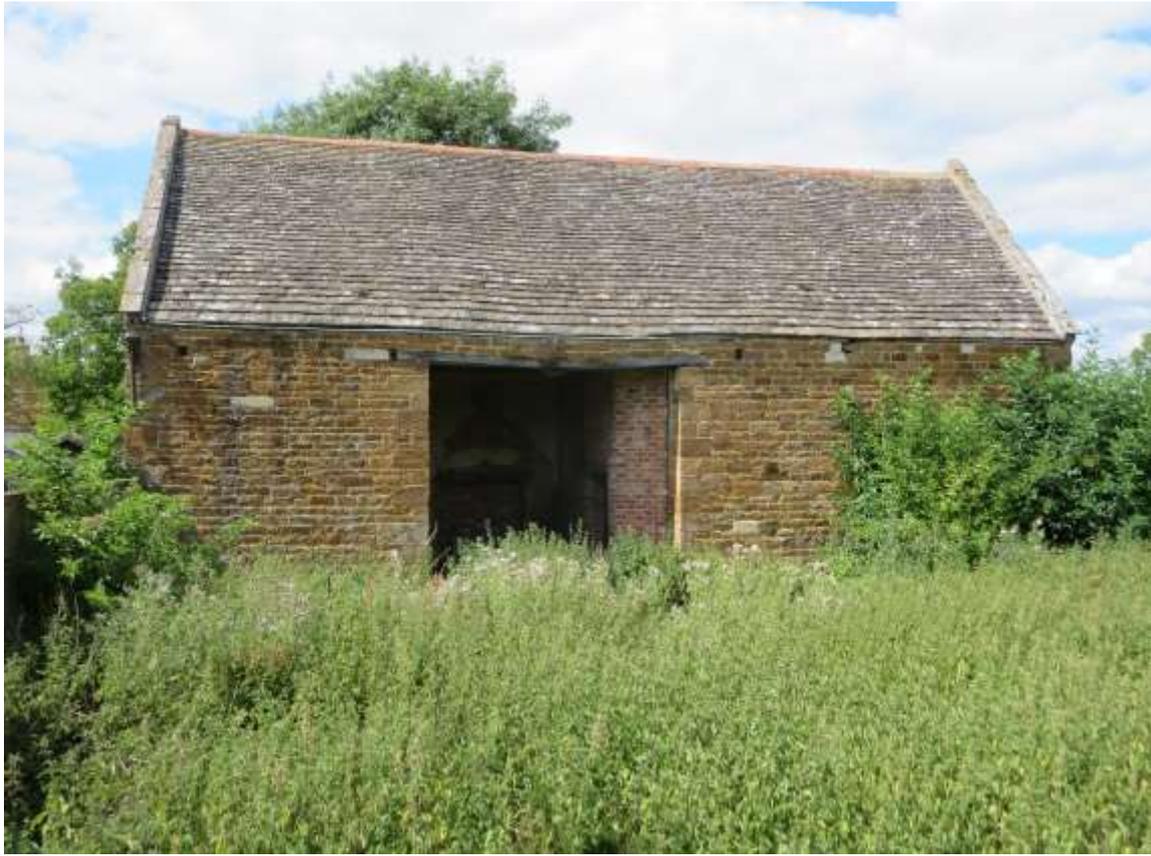
The south front

The S front has walling of well squared and coursed ironstone, with a few blocks of limestone. Good quality chamfered plinth, which returns onto the W gable, but not to the E gable. Large full-height barn door opening with good quality quoins, leading into bay 2 ie offset from centre. The doorway lintel, of fairly thin timber, has circular drilled holes at each end to receive doors on harr-hung hinges. Small window opening to bay 4, with timber lintel and plain rubble jambs.

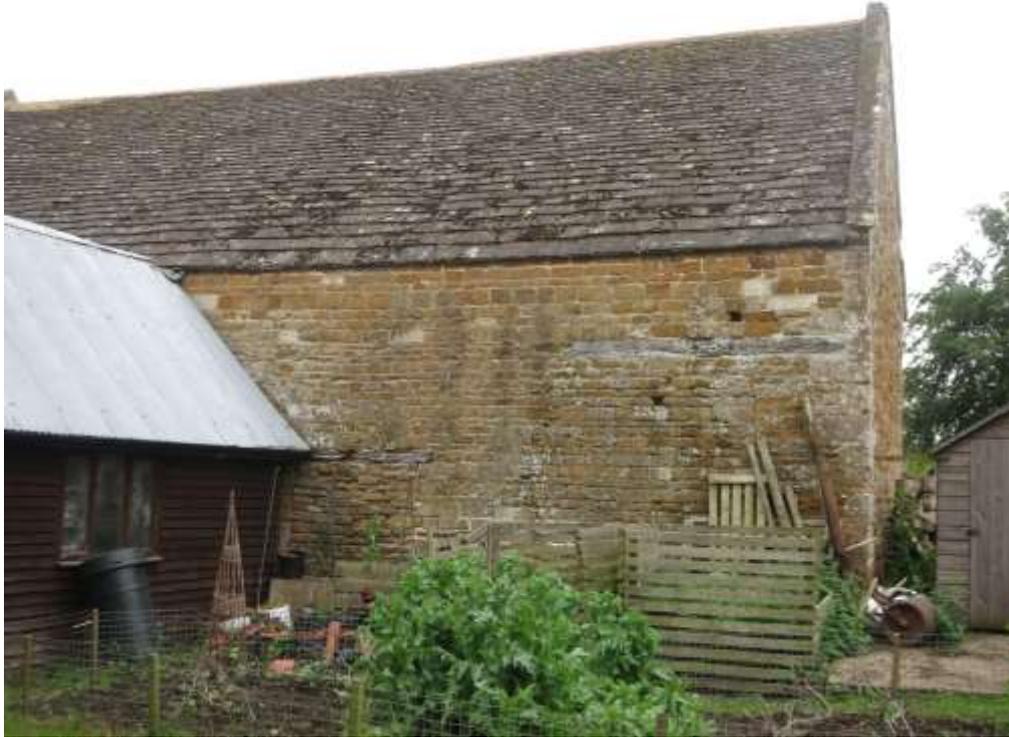
The west end of the north wall

On the N side a long low range abuts, with a long blank stone wall to E, timber boarding to N gable and W side, and metal sheet roofing. E of this is a blocked doorway, more readily visible inside than externally. W of the attached range is a blocked pedestrian size doorway, opposite the main barn S door. At the W end there is an odd large timber lintel at high level, and some evidence of a small rectangular opening near the corner – but no evidence of jambs of a large opening under the lintel (and no evidence of an opening inside). Small square-cut rubble plinth, projecting only c.15mm.

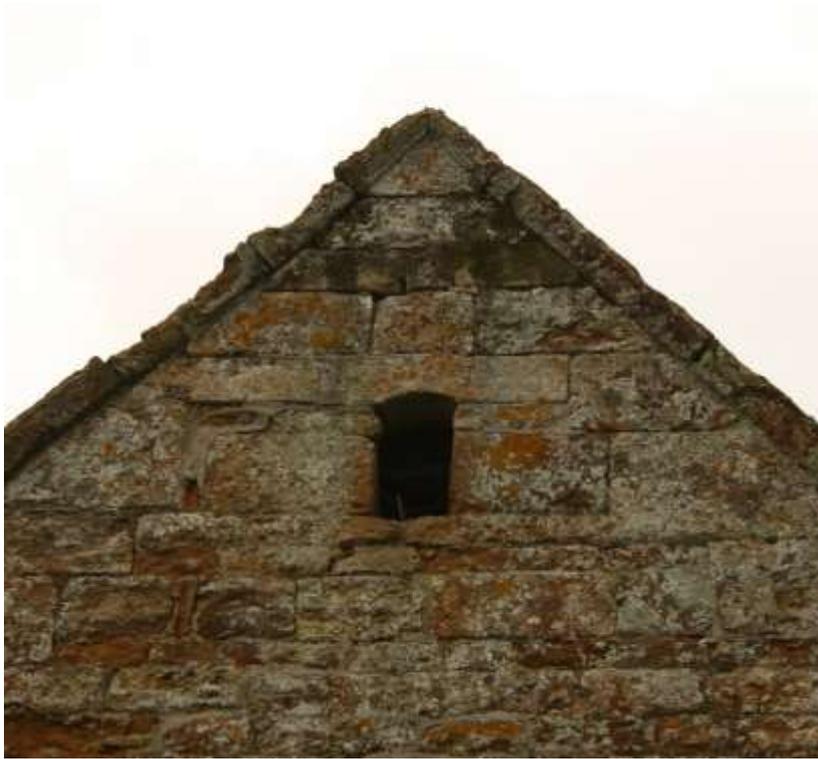
East gable apex

The masonry coursing both externally and internally indicates that this was an original opening – a loading door, before the insertion of the first floor. C19/20 softwood door and frame. At the apex is a slit opening, with unusual arched stone lintel, formed of a single very long block of stone.

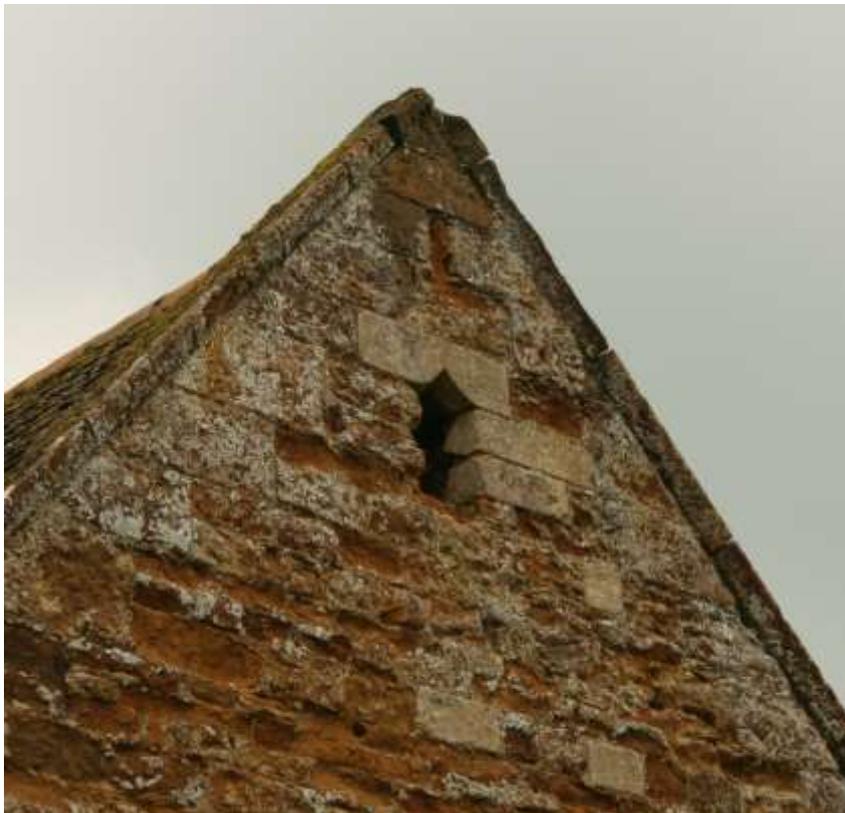
West gable apex

The W gable has a vent slit at ground level and another at the apex. Like that to the E gable, the apex opening is of unusual design, with a deep limestone lintel with unusual ogee arched head. Gable parapet and ogee corbels as to N gable, but here there is a good quality chamfered plinth, like the S front.

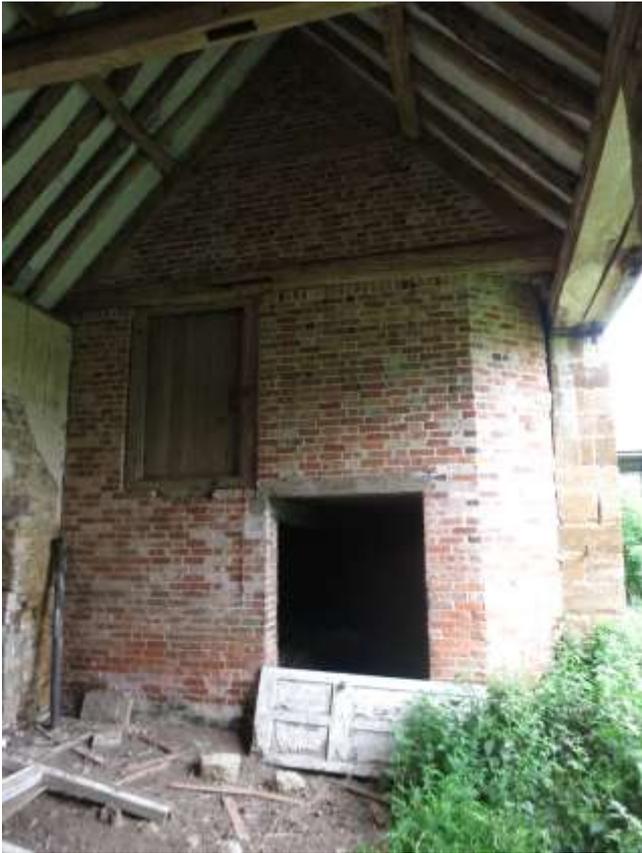
The inserted brick cross wall

The barn has an inserted brick crosswall on the line of truss T2, near the E jamb of the main door. The brickwork has a cant angle to meet the barn doorway, which enables it to follow the line of truss T2 at upper level, the brickwork forming infill to the truss. Bricks of c.1850-90 date, 225mm long x 70mm high. Ground floor doorway opening with pine lintel but no door; 1st floor boarded door and frame of late C19 date, with the tie-beam of truss T2 serving as the lintel. The N door is blocked with bricks of similar type, with C20 bricks for some repairs to the jambs. The walls have several original timber plates built into them, including two butted timbers running right across the W gable at eaves level. The ground floor to the W retains a few large, irregular blocks of early thick stone paving.

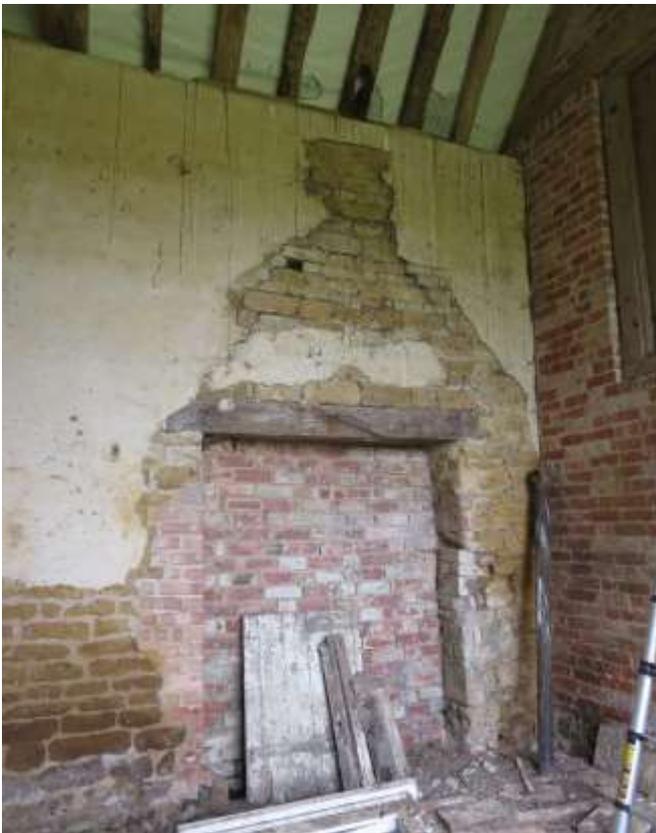
The blocked north door

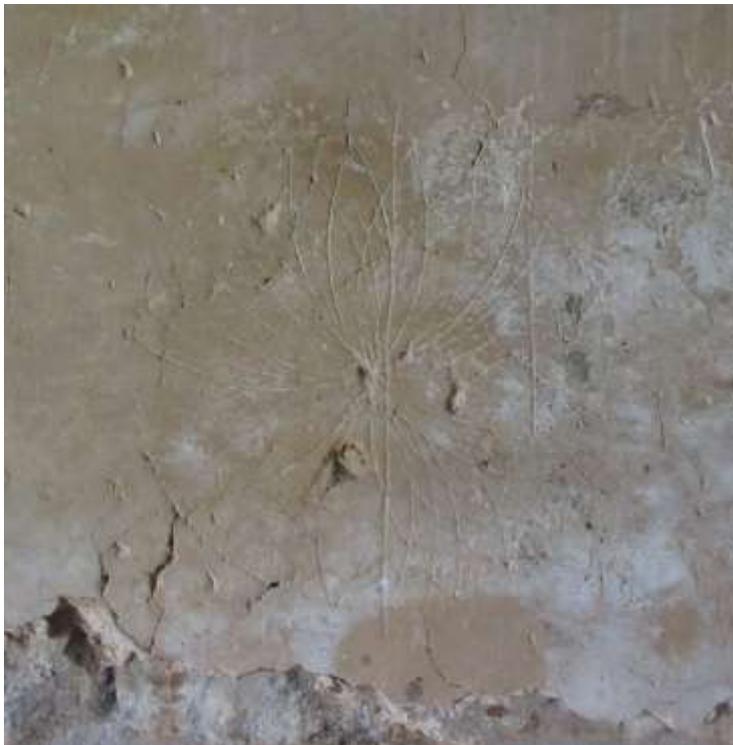
Daisy wheel pattern scribed on plaster wall to ground floor north-west

Although much smaller than the original structure, the new barn was well-built, with good quality masonry and a Collyweston slate roof. The two arched slit openings to the gable apices add an unusual level of sophistication for a farm building. It had the typical large double front doors, with a single door in the rear wall opposite, to create a threshing floor. The original additional doorway to the rear NE corner is an unusual feature, suggesting that the two bays to the E of the main doors were not only used for corn storage. There was also a higher level loading door in the E gable. The E part of the barn was also quite well lit by its front window, instead of having only the usual ventilation slits. The NE door was however blocked up before the end of the 18th century, with thin lime plaster applied internally to the north wall. Daisy wheel patterns were subsequently scribed into the plaster.

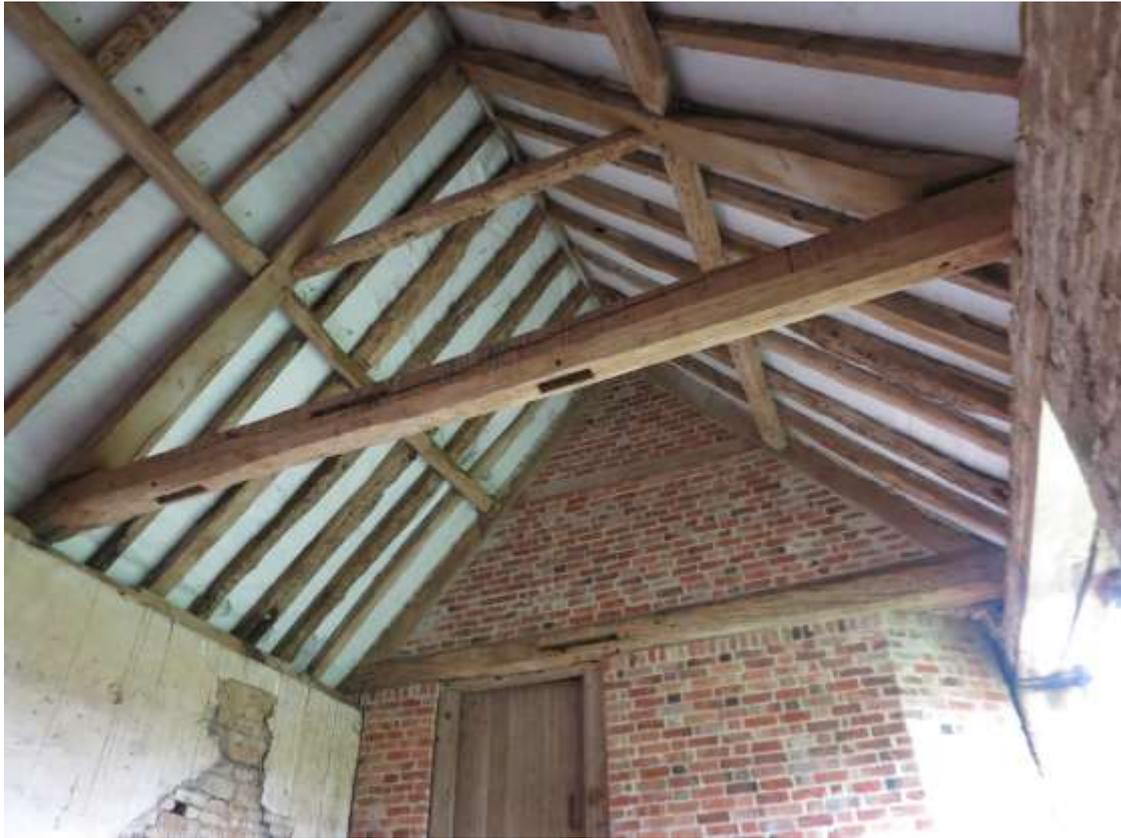
Truss T1 in the foreground, with T2 in brick cross-wall

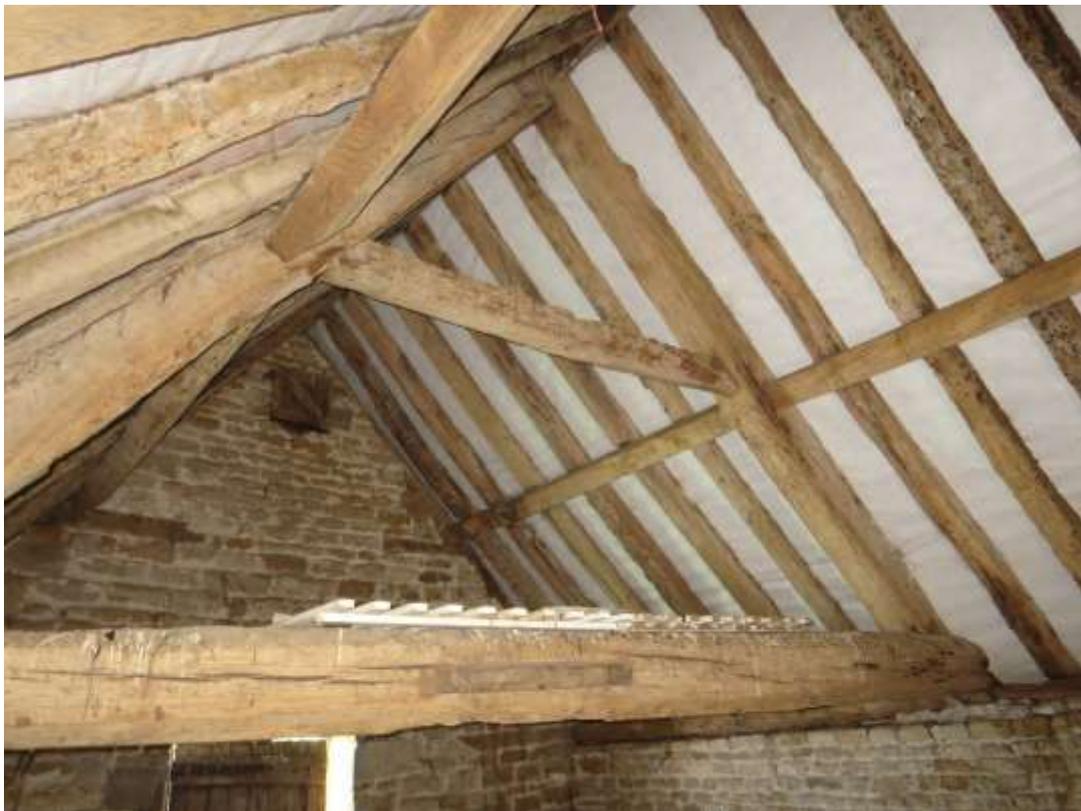
Truss T3, east face

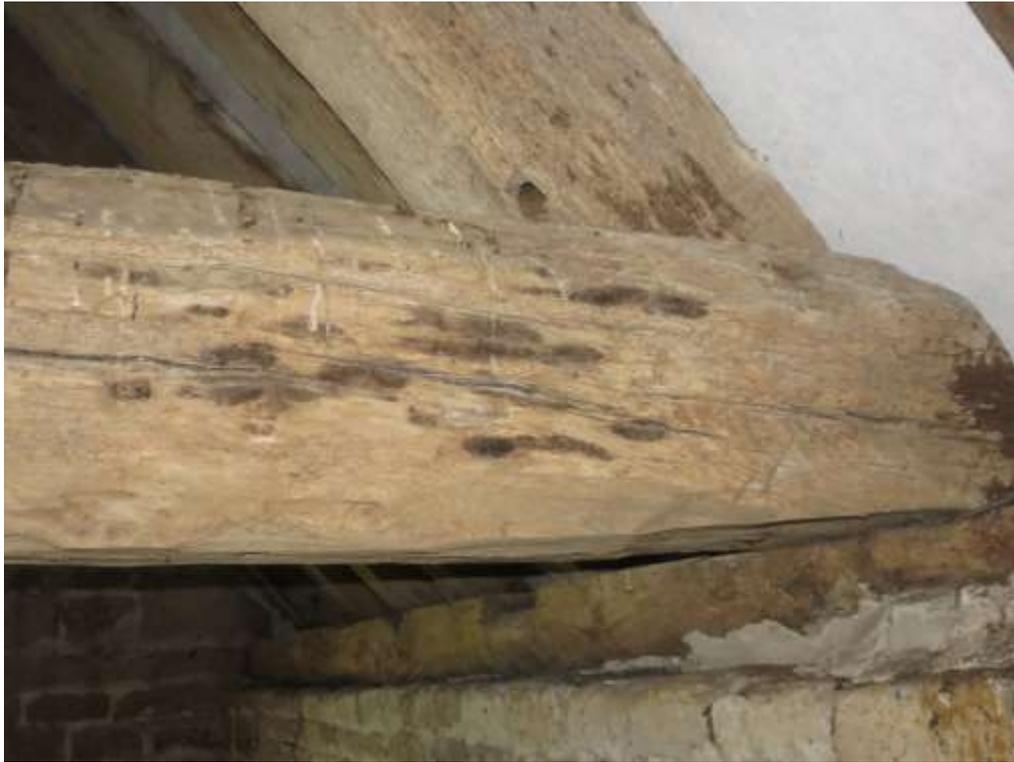
Multiple burn marks to south end of truss T3 tie-beam

The tie-beam of T3 has multiple burn marks near its S end to the W face, and there are similar burn marks near the E end of the N wall-plate of bays 3-4 and to the W end of the N wall-plate of bays 1-2. Recent study has proved that burn marks are made by deliberate ritual marking, and are not accidental. The burn marks provide several vital clues. First, the marks (of normal bulb-shape) show that the beams were upright posts, with the burn marks at the lower end. The location of the marks, at from c600mm to 1500mm from the end of beam T2, suggests that it was previously around 300mm longer, as burn marks are typically set at between c900mm and 1800mm from

the floor (at convenient working height when standing). The burn marks to all three beams are placed on the face opposite to the one with smaller mortices, with no marks noted to other faces. This face was clearly internal and readily accessible, as burn marks are always located inside a building, not on the outside face. The marks to T2 show that they were applied after this lower face of the post had been subject to some erosion, as they are applied over an irregular surface – unlike the marks to the NE wall-plate. The post of T2 was probably therefore in a location where it received considerable wear and tear – perhaps near a main doorway. The marks on both of the wall-plates appear to have been made prior to the timbers being cut in half, as the marks run over the edge of the timber. Finally, the burn marks (whose date range appears typically to be late C16 to mid C18) were probably applied over a period of some years to an older structure. So it seems that this earlier structure was still standing in the 17th century and was later dismantled, with the timbers re-used in the current building.

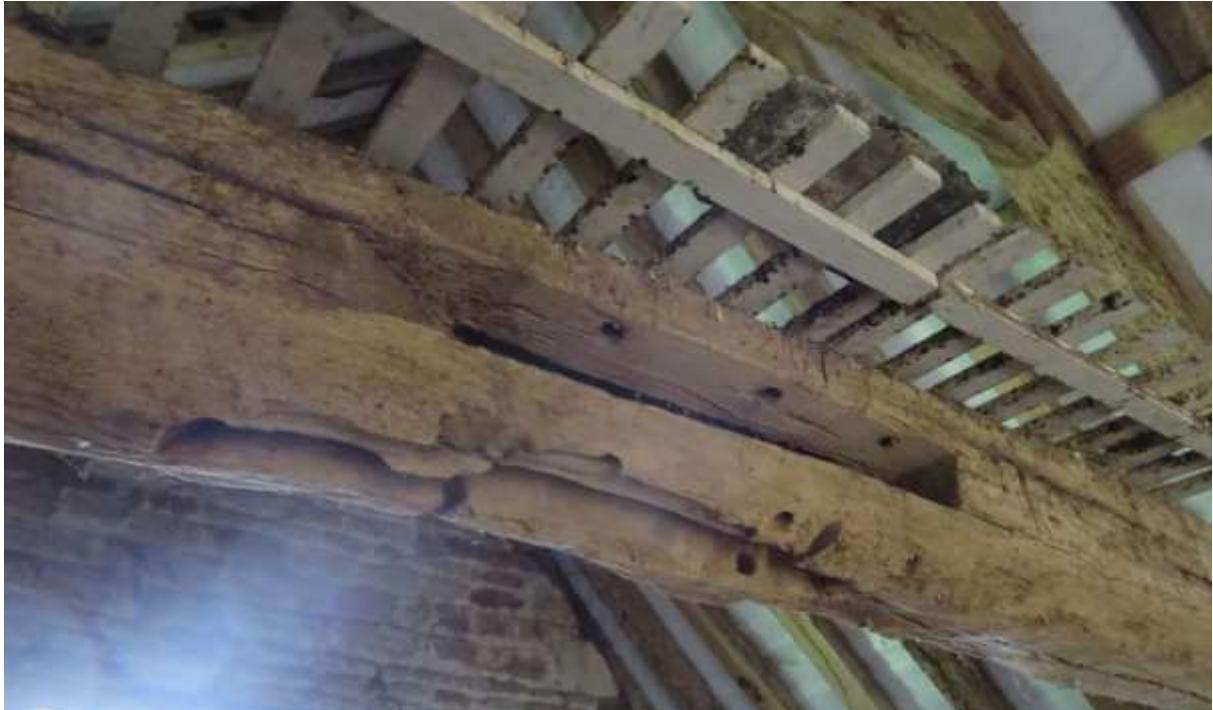
Mortices to tie-beam of truss T3 – a former aisle post

By far the most interesting feature of the barn is the presence of re-used timber, in particular the three tie-beams. Detailed examination reveals a clear and regular pattern to all three of these, and shows that they were formerly large aisle posts in a timber-framed roof structure, with large raking braces. Truss T3 to the E has the most accessible beam, and has been examined in detail. The tie-beam to T2 is partly embedded in the brick partition wall, but the long mortices can still be inspected. Truss T1 is set at high level, so has not been measured at this time, though the mortices are clearly visible from below. Each beam has three long, pegged mortices (c750mm long x c75mm wide – dimensions vary somewhat), set rather to one side of the tie-beam centre point. One end of the mortices is splayed, showing that it held a raking brace. On the fourth side, each beam (c290mm wide x 310mm deep) has evidence for two mortices, one straight-sided (c250mm x 85mm) for a horizontal timber, the other (c.290mm x 85mm) splayed to one side, indicating a raking brace running towards the horizontal timber. At least three of the four lengths of heavy wall-plate to the barn have the same mortice features, the original beams having been cut in half to form wall plates of c.300mm x 150mm in section. With the three wall-plates, there is evidence for five original beams.

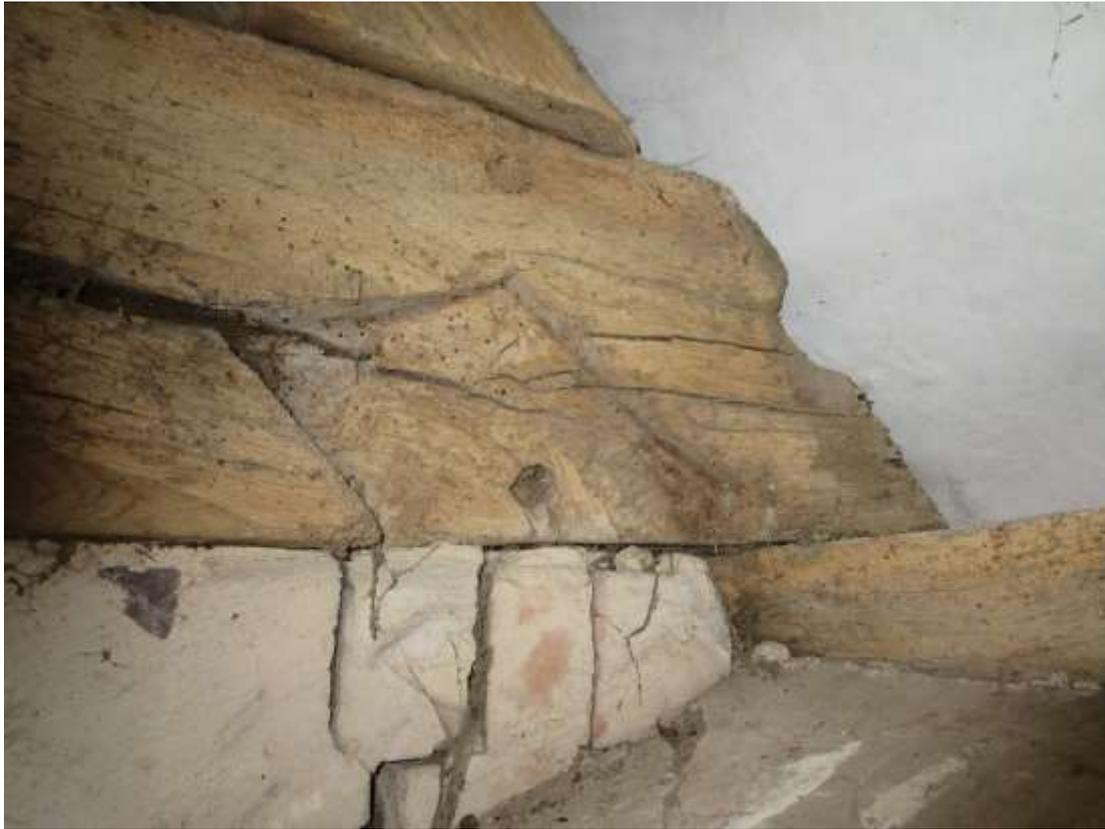
Notch lap joint matrix to north end of truss T2

Another particularly important feature survives on the E face near the N end of tie-beam T2. This is the empty matrix of a notch-lapped joint, with some slightly curving sides and a single peg-hole. Such joints typically date from the 13th or earlier 14th century. No similar joint matrix can be seen on T3, but the relevant location is probably now hidden by the wall-plate or principal rafter.

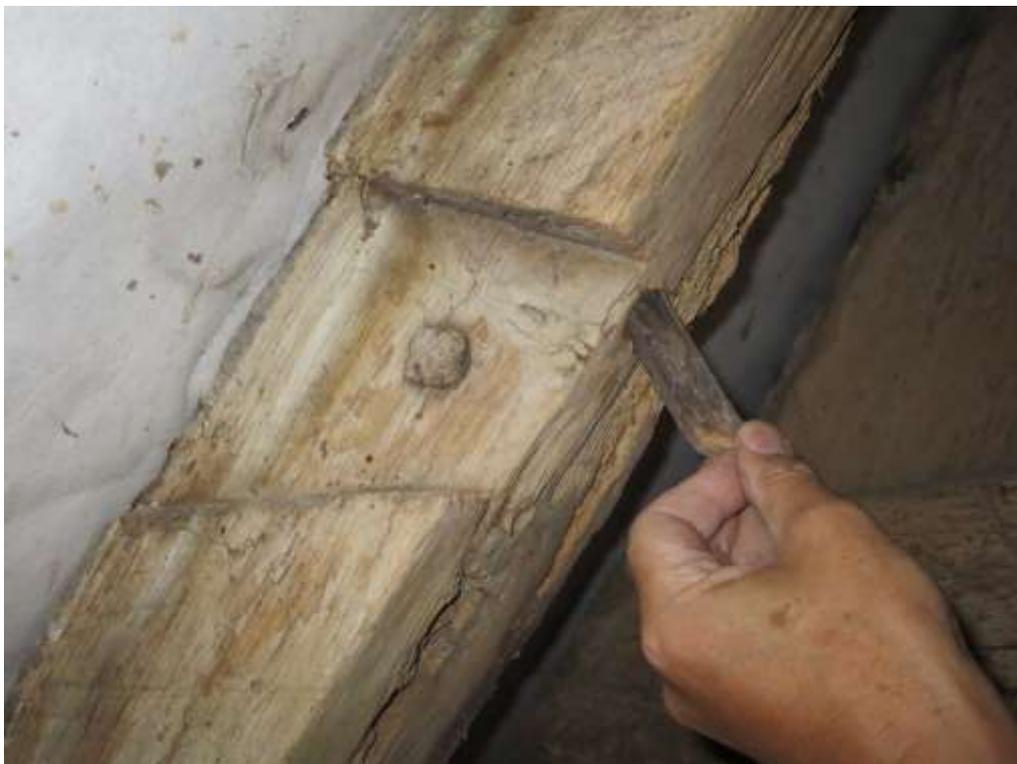
Dovetail lap matrix to a common rafter, with horizontal and vertical pegs

Besides the tie-beams and wall-plates, there is much other re-used timber in the roof. This includes some of the principal rafters (with peg-holes or joint matrices), at least one collar and many of the rafters. Two rafters (Bay 3 N, rafter 6 from W; Bay 4 N, rafter 4 from W) have features of special importance. There is a plain dovetail lap joint matrix near the current foot of each rafter, which has the normal face peg-hole, but also has a peg driven vertically upwards, which would have passed through the collar and into the rafter. The end of the vertical peg, embedded (not passing through) the rafter is still in situ to the rafter of bay 3. The upper section of both rafters also has an empty matrix for a dovetail-lapped joint, but this upper collar had only one face peg. The double-pegged lap joint is another early feature, found in other buildings in the area of 13-14th century date. Its presence provides not only additional evidence of early date, but also suggests that considerable parts of the early structure (not just the tie-beams) survive in the current barn. Unfortunately, the remaining re-used timbers do not have clear features to identify their original use. But the N principal rafter of T3 does have a cut-down mortice for a raking brace, and beside it on the W face is a light, long scribed carpenter's mark: 'III'. This could well be a carpenter's mark from the original structure.
