**Lyddington Manor History Society
Historic Building Survey**

**The Marquess of Exeter,
Lyddington, Rutland**

HISTORIC BUILDING SURVEY REPORT

THE MARQUESS OF EXETER 52 MAIN ST, LYDDINGTON

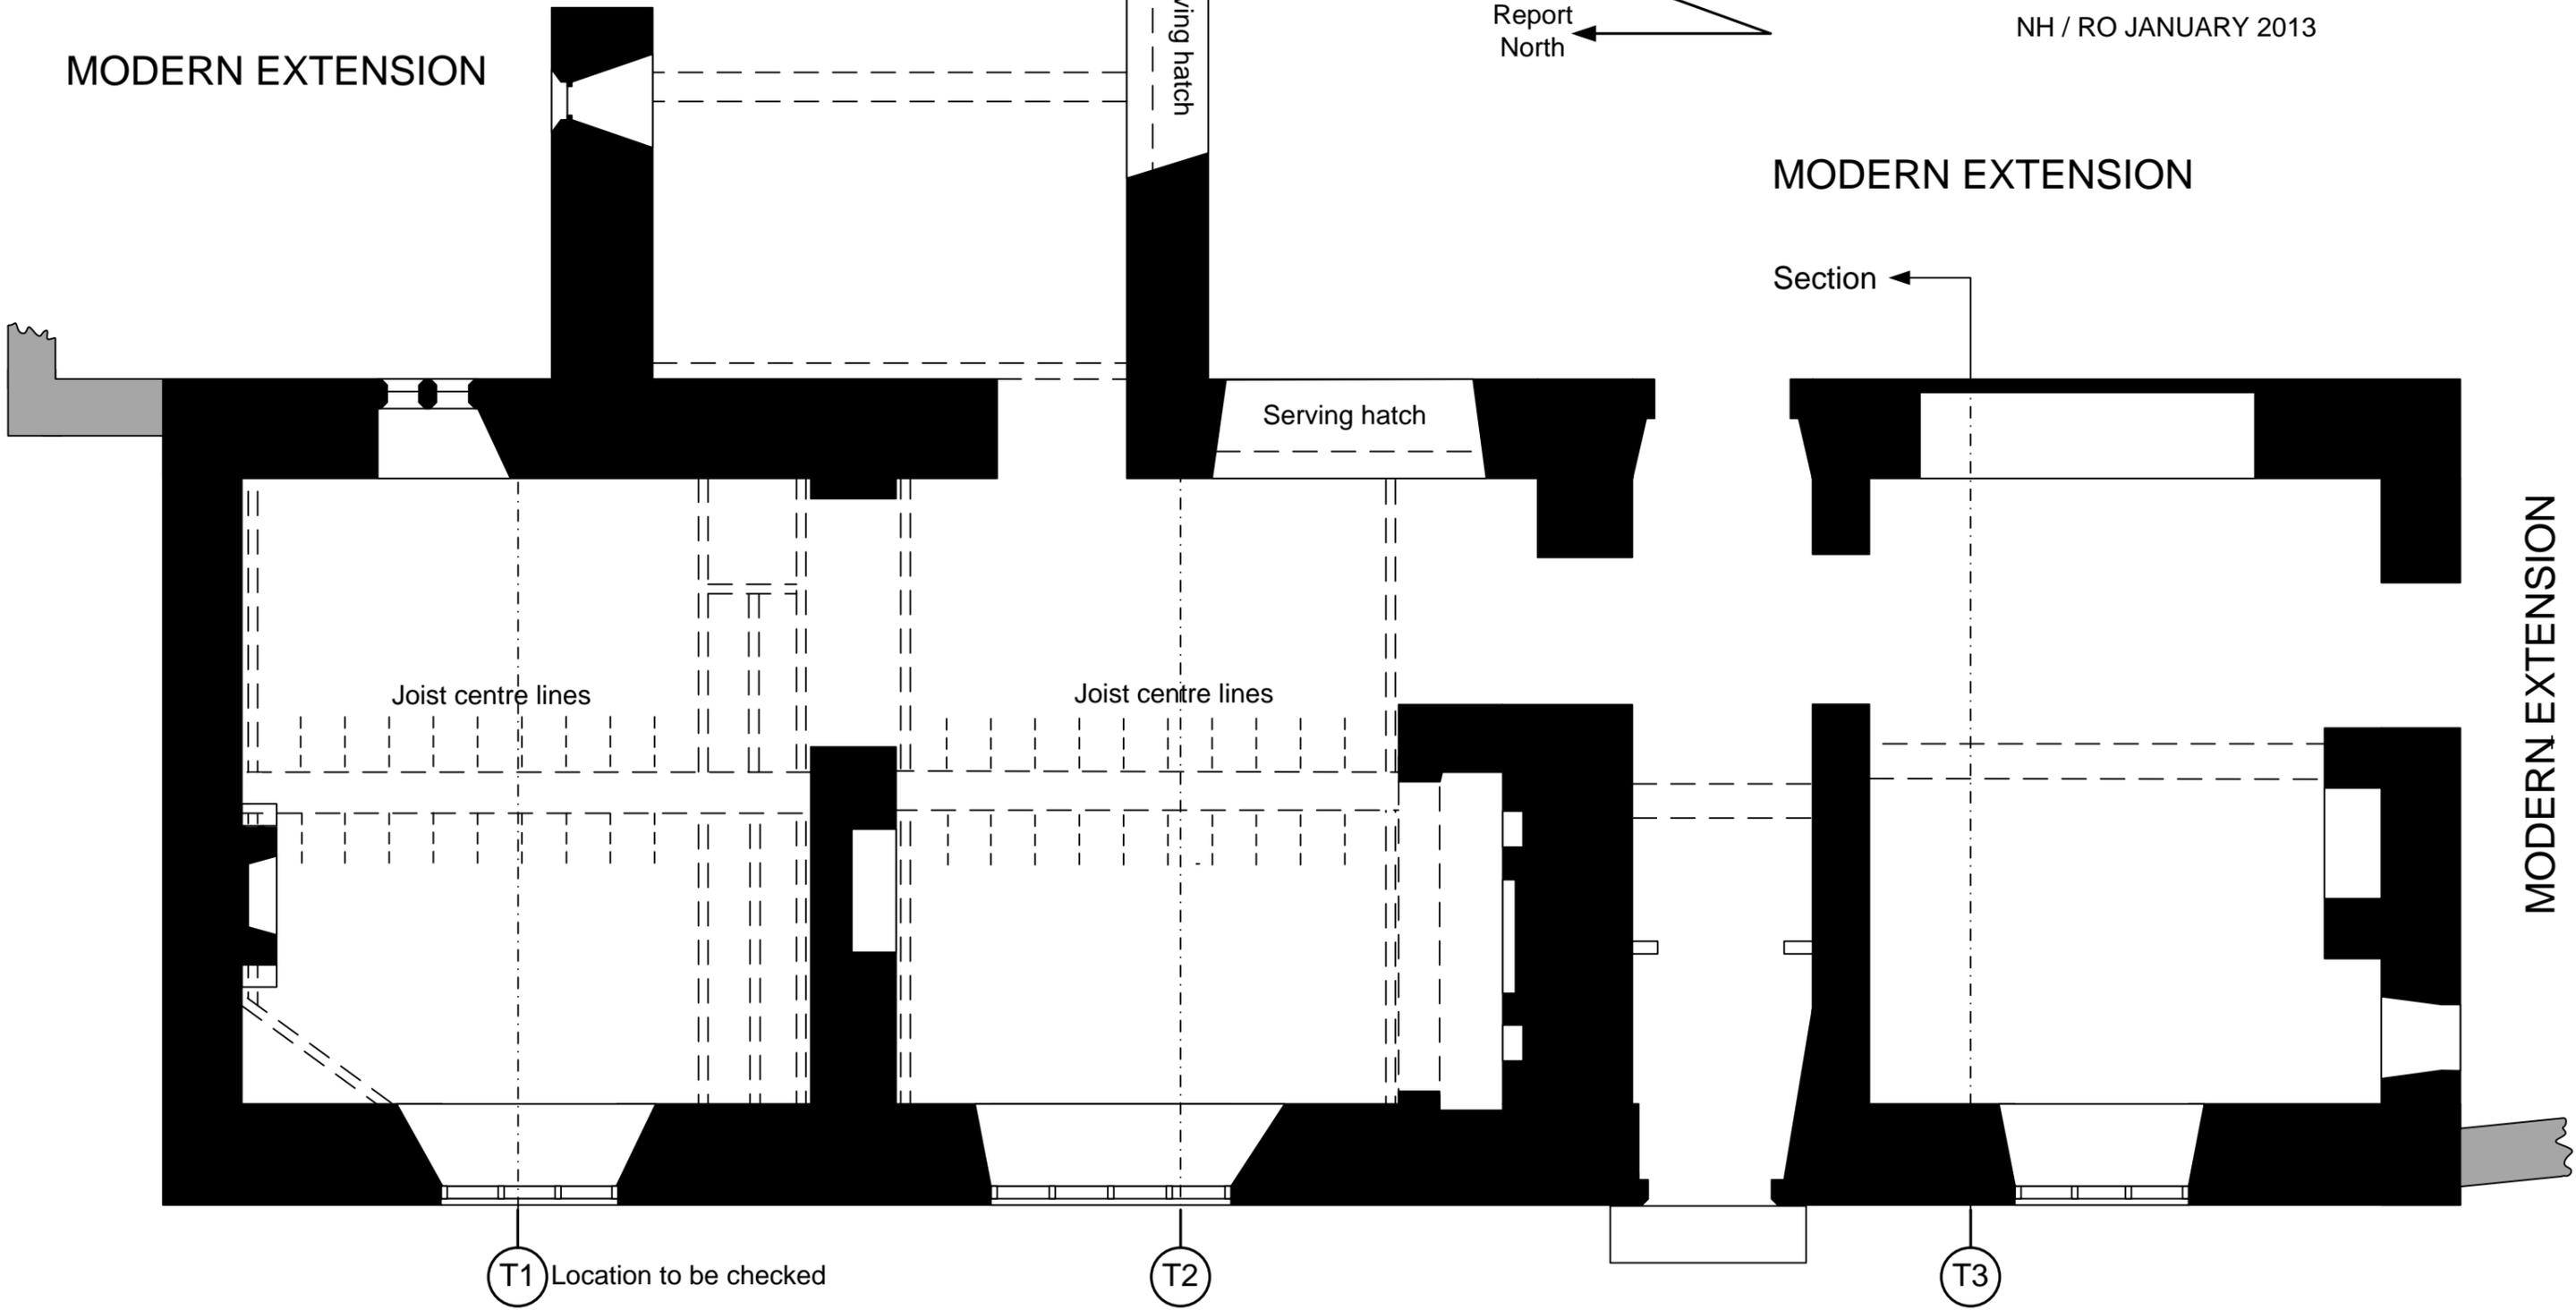
GROUND FLOOR

The plan form is a classic example of a cross-passage plan. The passage is quite wide, and leads past the rear of the hall fireplace. There is a N-S ceiling beam with chamfers but no stops. It therefore seems that the first floor joists span W-E, rather than spanning between the stone walls of the passage.

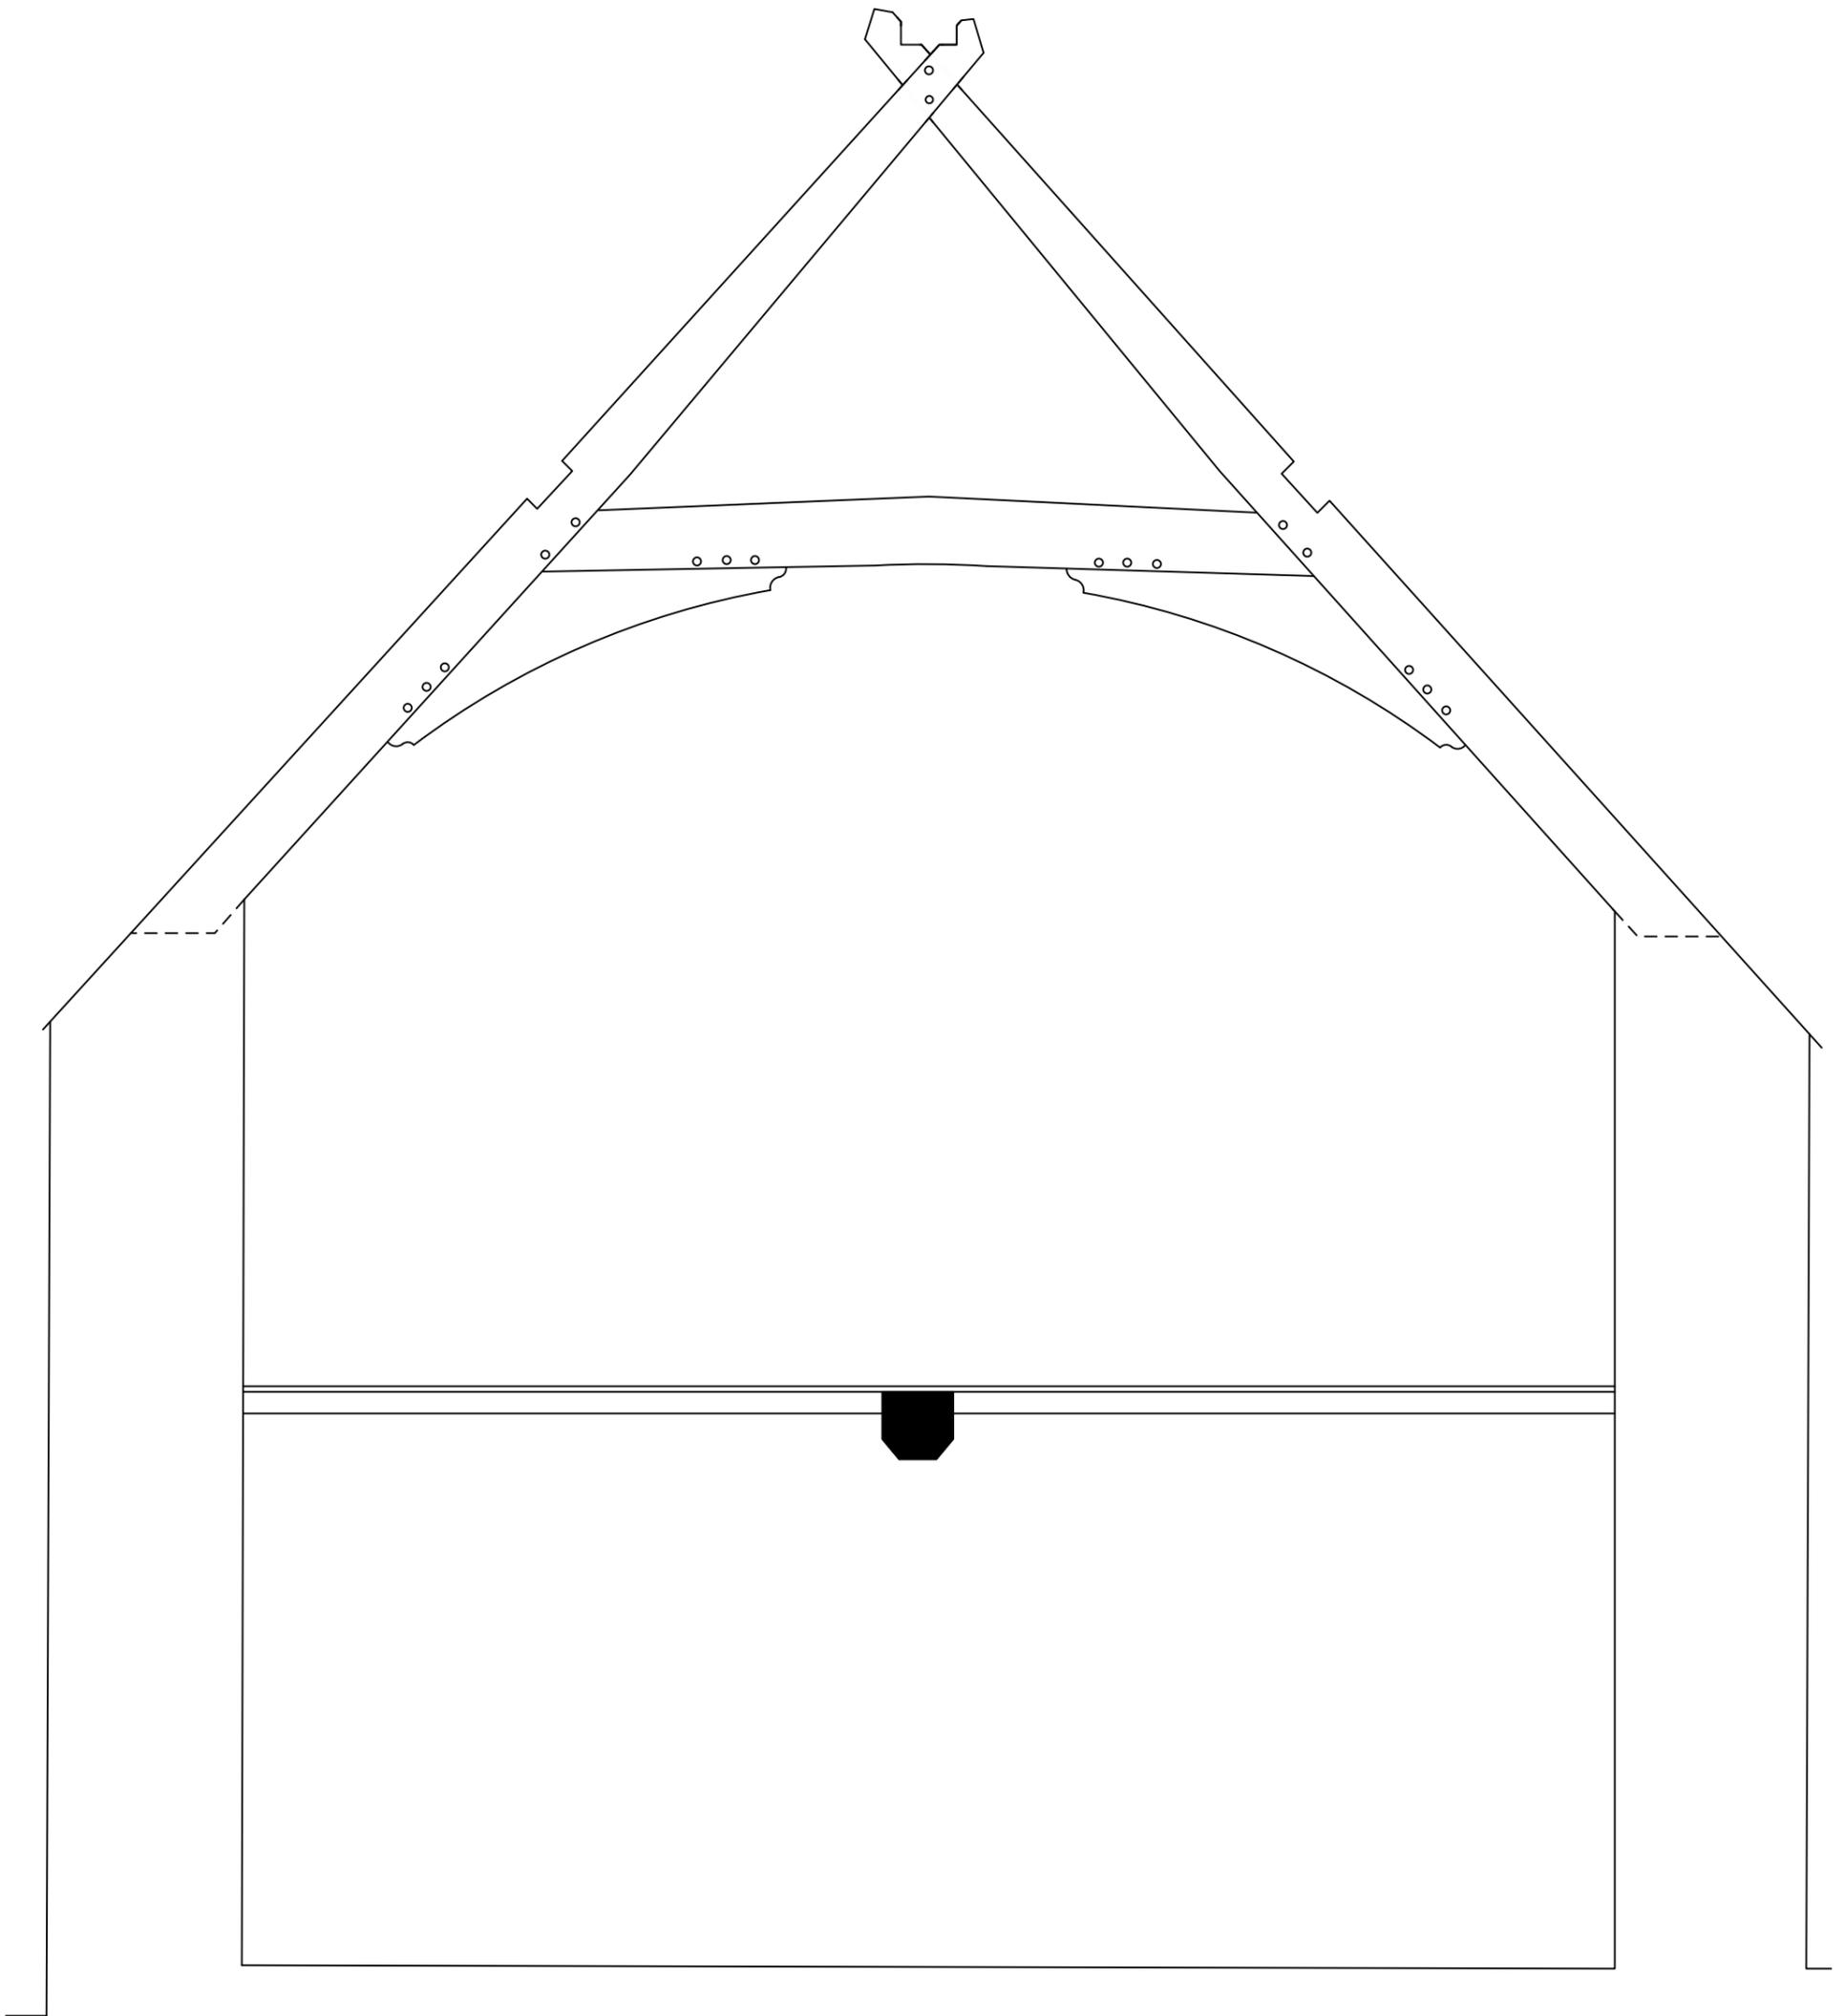
SECTION – TRUSS T3, SOUTH FACE

The roof has three A-frame trusses, their feet set nearly at the lintel height of the windows, creating a lofty first floor space. The trusses are heavily charred from the fire, and the rest of the original roof timbers have gone, but the details are clear. The trusses are of high quality, with tenoned, slightly cranked collars and arch-braces, with ogee-shaped ends. The apex is more crudely treated with a lapped, scissors crossing, with a square-cut seating for the (missing) ridge). The principal rafters are trenched for back purlins. The stone cross-wall of the hall inglenook rises to full-height in the roof space to support the purlins, as also – unusually – does the cross-

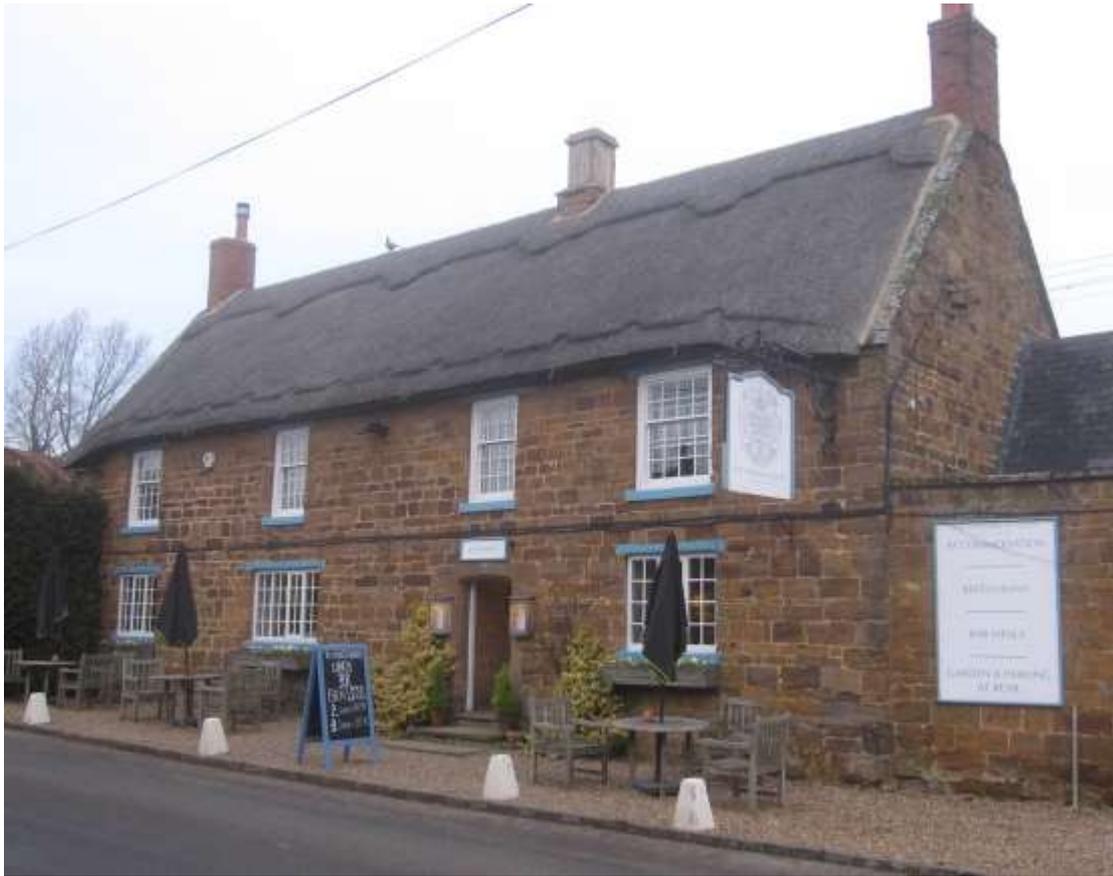
View from the south-west

The W front has coursed ironstone, with good stone blocks of larger size than normal. There is only slight disruption of stonework around the timber windows; it seems that the stonework was carefully pieced in when the original stone mullioned windows were replaced. The presence of a chamfered plinth, with stonework of the same large-sized blocks, indicates that the facing is probably original. The plinth has vertical returns to either side of the doorway. Good quality 17th century stone doorway of light brown Uppingham stone; 4-centred head formed of two large blocks, large plain

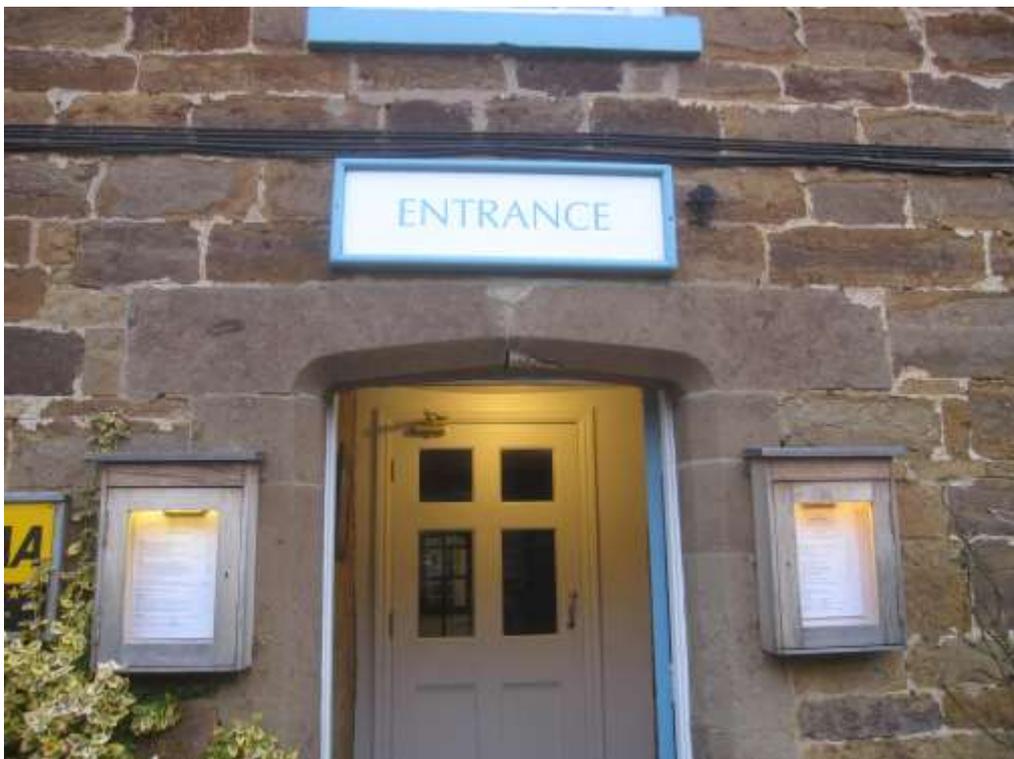
The front doorway

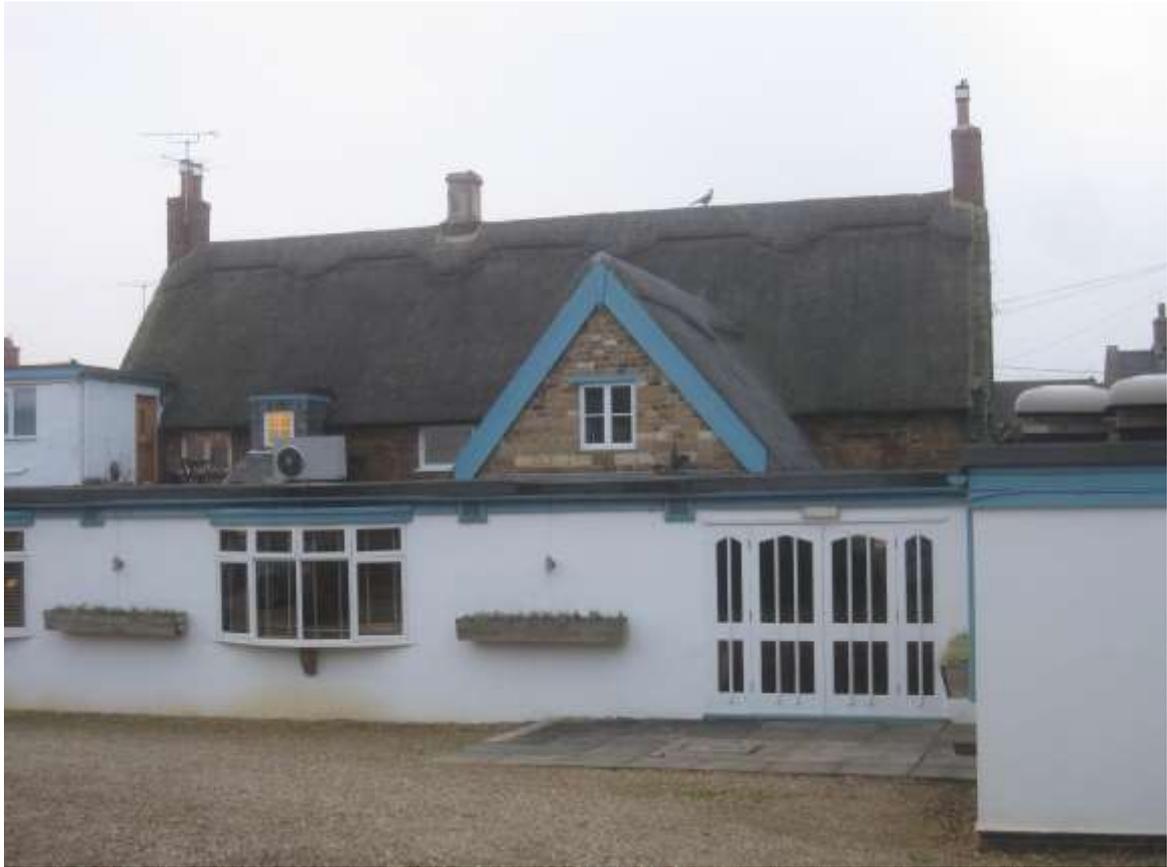
View of rear

The rear E side of the building is largely covered by modern extensions. The first floor masonry is of the same good-sized blocks. To the S of the projecting wing there are two modern windows and a slate-hung projection for a modern stair. To the N of the wing there is a blocked window opening with a plain lintel. In the listed building description of 1985, this is described as ‘blocked 3-light window with chamfered wooden mullions to first floor right’ – an interesting survival of a mullioned window of timber rather than stone. Sadly, this has now been lost, probably in the fire of 1994.

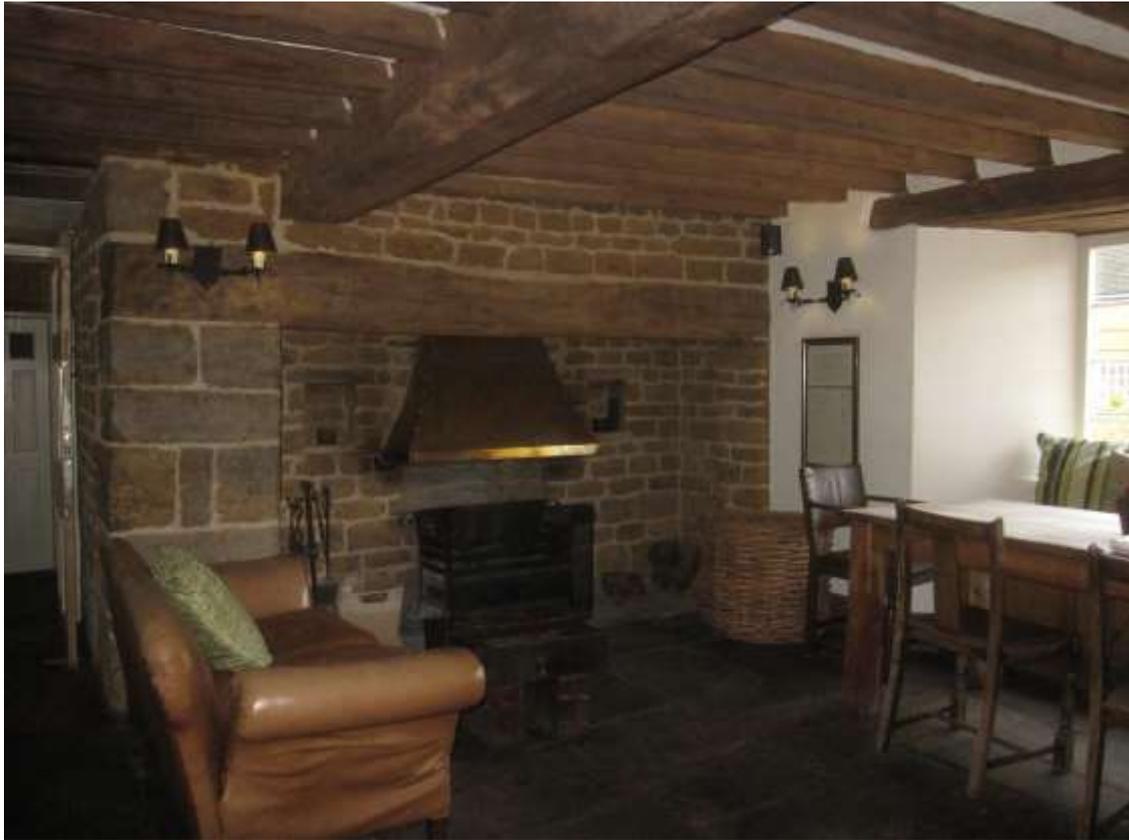
Inglenook fireplace in the hall (central room)

The other doorway from the cross-passage, also with good quoins, leads into the central and largest room, the original hall. Large inglenook fireplace with stone jamb (rather wider than normal) and chamfered beam with step-stops. There are three singly-applied burn marks to the beam. The stone fireback has been somewhat rebuilt, but incorporates a shallow recess, sloping upwards into the flue. Spine beam with wide chamfers and big step-stops. The oak floor joists are largely original, except for area of re-worked modern timber to the SE. The joists are morticed to the beam with soffit tenons and diminished shoulders. A full-height recess to the N wall may represent the original doorway; the current, wide opening with arched head is modern. The oak lintel to the front W window is chamfered, with step-stops. In the rear E wall, the wide opening over the bar has probably been enlarged. N of this is a doorway with good stone quoins to both sides. Given the presence of a cross-passage, it seems unlikely that this doorway is original, but the rubble stone walling of the rear wing abuts the quoins, which would normally indicate that the doorway preceded the addition of the wing.

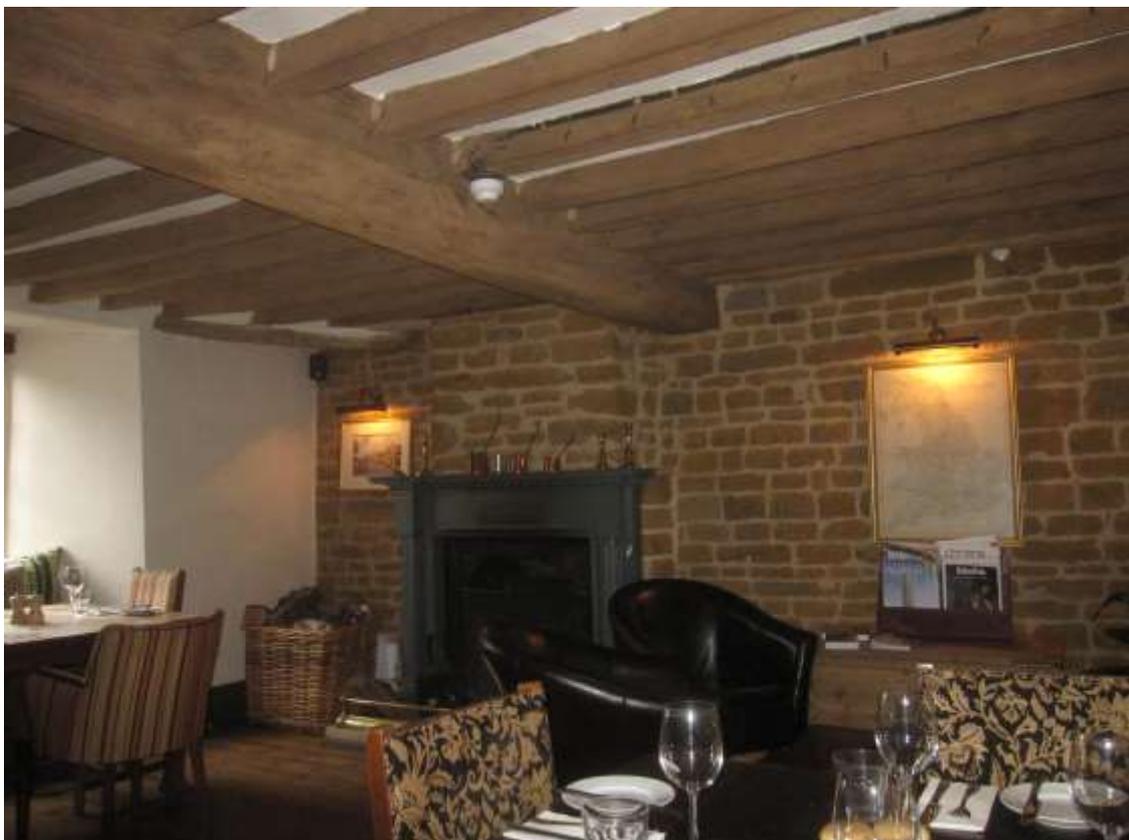
The north room (parlour) with inserted fireplace

The N room would have formed the parlour of the original house. Spine beam with wide chamfers, step-stops and tenoned joists, as to the central room. To the SE corner there is a trimmer for a previous stair, though the stair may have been a later insertion, not original. Shallow projecting stone chimneybreast to the N wall, whose sides step in at half-height. This cuts across an original floor joist, so is clearly a later insertion. In the NW corner is a diagonal trimmer, also inserted to support the hearth of a corner fireplace in the bedroom above. In the E wall is preserved an original 2-light ironstone mullioned window, with plain chamfers and a cavetto-moulded cornice. The external wall facing is also visible here, with coursed ironstone and good quoins.

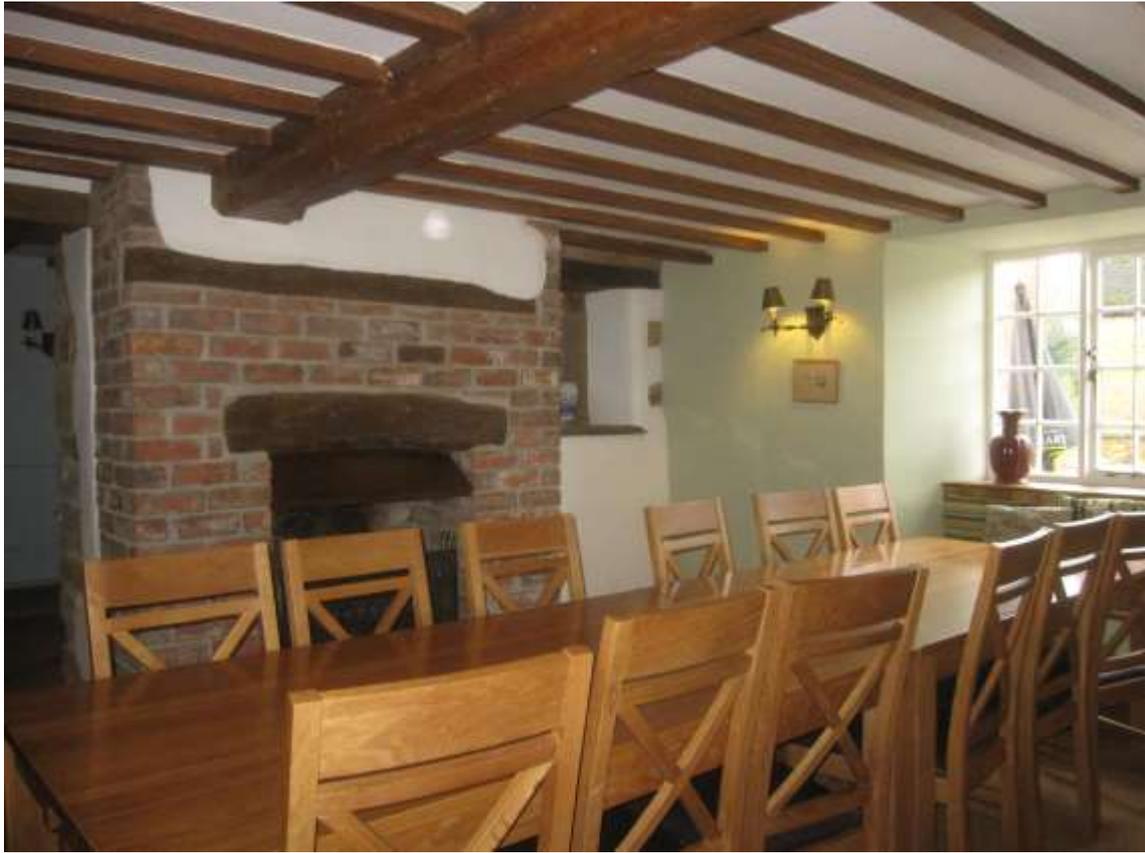
The south room

A doorway with good stone quoins and a plain oak lintel leads into the S room. This has a chimneybreast and fireplace of later 19th century brick, with an oak lintel over the fireplace opening and a high-set oak plate – all largely rebuilt in the 20th century. To the right side of the chimneybreast a small area of sooted/fire-reddened stone shows there was an earlier, larger chimneybreast here. To the right of the fireplace is a rectangular window opening. The S face of this (originally external) has an ironstone surround, with deeply chamfered head and cill, though the jambs are square and have been re-worked. There is a ceiling spine beam with wide chamfers and good step-stops. The stops to the E end of the beam relate correctly to the rebuilt chimneybreast, suggesting that there was an original chimneybreast here, of similar depth. The ceiling/first floor joists are probably of C19/20 date. The E wall, covered

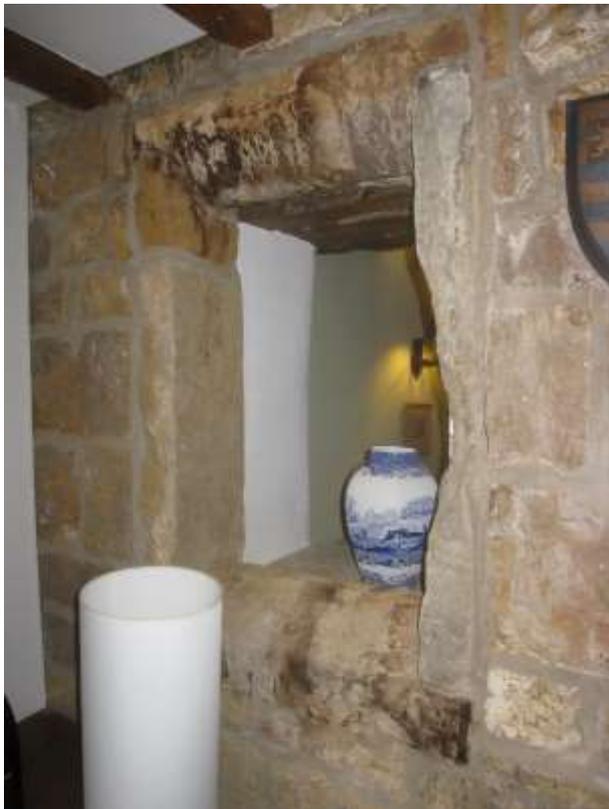
The south (external) face of the former window in the south room

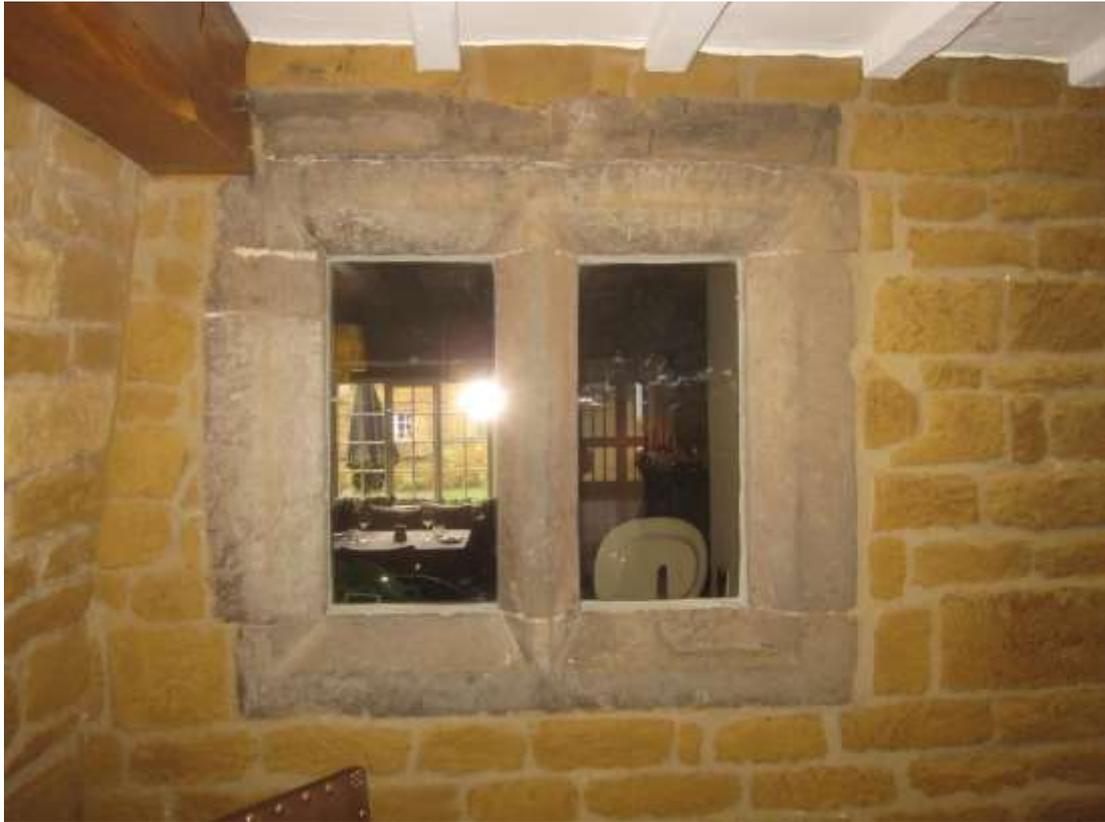
The east (external) face of the mullioned window of the north room (parlour)

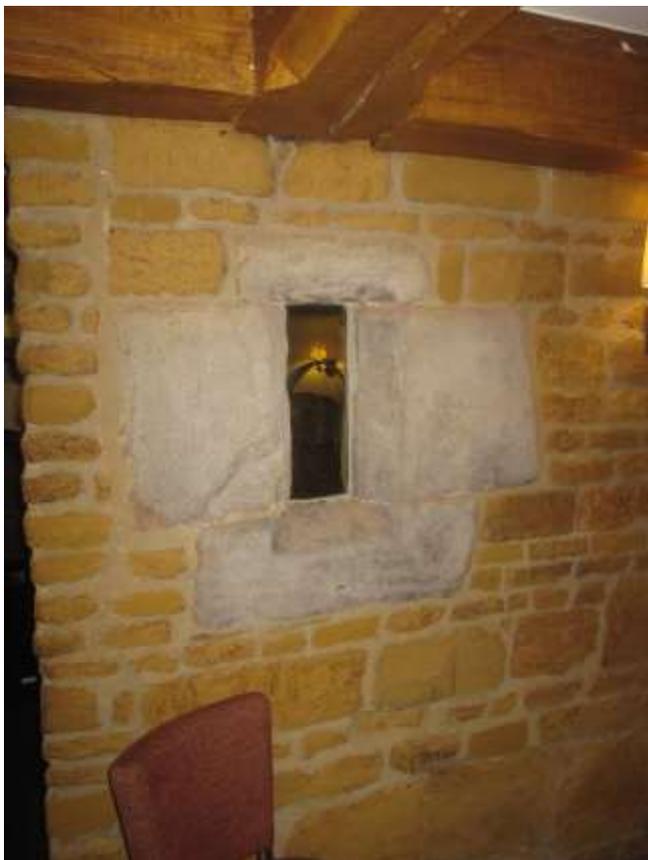
The slit window in the rear wing

The rear E wing has walls of ironstone rubble, quite well coursed to the exterior face (N wall) but more thinly coursed and irregular to the inner faces. Although much altered with large openings, sections of all three original walls survive. In the N wall is a narrow window with a chamfered ironstone surround, formed of four large blocks – of 17th century date. The ceiling beams and joists are modern.

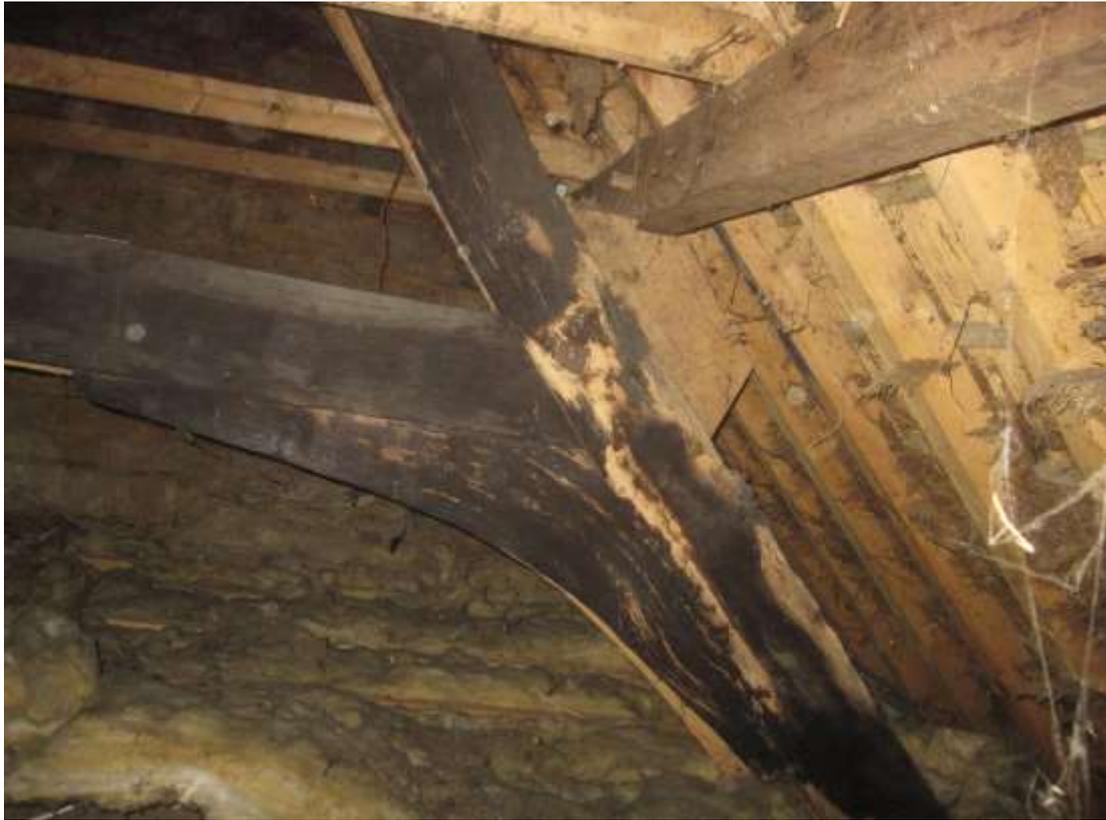
Truss T3 with arch-brace

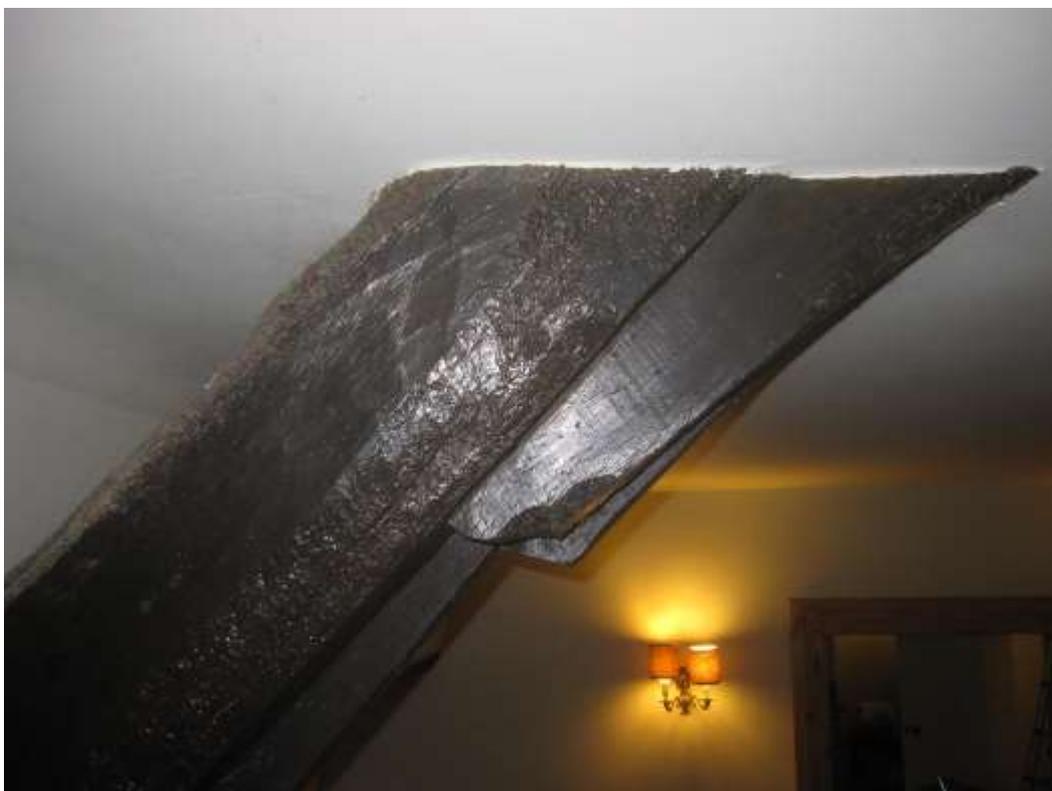
Ogee-shaped foot to arch-brace
