**Lyddington Manor History Society
Historic Building Survey**

**Rose Cottage
7 Main St,
Lyddington, Rutland**

HISTORIC BUILDING SURVEY REPORT

ROSE COTTAGE 7 MAIN STREET, LYDDINGTON

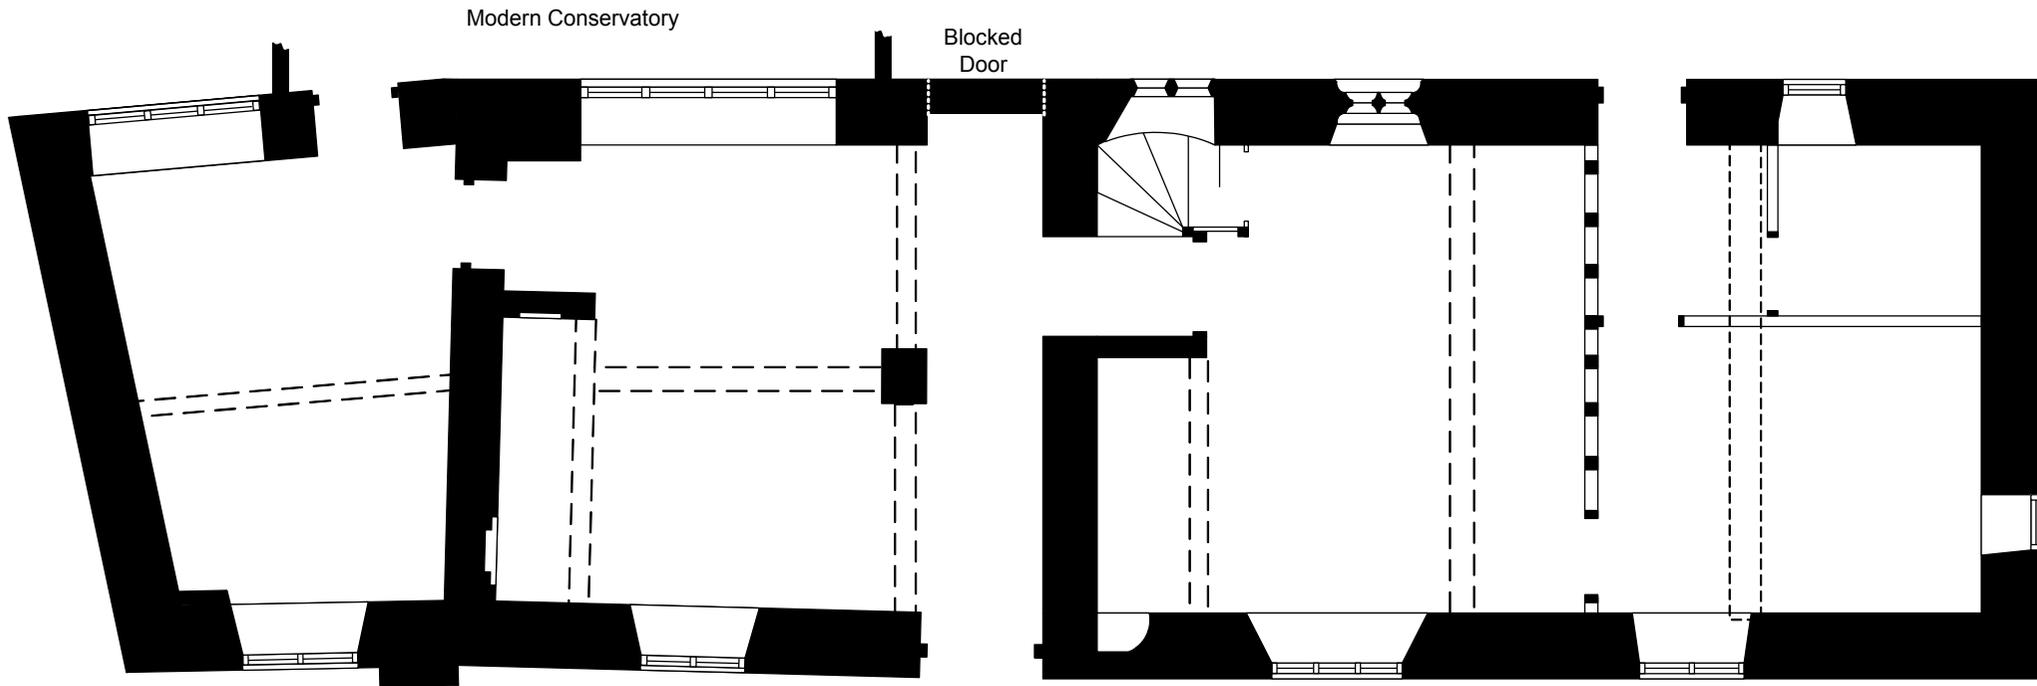
GROUND FLOOR

ROSE COTTAGE, 7 MAIN STREET, LYDDINGTON

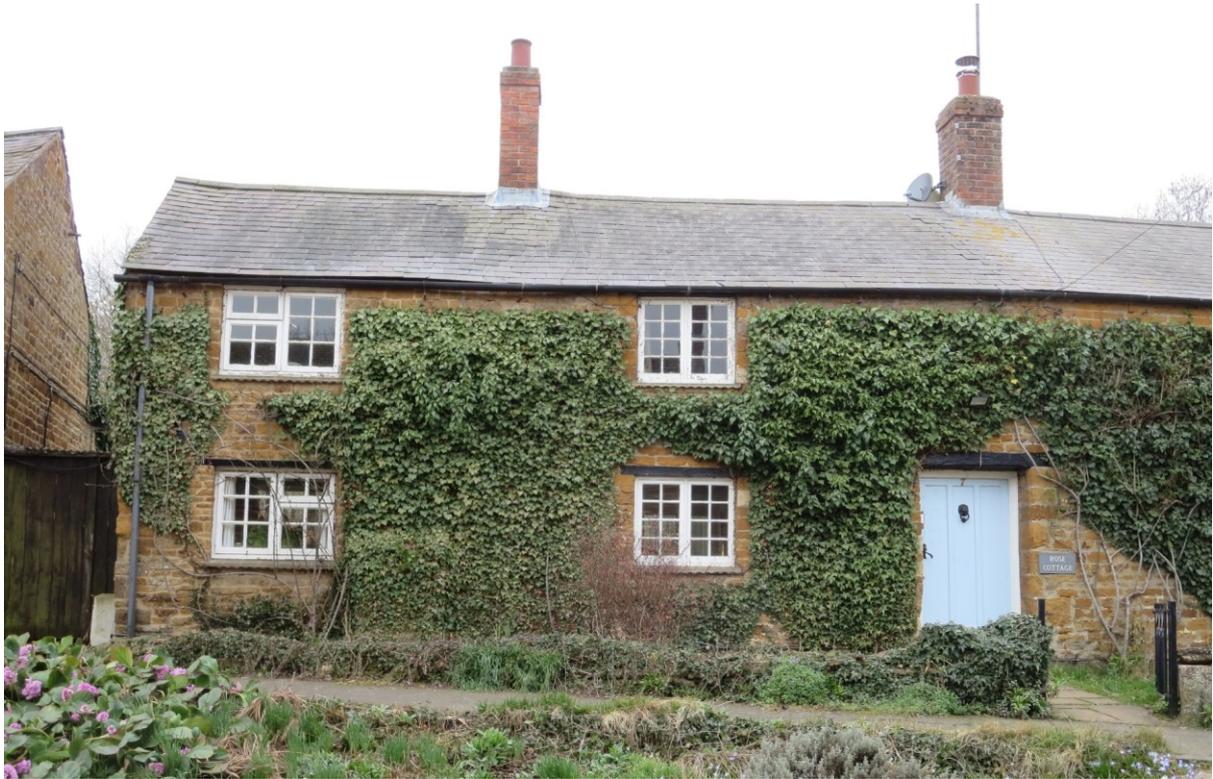
The east front – south part

The E front has coursed ironstone rubble, with more uniform, neatly dressed ironstone from the 1st floor window cills upwards, no doubt an alteration when the roof was raised. Much of the masonry is covered by vegetation, but it is more clearly visible in

a photo of 1968. Offset front door with two windows to N and one to S, all with old timber lintels. Towards the S end is a small buttress-like feature around 1m high, of brownstone ashlar with a chamfered plinth and sloping top. This must be part of a former bake-oven, whose doorway opening can be seen inside. The ground and first floor windows to the former outbuilding part at the S end were inserted after the 1968 photo. On the 1968 photo, a joint line is visible for a short distance above the bake-oven feature, where the outbuilding adjoins the main block, but the masonry is now much obscured by ivy.

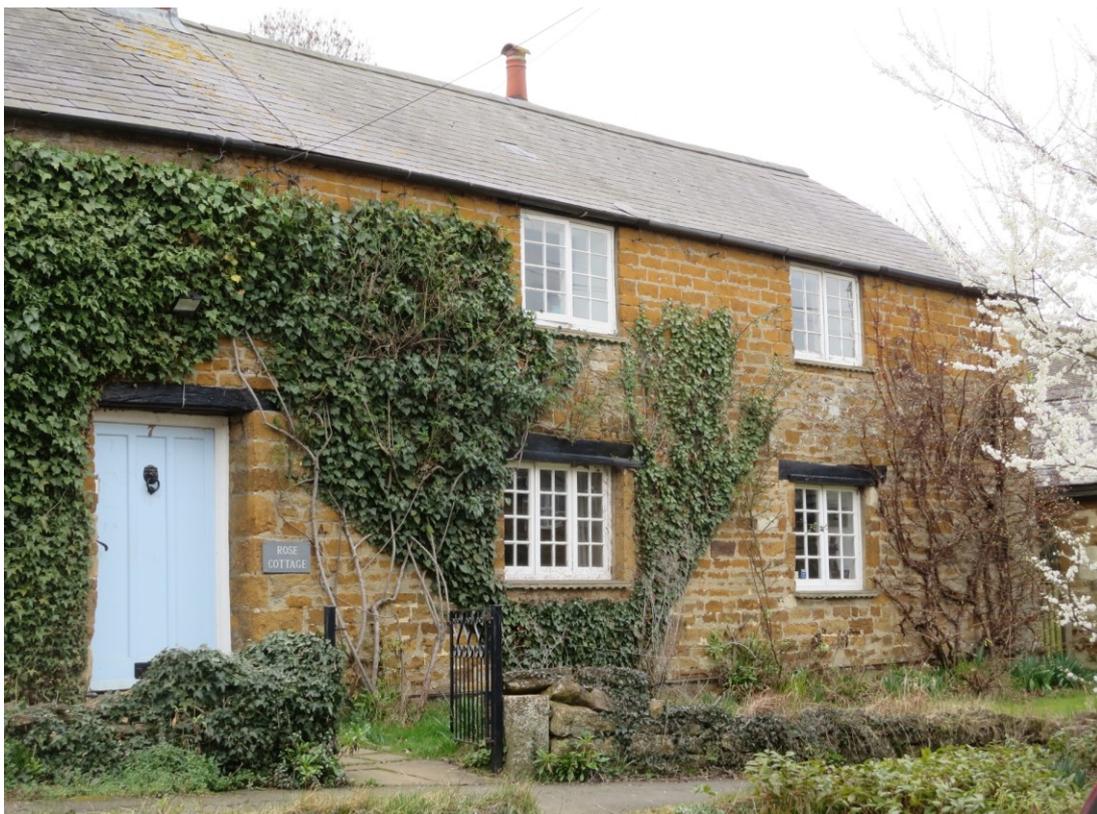
The east front – north part

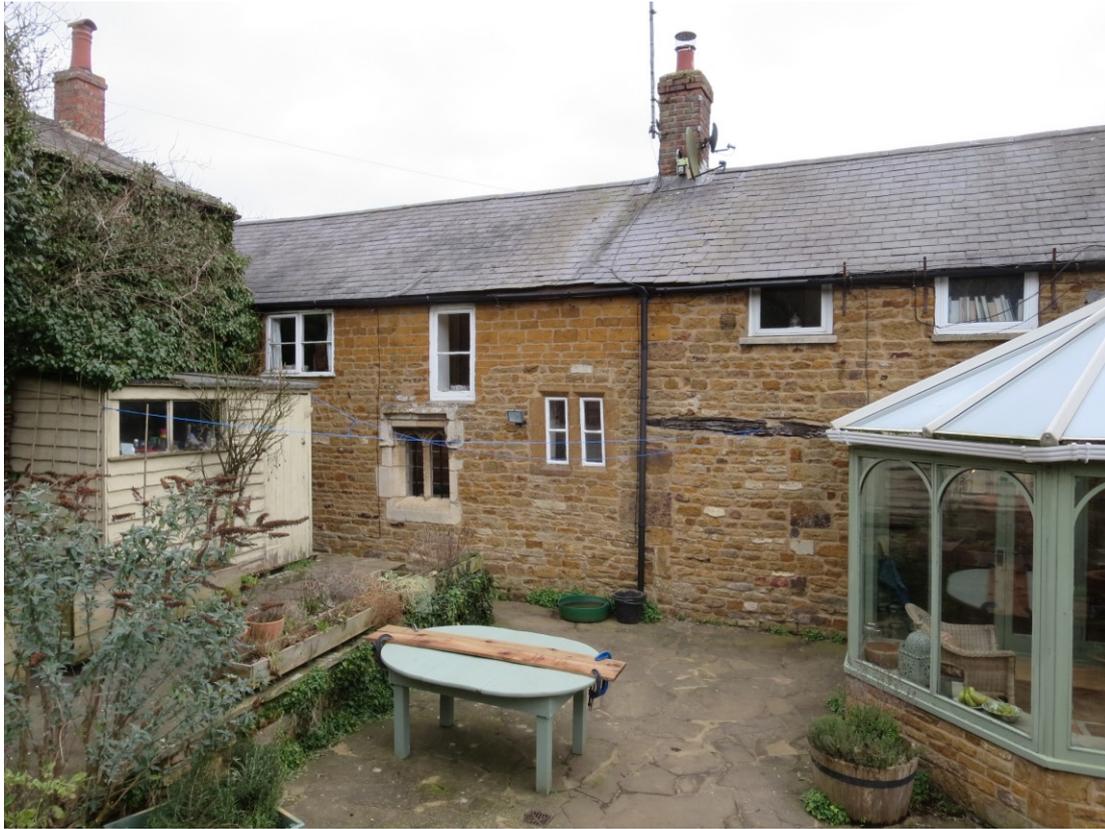
The rear west side – north part

The N end of the rear W side has a back door and ground floor window opening with no indication of early date. The 1st floor window openings to the W side are all of 19/20th century date. The N gable is blank except for a small ground floor window. The gable has good ironstone quoins and a plain verge.

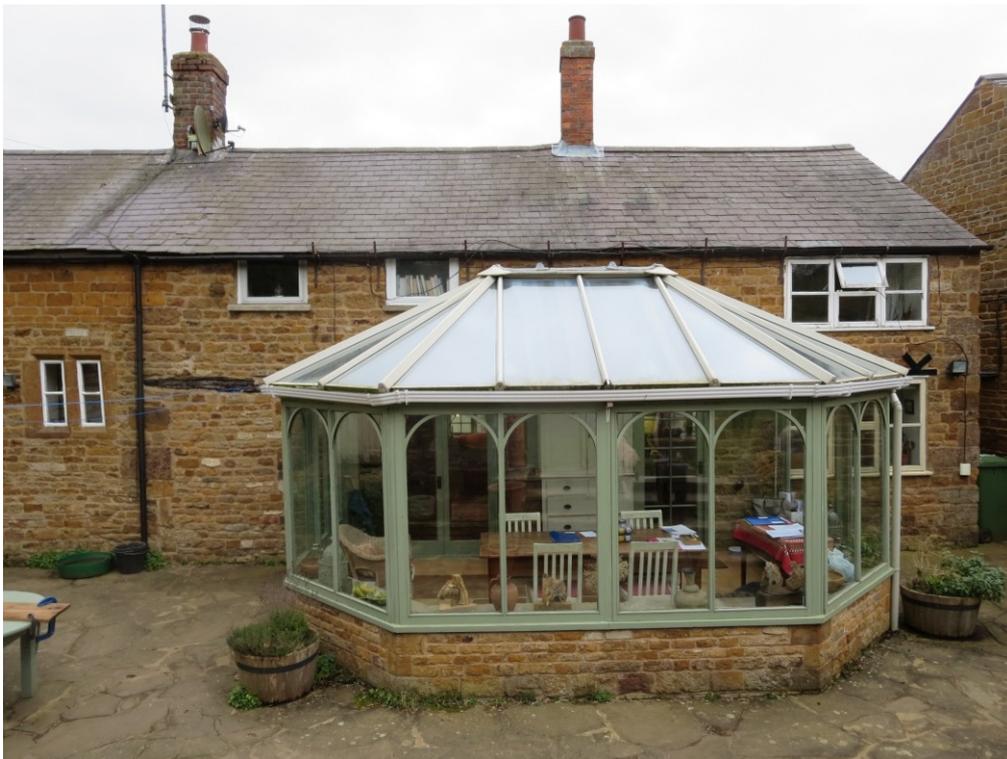
The rear west side – south part

The rear W side has coursed ironstone rubble, which has been re-worked towards the S end, so any evidence of a joint where the outbuilding abutted has been removed. The S end has large modern window openings to ground and 1st floor, then a modern conservatory. The doorway and French windows leading into the conservatory are modern openings, though they may replace an earlier door to the outbuilding and a rear window to the house. Beyond the conservatory, the walling is of older ironstone rubble, except where rebuilt in more uniform masonry at upper level (as on the E front). Just N of the conservatory is the blocked doorway of the cross-passage, with an old oak lintel and some large ironstone quoins. Next to this is a 2-light ironstone window with chamfered mullion and surround, set at mid-floor height to light the stairs.

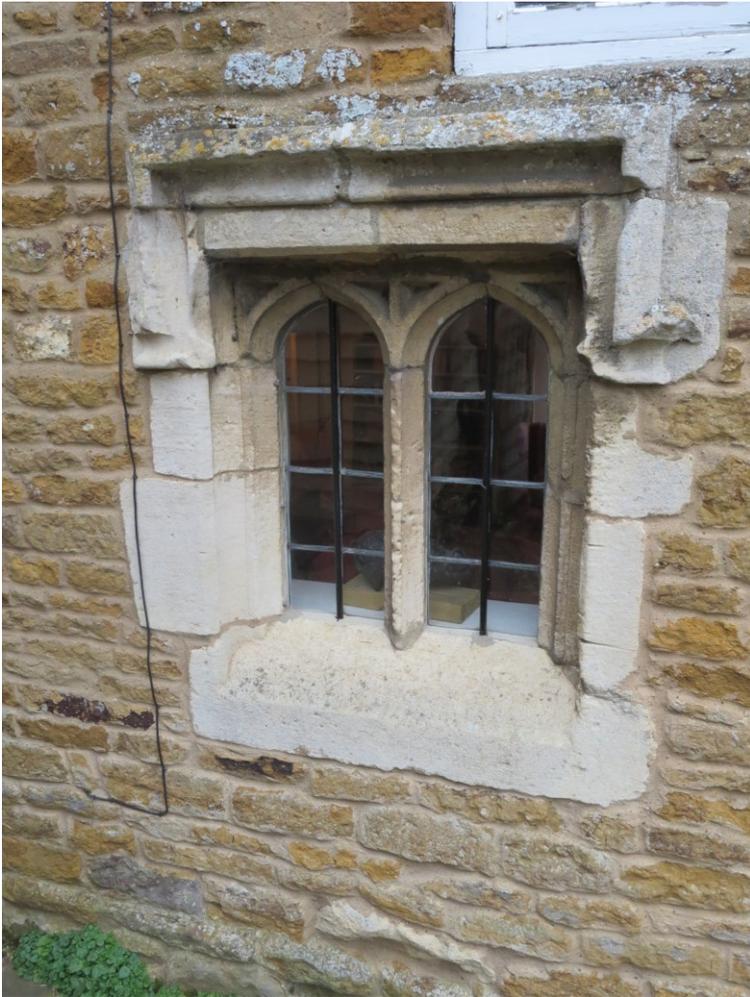
Re-set 15th century window
to rear west side

The ground floor window to the N of the stair window is of most unexpected type. It is a 2-light mullioned window of Weldon-type limestone, with cavetto-moulded mullion and pointed arched heads to the lights, with recessed spandrels. Hollow-moulded casement surround, with cavetto hood mould, with dropped ends to either side. Inside, the mullion and jambs are also cavetto-moulded, with recessed spandrels to the arched heads, though the window head is slightly cut by the ceiling. This is a well-established type of window design for high-status buildings, dating from the second half of the 15th or the very early 16th century. It clearly does not originate with this house, but is a re-used feature. The most likely source is Lyddington's Bishop's Palace, where much fabric of this quality and date was lost after the Reformation, when it became the Bede House.

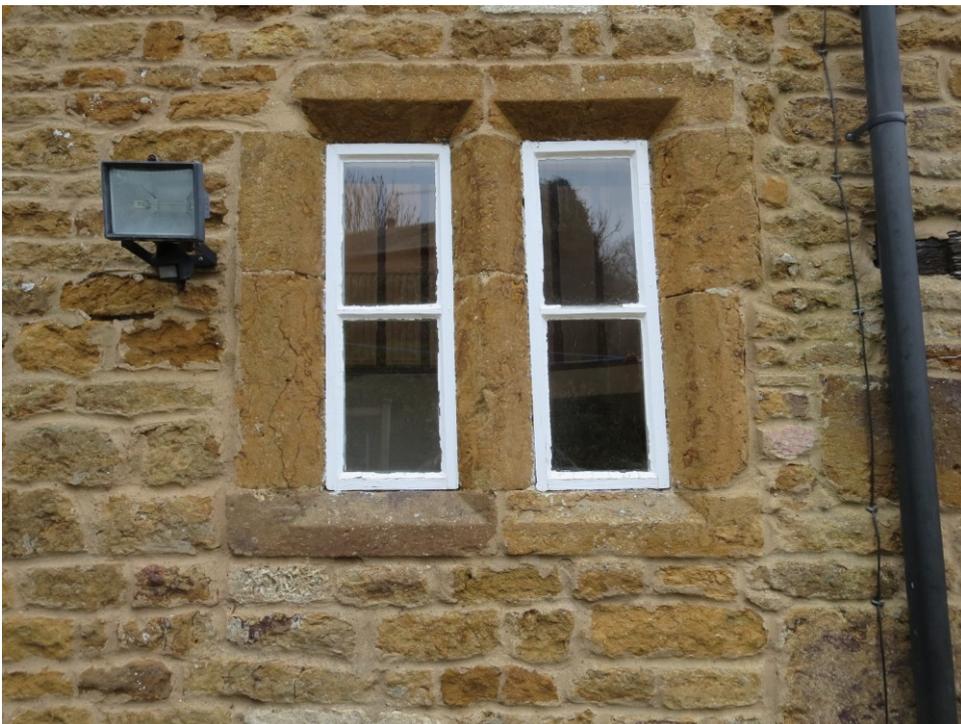
Stair window to rear west side

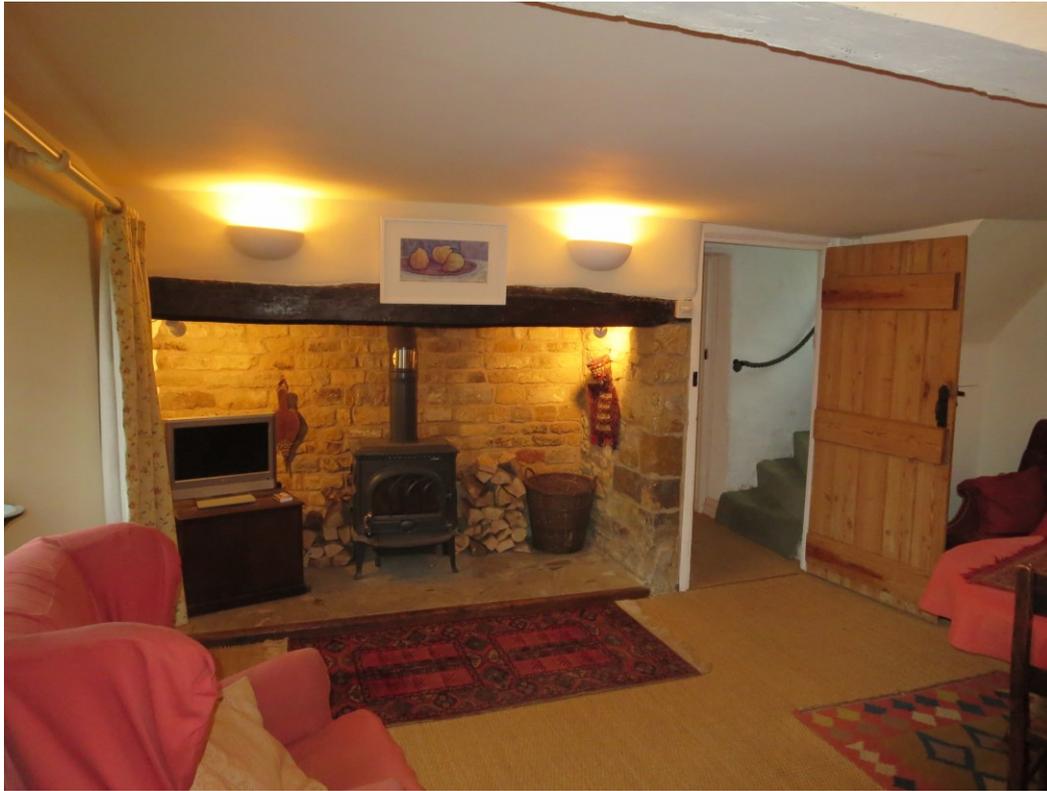
The original hall room, with inglenook fireplace

The central room of the main house has another inglenook fireplace, backing onto the cross-passage. Masonry cheek wall, chamfered ingle beam with no stops. There is a single burn mark applied to the ingle beam near its centre. An irregular recess to the left side suggests another bake-oven or similar feature. The room has a transverse ceiling beam, chamfered with step stops to the E end only. To the W of the chimneystack there is a winder stair, the treads set into a curved recess in the rear W wall. The stair treads and bearers seem to have been re-worked, but there is a very interesting survival to the NE part of the stair structure. The stair newel and an upright stud to the N of it are linked by tenoned rails, at the top, bottom and two intermediate points. The rails and uprights have the remains of fine moulding, indicating that this was a panelled partition to the side of the stair, of 460mm in width. The panelling presumably once returned W to meet the external wall, forming a partition around the upper part of the winder stair to separate it from the main room. The mouldings, though somewhat obscured, are suggestive of a 17th century date, which would be a rare survival for the area.

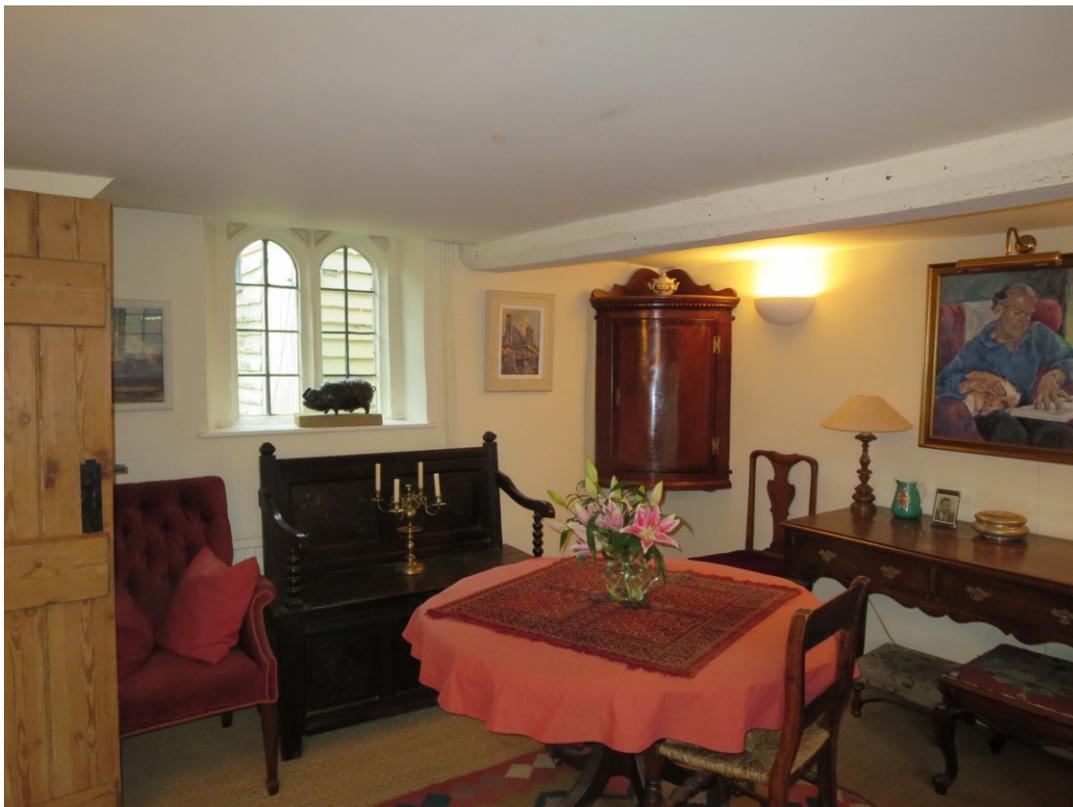
The hall room, looking west

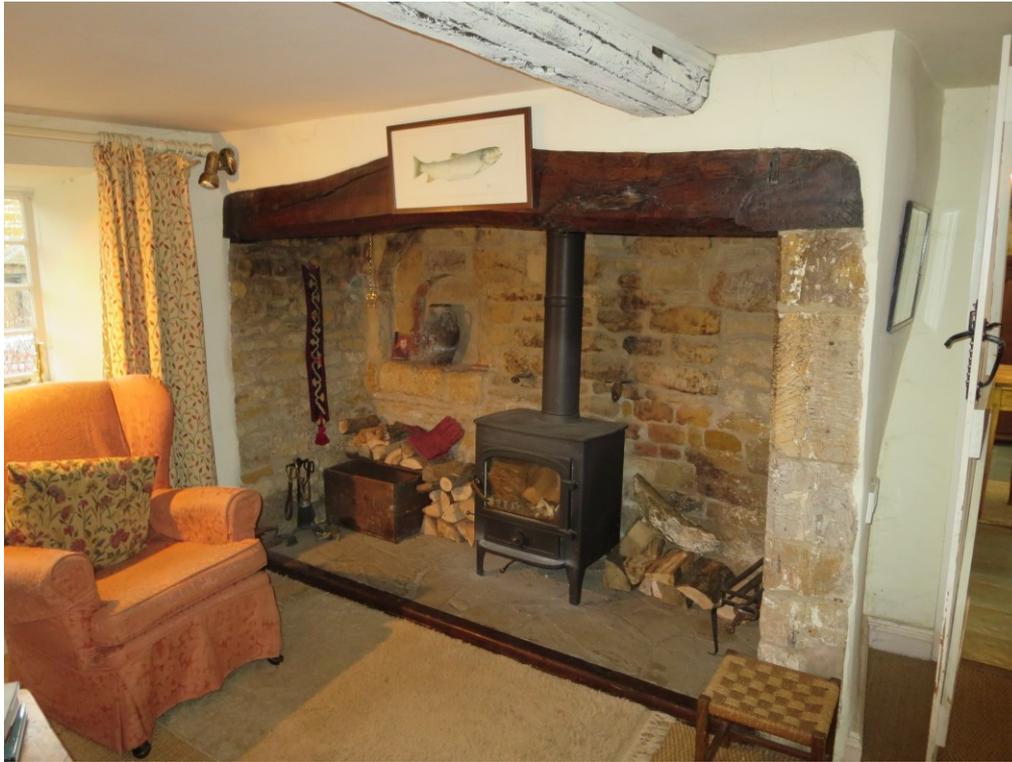
Inglenook fireplace to the south room, the original kitchen

The S room of the main house is now open to the former cross-passage, with a modern central stone pier and transverse beams. There would originally have been a partition wall here, probably of timber studs. The oak spine beam has some applied ovolo moulding, but is noted in the re-listing description (of 1985) as ‘inserted c.1980’, so must have been part of the cross-passage alterations. Large inglenook fireplace with masonry cheek wall and slightly arched beam, chamfered with good ogee stops. The rear left wall of the inglenook has a blocked, double-arched opening, which would have been for a bake-oven (as also evident from the external projection to the front wall). The cheek wall has a chamfered recess at low level, of unexplained purpose.

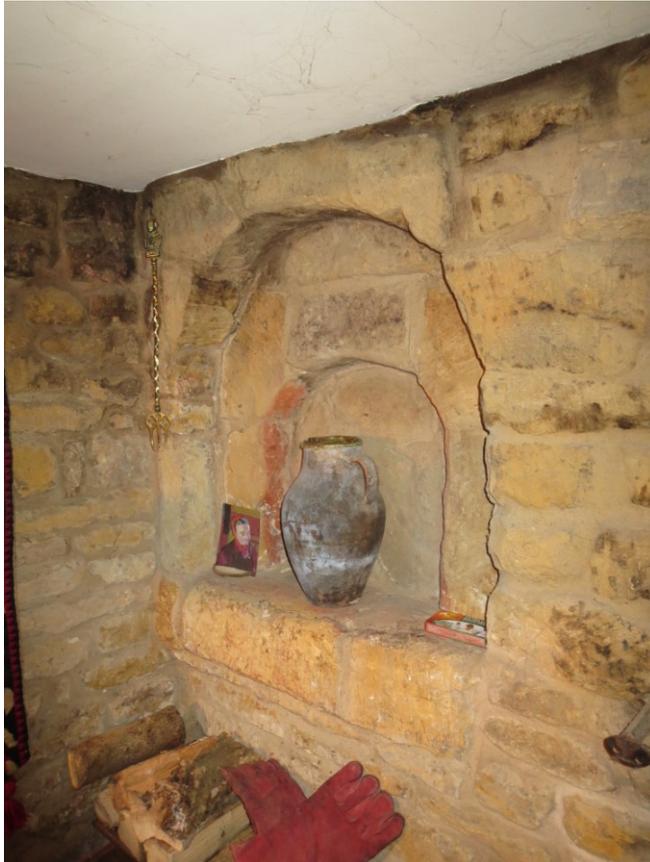
Blocked-up doorway to the former bake oven in the kitchen inglenook

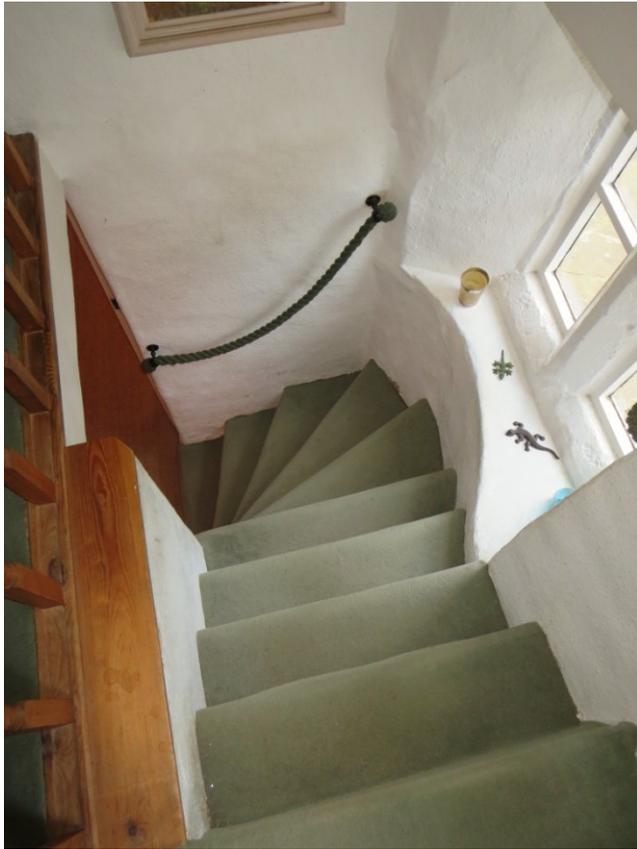
Winder stairs, set into hollowed-out wall

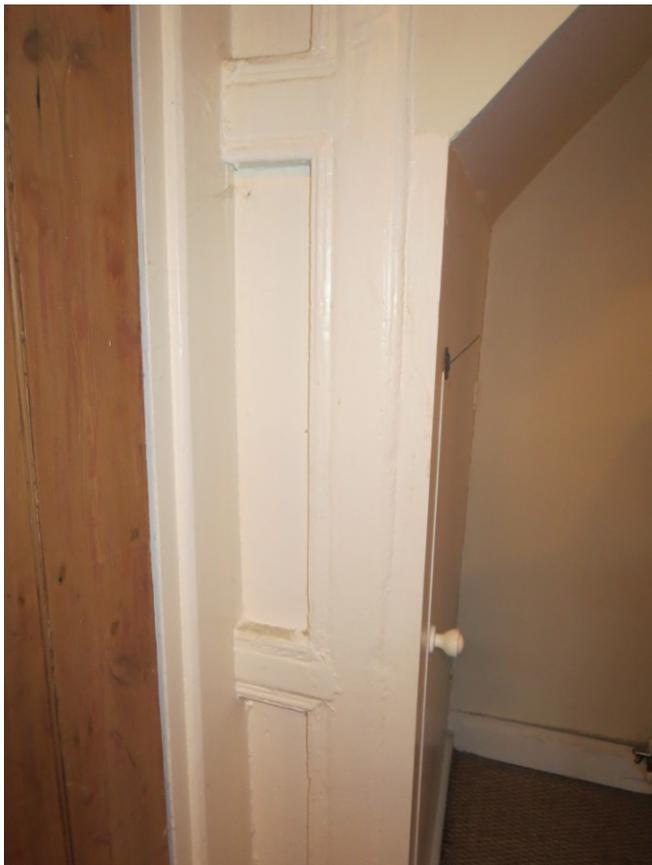
Part of the 17th century panelled partition to the stairs

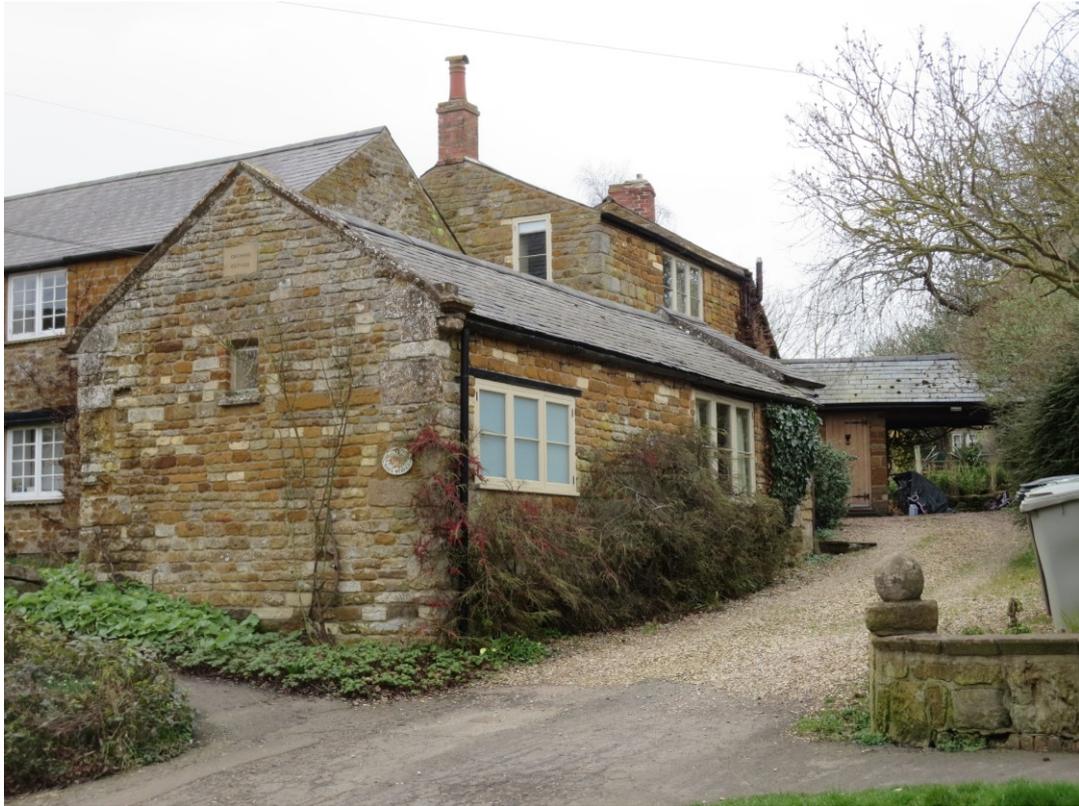
The adjoining building, No 9 Main St (Orchard Cottage)

There is a re-set datestone on the gable end of the adjoining building, No 9 (Orchard Cottage). To each side of this gable are high quality ogee half-pendant corbels with moulded kneelers, with base for a missing finial. The gable copings above are now set at a pitch of around 35°, but the coping angle on the kneelers is of the normal 45-50° pitch. The N kneeler has the initials and date:

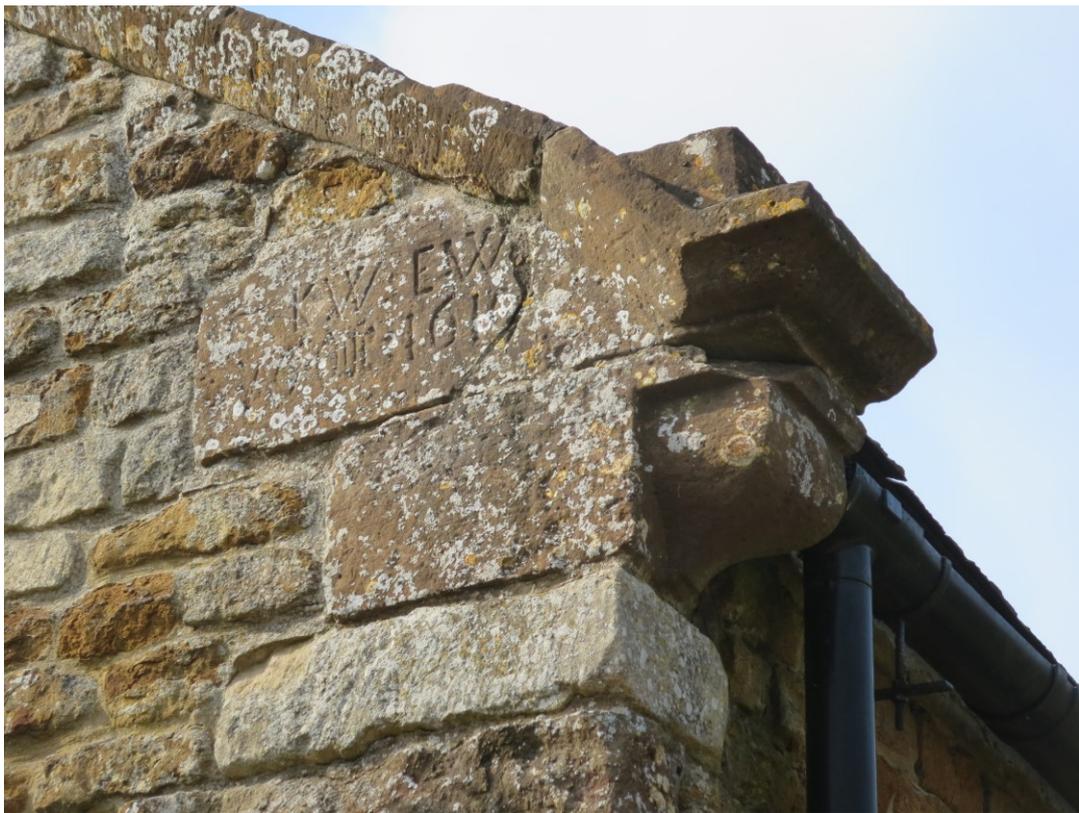
Date-stone to No 9: KW EW Ao dm 1619

KW · EW
Ao · dm · 1619

The letters Ao and especially dm are not fully legible, but the meaning is evident ie Anno Domini (year of our Lord). A photo of c.1905 shows the gable end rising higher and with a gable parapet, but it is not clear whether the kneelers and corbels are in situ on the building. They seem of very high quality for a building which was only around 3m wide internally and of fairly low status. It is possible that they came from No 7.

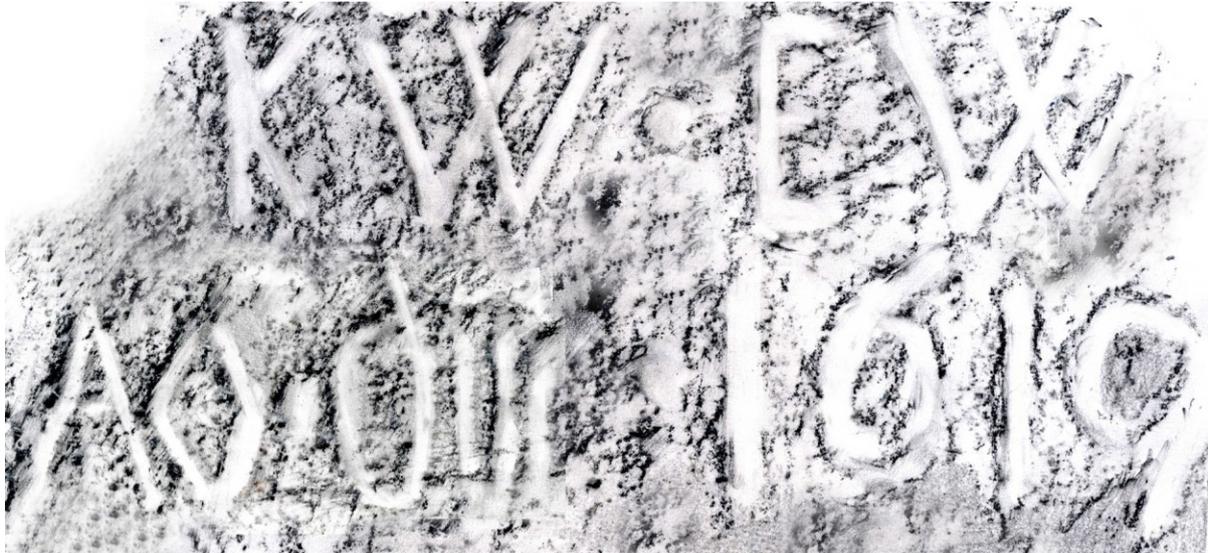
A rubbing of the 1619 date-stone to No 9

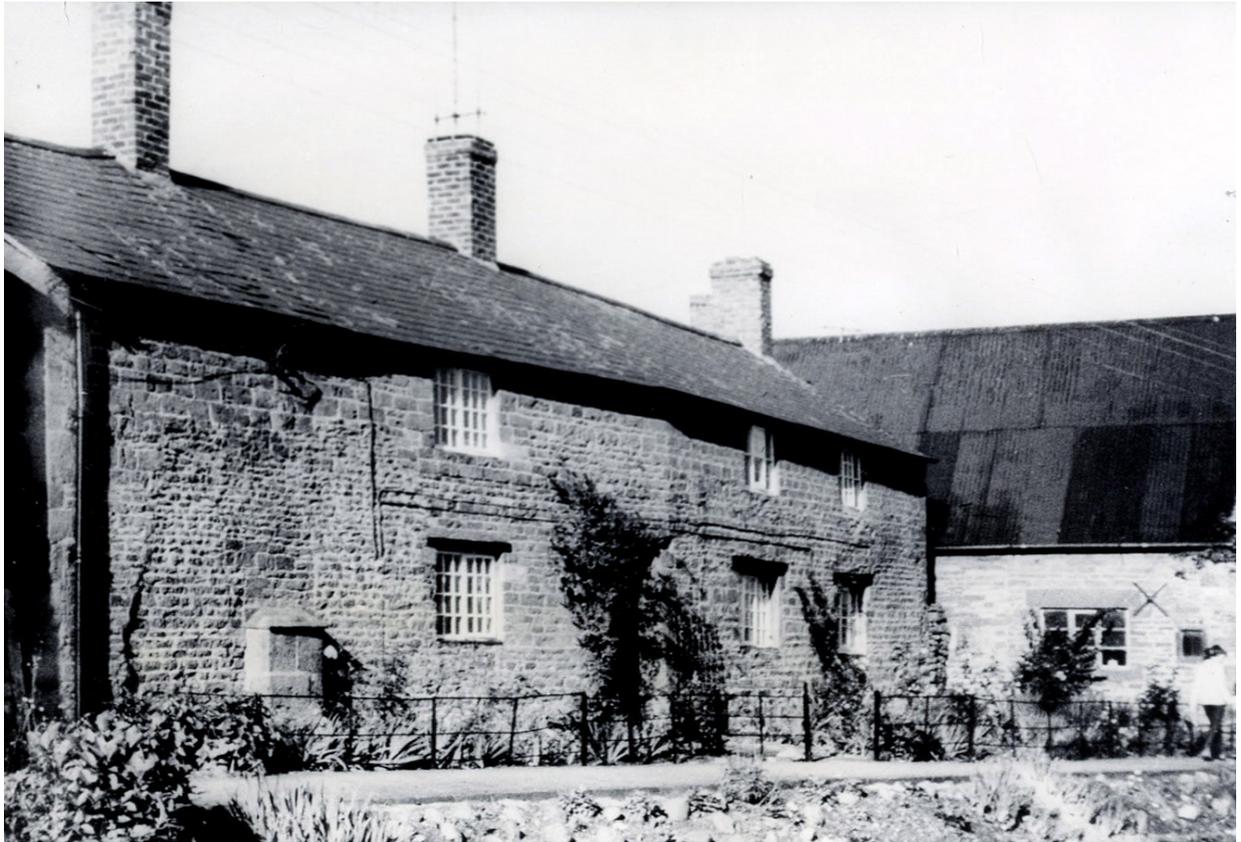
View of 7 Main St in 1968. The buttress-like projection of the former bake oven is evident

Along the roof ridge there are two single-flue brick chimneystacks, of rebuilt 19/20th century brick. The 1968 photo shows a 2-flue brick stack to the N gable, now gone. The windows and external doors are of late date, mostly 20th century, though the old 12-pane casements are visible on the 1968 photo.

The N room is separated from the central room by a stud partition, with original oak studs visible to the N side. The studs are plain and rather irregular, with no bottom or top rail visible, probably with mud infill. The room has a transverse beam, chamfered with step stops to the E end only. The spacing of the transverse beams and partition to the central and N rooms indicates that the floor joists were designed to be carried by the beams, not the partition. The chimneybreast on the 1968 photo is no longer visible.

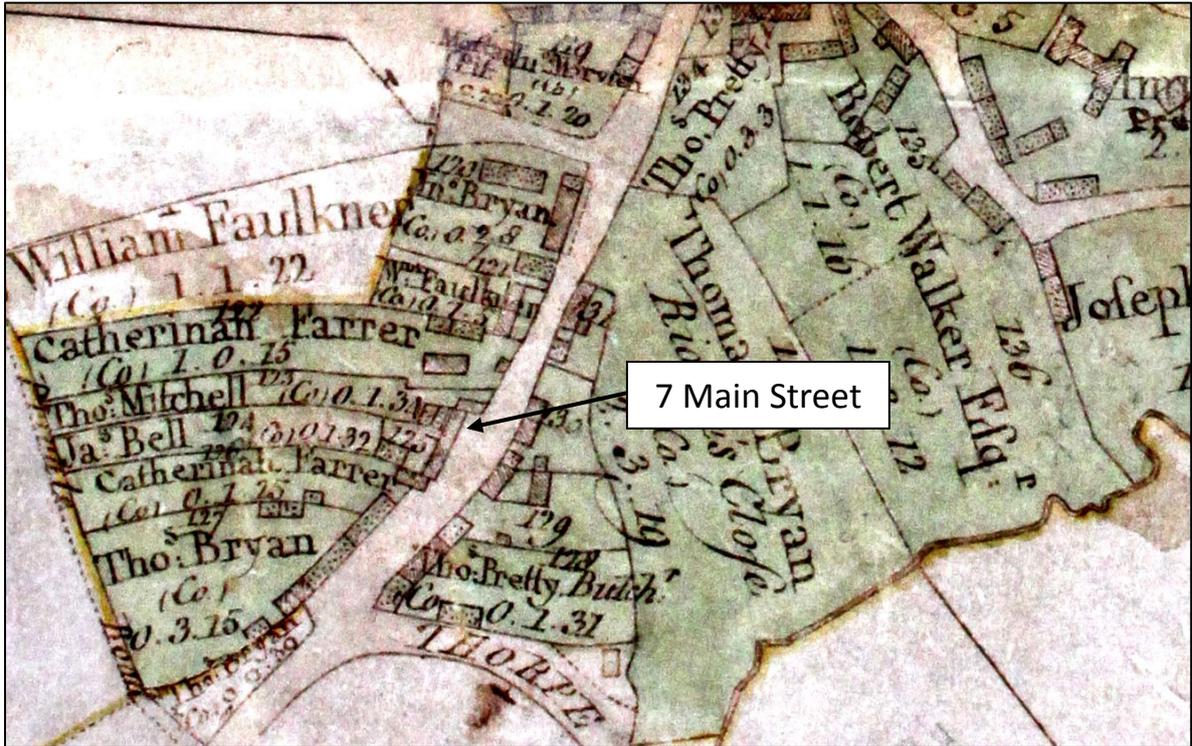
Lyddington Enclosure Map - 1804

The 1804 enclosure map shows the building (plot 125) as single long range in domestic use, stretching across the whole of the front of the plot. An outbuilding is

shown in the SW corner of the rear yard, which does not extend as far W as the current garden. The copyhold owner was Edward C a ? (illegible), and the plot area as 3 roods 7 perches.

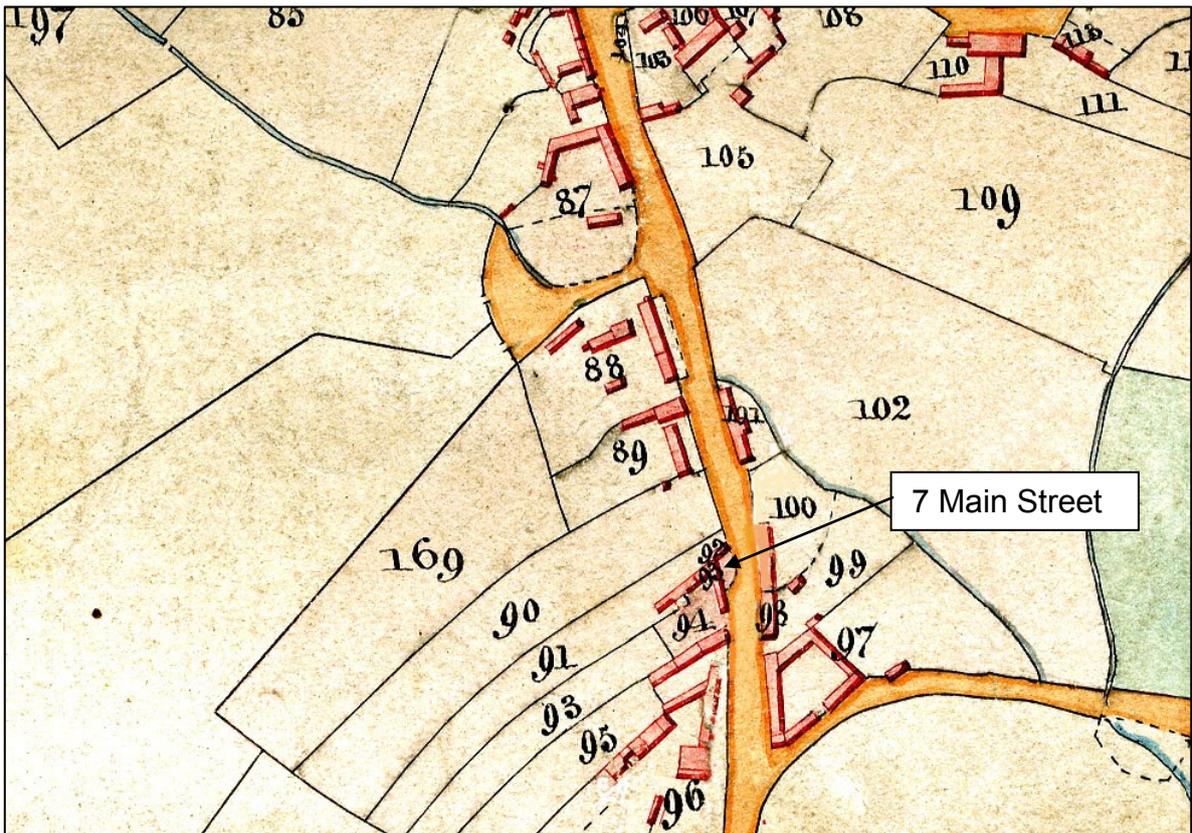
Lyddington Estate Map, 1848 (Burghley Archives)

The 1848 estate map shows the building as plot 94, though not extending to the S boundary. The outbuilding of 1804 is not shown. The copyhold owner was Robert Caister, the occupier 'Lewis Berridge & Unoccupied' and the description 'House in two tenements & gardens', of 17 perches. On the 1886 1st edition OS map the S end of the block is indicated as a separate section (which would fit with its use as an outbuilding).
