**Lyddington Manor History Society**  
**Historic Building Survey**

**Tudor House**  
**Thorpe by Water, Rutland**

# **HISTORIC BUILDING SURVEY REPORT**

## **TUDOR HOUSE, THORPE BY WATER**

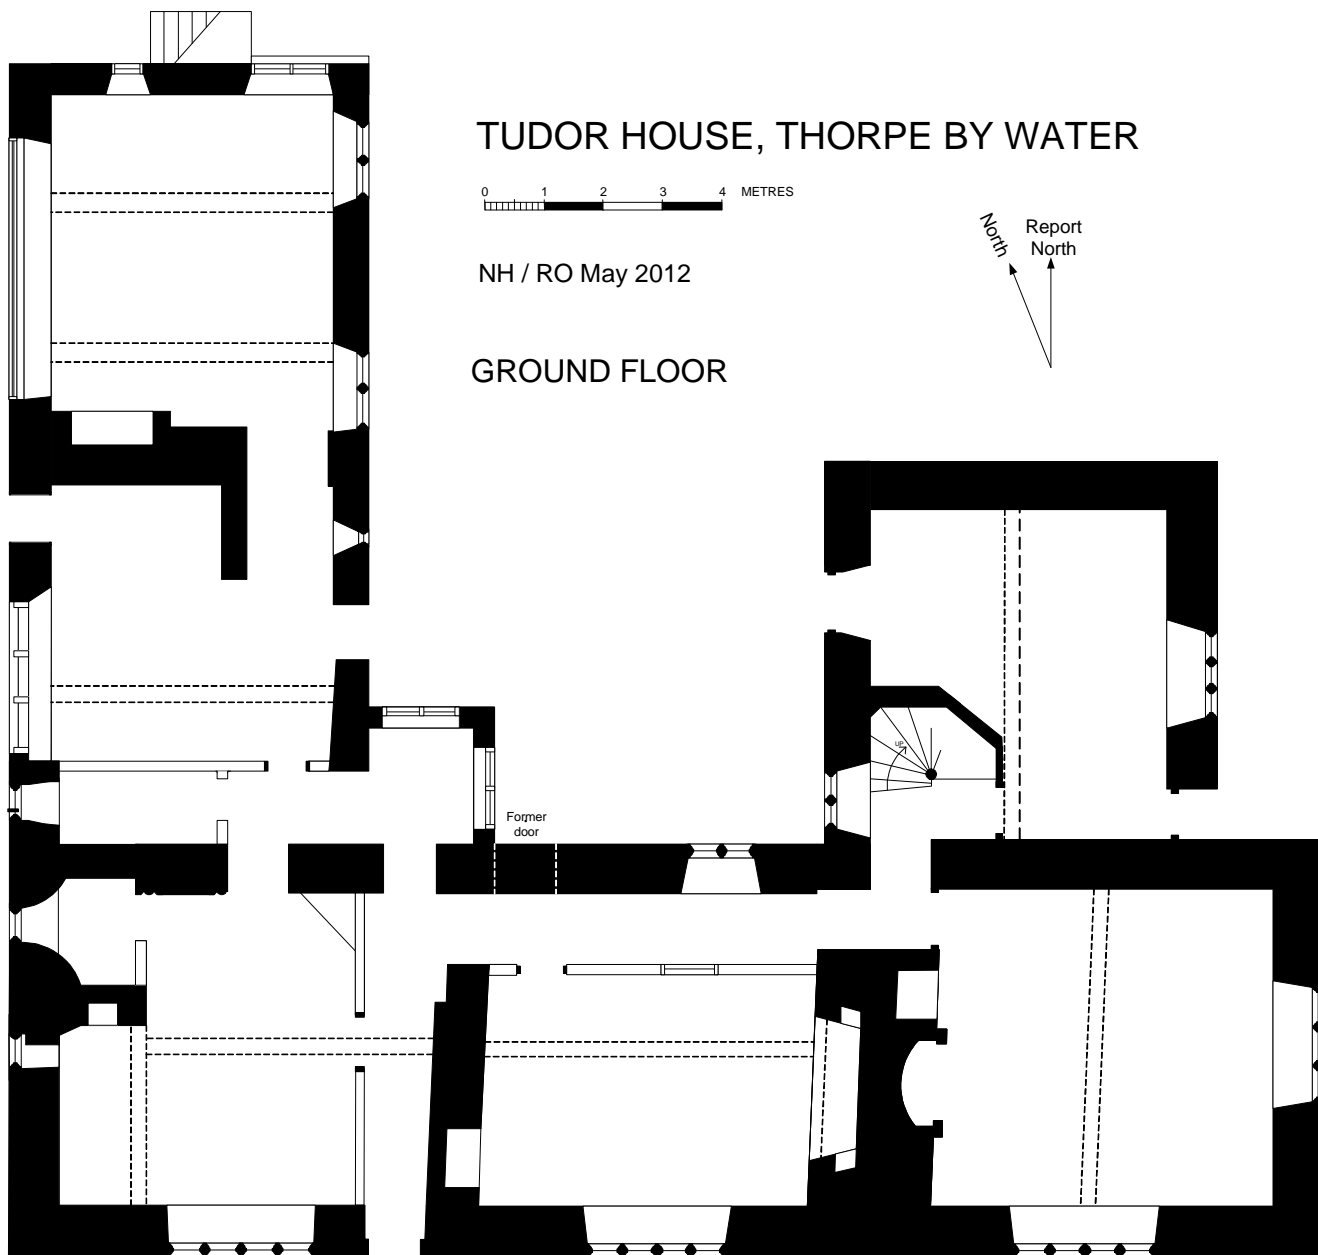
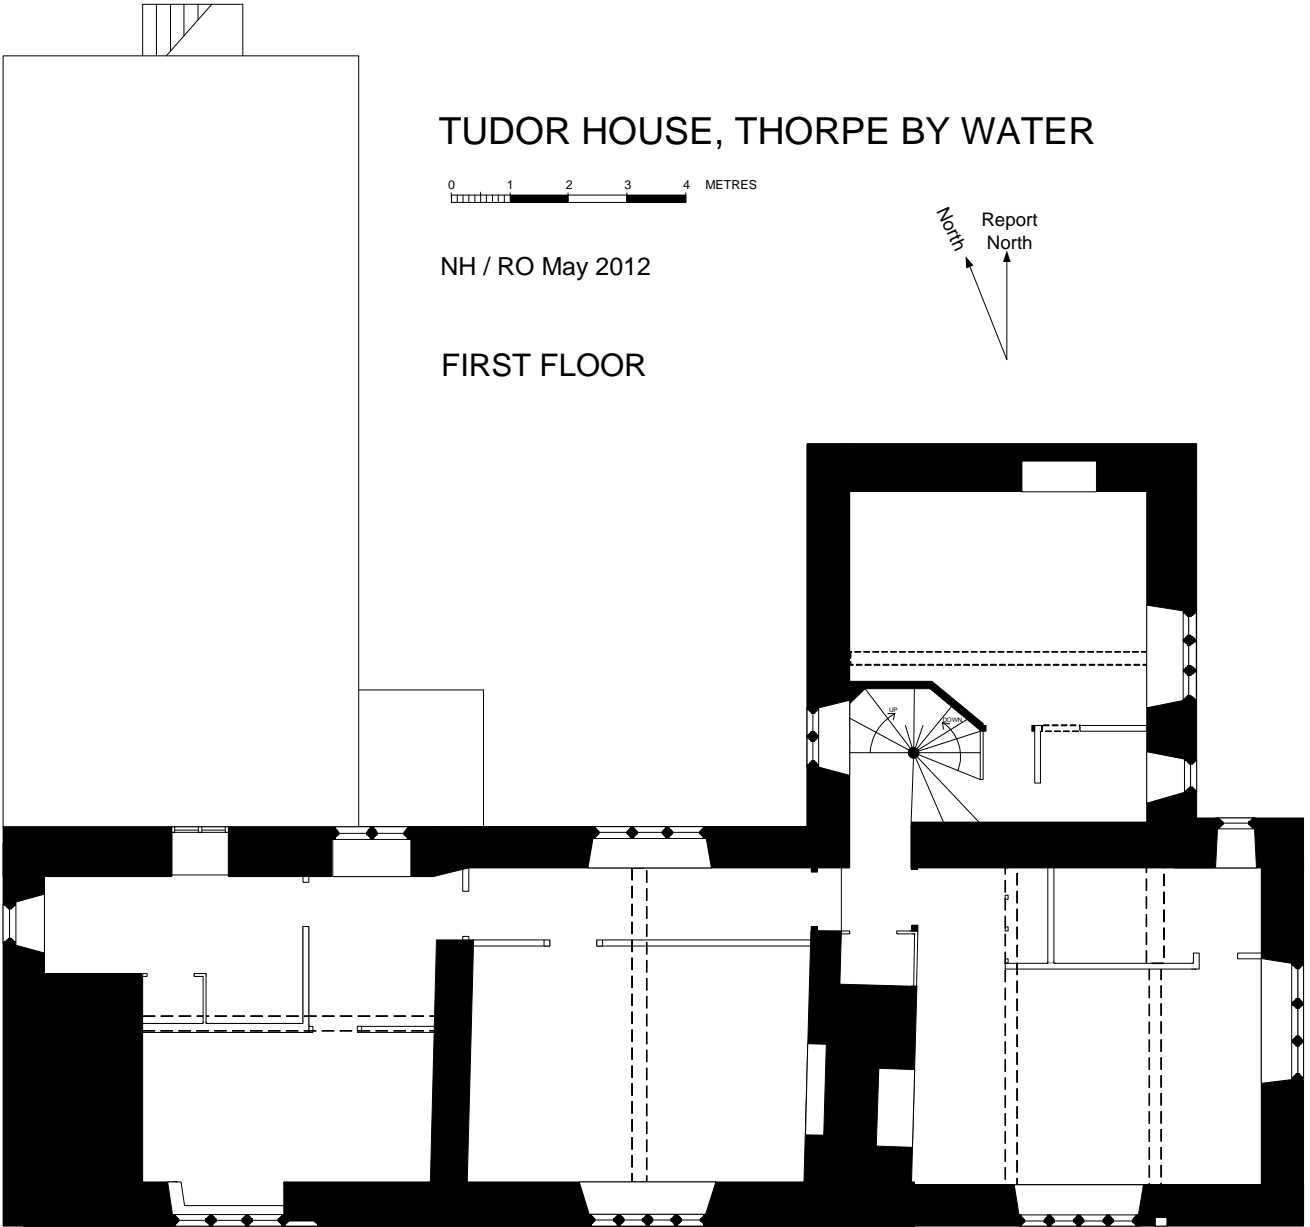
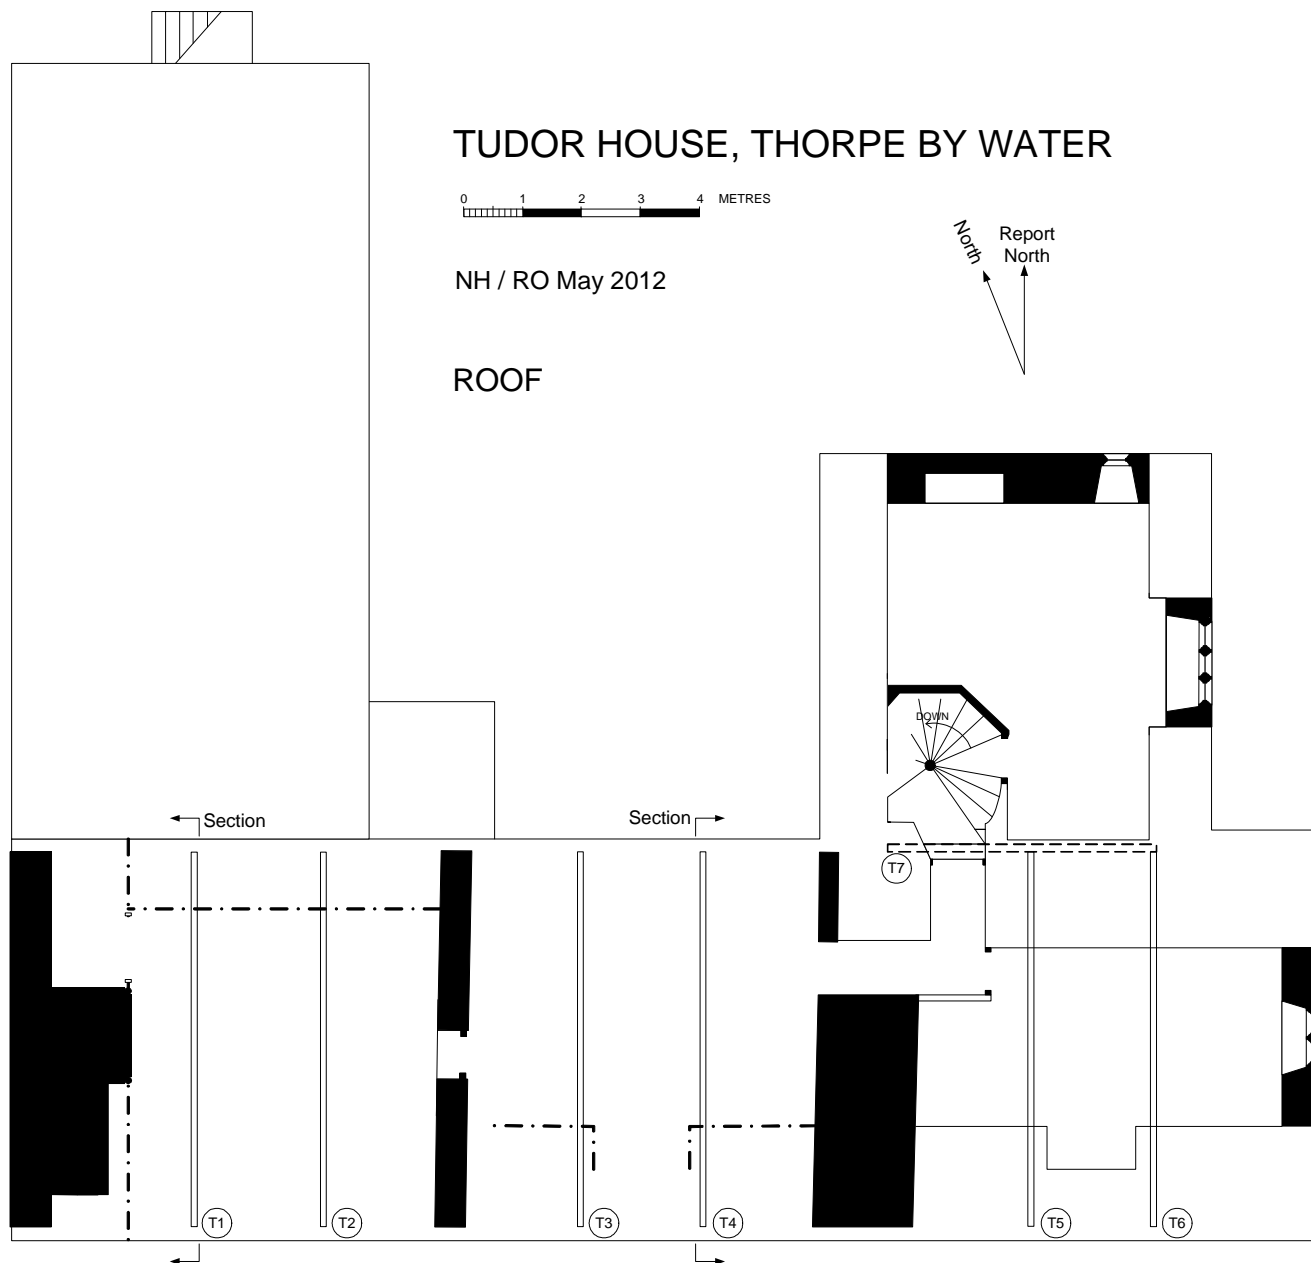
FIRST FLOOR

The front block is now of three-room plan form, with a cross-passage separating the central room from the kitchen at the W end. The rear E wing, with lower ceilings than the front block is an integral part of the structure, with a spiral stair set at the junction, rising from ground floor to attic. The rear W wing has been much rebuilt, but seems likely to have been a later addition, making a U-shaped plan, which included a second staircase. Wall thickness is around 820mm to most ground floor walls, in both the W and E sections of the front block, and the rear E wing.

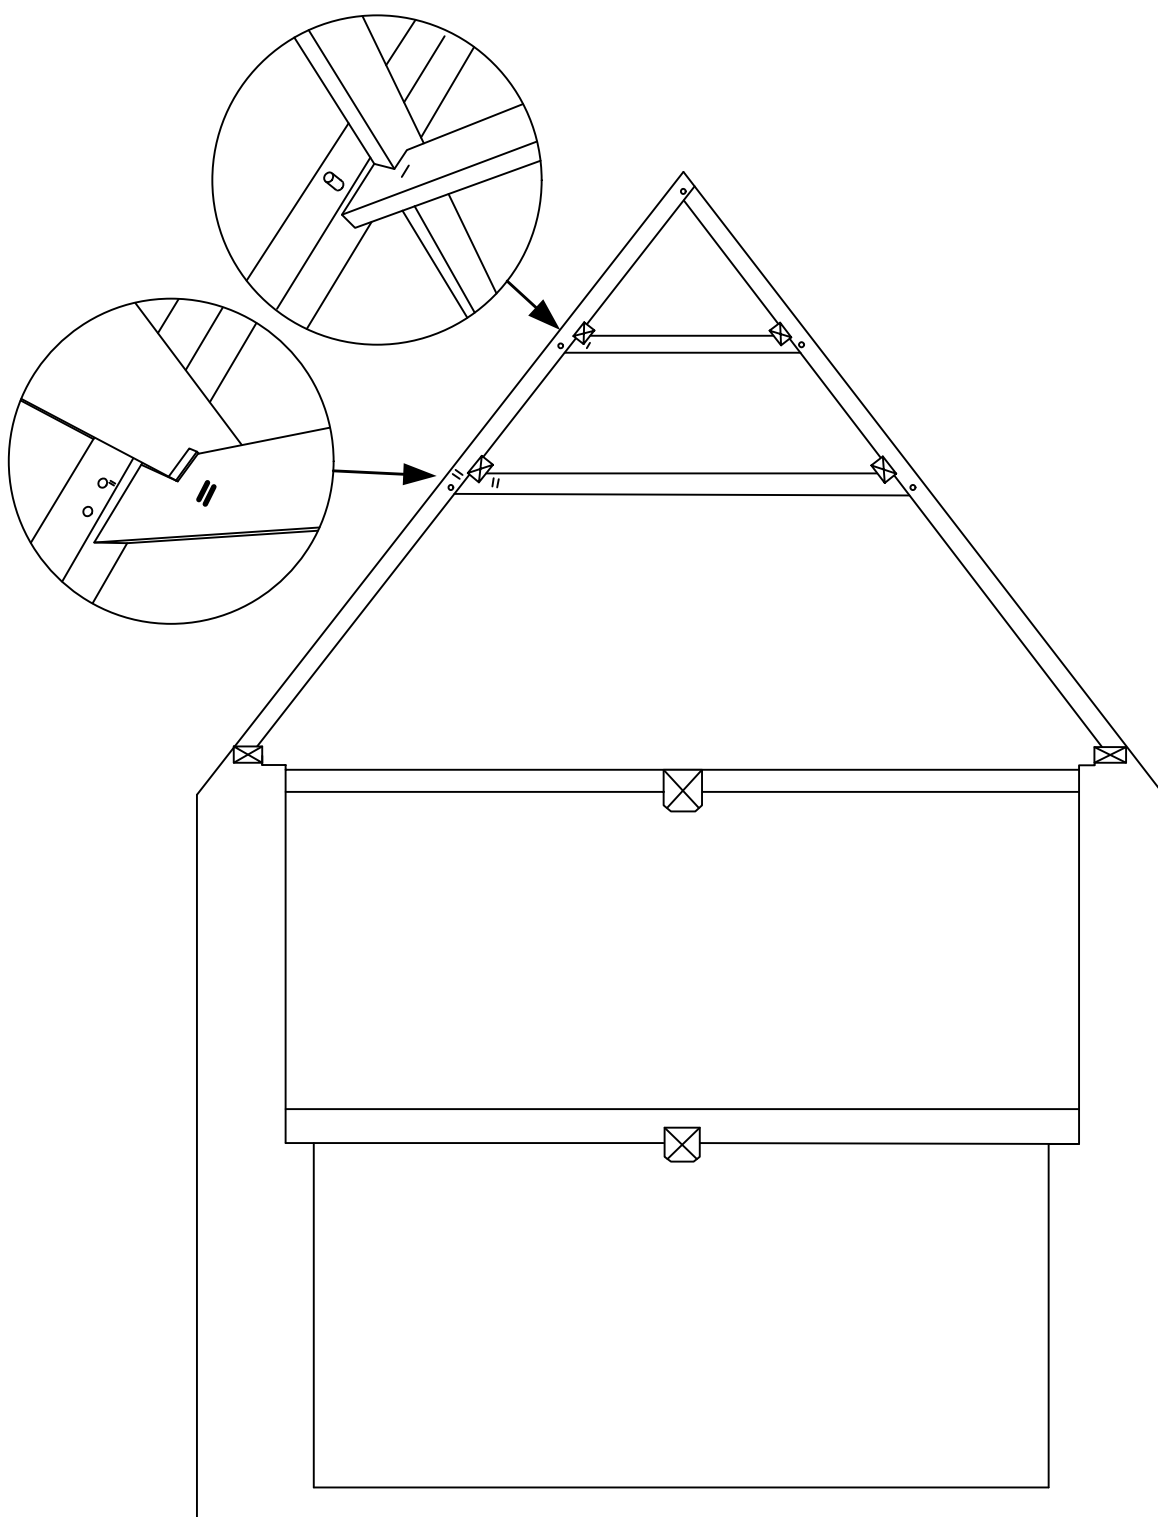
## Section – Truss T1 East Face

The roof structure to the W end of the front range has two quite slender A-frame trusses (T1 and T2) without original tiebeams and two sets of high-set tenoned collars which carry two sets of clasped purlins. Timbers are very neatly square-cut and without chamfers. Bridle joints at apex, with no ridge. Purlins have straight-splayed scarf joints. The W truss (T1) has chiselled carpenter's marks: 'II' to the lower collar S side and 'I' to the upper collar S side. But T2 has no carpenter's marks to the N, though the S side is covered by plating. The feet of the principal rafters are tenoned into heavy wall-plates. The high-set collars suggest that the roof was designed to allow clear headroom. Oak ceiling joists are nailed on top of the lower collars, though may not be original. As noted above, the rafters to the central bay (T1/T2) on the S side are cut at the lower purlin height, indicating a former dormer. Evidence of dormer boxing and cheeks on the S side does not survive, though there is a cill and early oak ashlar studs all along the N side. A very odd detail is that all 5 rafter couples to the E bay have straight-splay scarf joints to the rafters, towards one end, with multiple nailing. This is clearly an original feature of the roof, not a later alteration, and suggests some re-use of timber or alteration in design intent. The rafters in other bays (except the former dormer position) are in single, unusually long lengths.

Tree-ring dating was carried out by Robert Howard of Nottingham Tree-Ring Dating Laboratory in 2012. Eight samples from trusses T3-T7 had a felling date range of 1586-1611. Samples came from the principal rafters and collars, with parts of all five trusses dated. Six samples from trusses T1 and T2 had a felling date of 1678. These samples came from the principal rafters and lower collars.

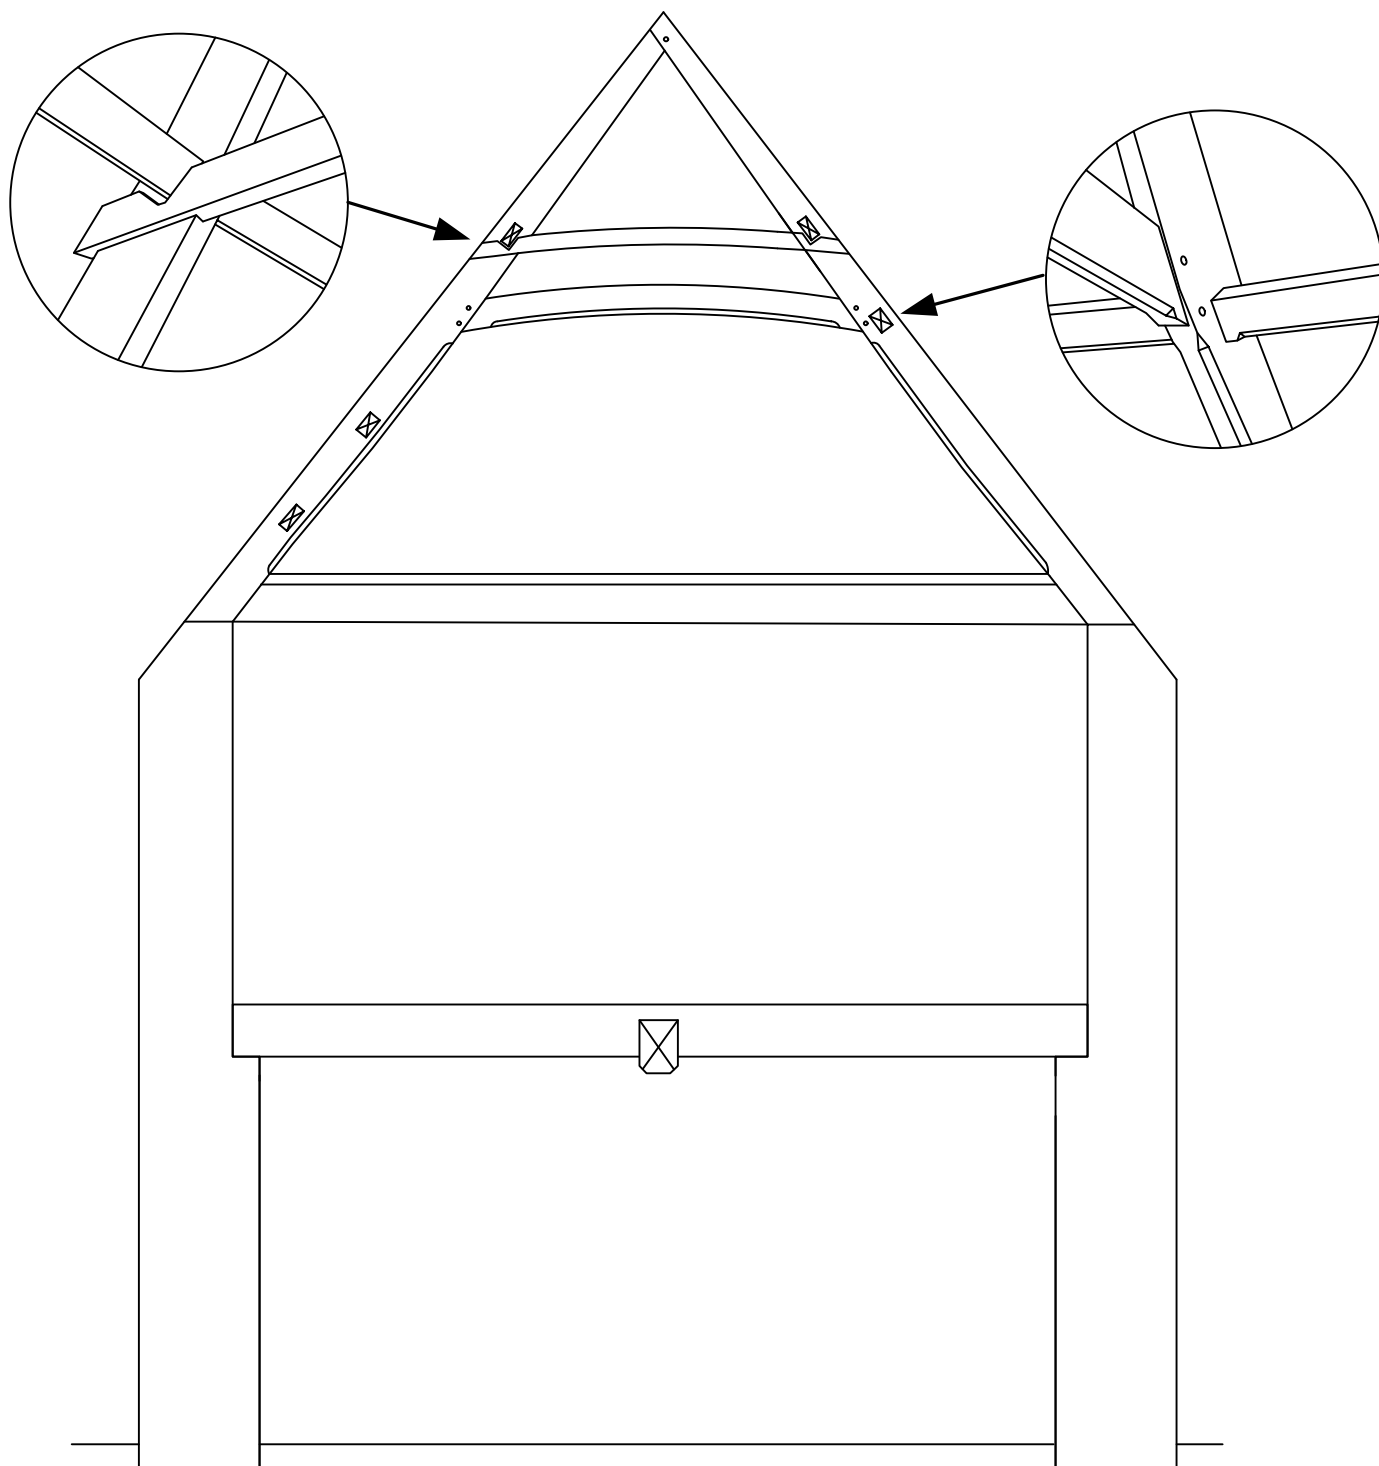
Section – Truss T4 West Face

The roof structure to the rest of the front block and to the rear wing is of different type. The central section has two trusses (T3 and T4), the E section two trusses (T5 and T6) and the rear wing has a single truss (T7) at the junction with the front block, then rafter couples, without trusses. The trusses have a high-set, slightly arched collar tenoned to the principal rafters. Trusses T3 and T4 are of A-frame type, without tiebeams, though it is possible that the other trusses have tiebeams. Tenoned purlins, set high up at collar level to the S bays between T3/T4 and T5/T6 for former dormer windows and to crosswall/T5 bay for doorway from spiral stairs, but set lower elsewhere. Bridle joint to apex, no ridge. T3 and T4 have the face side to the W, but with no carpenter's marks in the three joint locations where evidence is visible. T5 has the mark 'II' and T6 the mark 'I'. Neat chamfers to the underside of the principal rafters and collar, with ogee stops. At the level of the upper purlins a higher oak collar has been nailed onto the rafters to support a ceiling – perhaps original. Cranked wind-braces are tenoned to the principal rafters, but simply lapped and nailed to the upper side of the lower purlins. The nailed joint detail is unusual, but clearly original. The continuity of the roof structure from the front block into the rear wing, including the valley construction, shows that both roofs are of the same date. The S section of the rear wing roof has slightly arched ceiling joists to the rafter couples, with flat joists to the N half. The rafter couples are simply supported on a long-span purlin, and have a plain-lapped upper collar, fixed only with nails – an original detail.

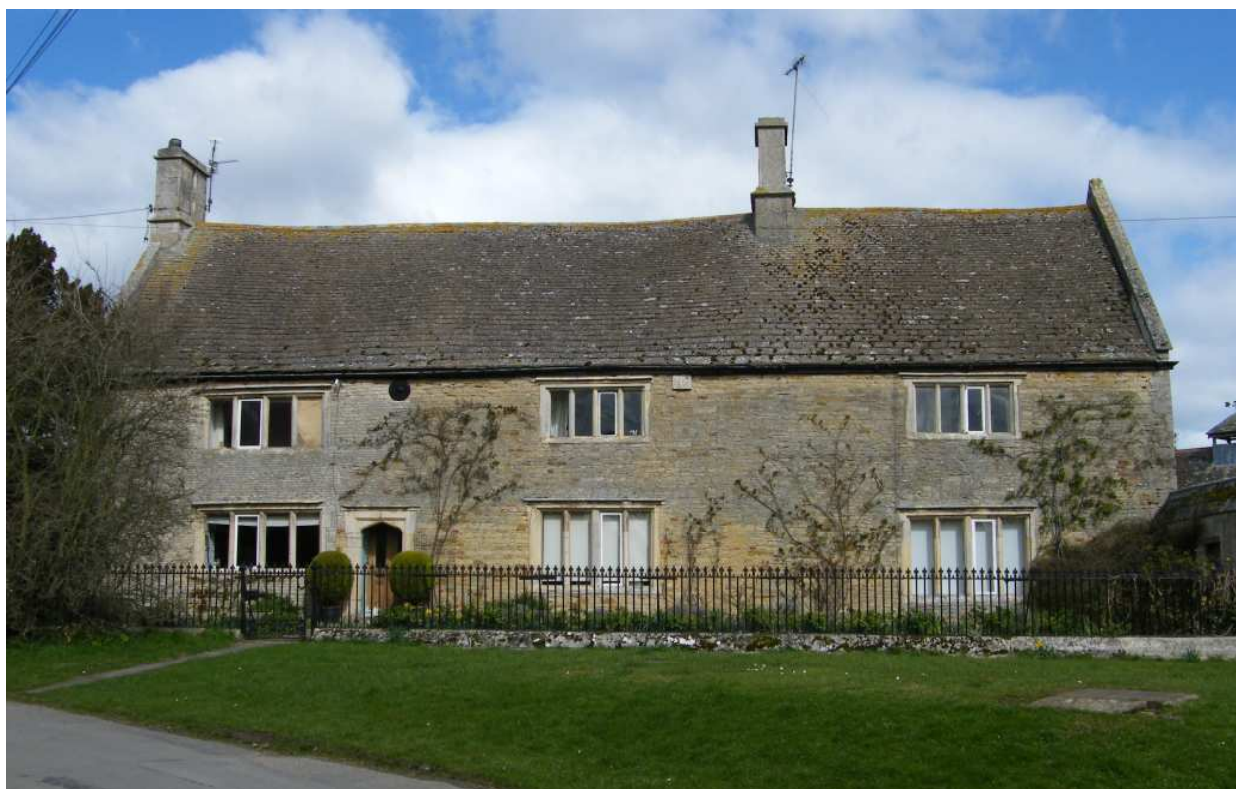
The S front has a regular arrangement with three windows to the ground floor and three windows aligned above to the first floor. The windows are all ovolo-moulded stone mullions of 4 lights, rather than the usual 2 or 3 lights. The door is offset to the L. The two R bays are rather different in character to the L bay. These two bays have rather irregularly coursed limestone rubble, with occasional blocks of ironstone, a few of which are pink in colour, having been exposed to fire. The central and R ground floor window mullions are quite tall (1450mm, in two pieces, 1070mm + 380mm) and have a slightly wider 'king' mullion to the centre of the 4 lights, though the first floor window mullions are all of the same width. All four of the windows in the central and R bay have cavetto-moulded cornices. The doorway has a 4-centred arched head with a cavetto-moulded cornice over, and moulded jambs with fairly high-set stops. Around the doorway, the walling stone changes, and the L bay has thin, regularly coursed limestone rubble. The ground and first floor windows to this bay also differ from the other bays, with quadrant cornices, and the ground floor window has no 'king' mullion, the mullions here being less tall (1140mm). The E light of the 1<sup>st</sup> floor window is blocked, though there is no need for this internally. Set high up to the R of the central first floor window is a date-stone: '1597', in numerals, cut into a rectangular block (probably of Ketton stone) which projects from the wall. The lettering is of authentic style for the date, though very much neater than others of similar date, and is probably original, but the block has been re-set. A photograph of c.1958 shows the front wall with some patches of thick render.<sup>1</sup> This was subsequently removed, though may have been relatively modern.

View of the south front

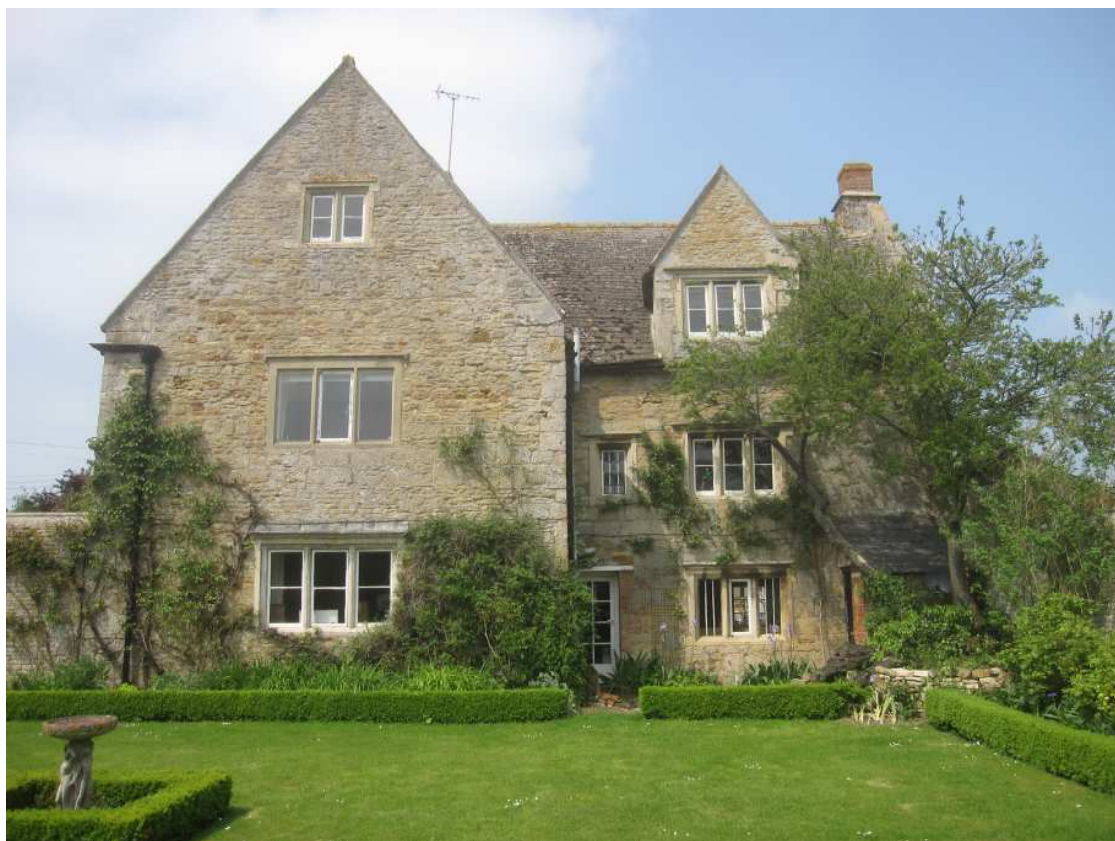
The E gable has a symmetrical arrangement of windows, with 3-light mullion windows to ground and first floor, and a 2-light window to the second floor. However, the first floor window is modern, of cast stone. The ground floor window has an ogee-moulded cornice, and the second floor window cornice was cavetto-moulded, though has now largely broken away. Walling is of the same, irregular type as the W front, except for a band of much larger stone blocks just below the first floor window. The raking lines of a former gable end are visible, set about a metre below the line of the current gable parapet. The gable has fairly good quoins, plain kneelers and an apex with eroded finial. The short east-facing return wall has similar stonework to the S gable, and a modern cast stone window to the first floor.

View from the east

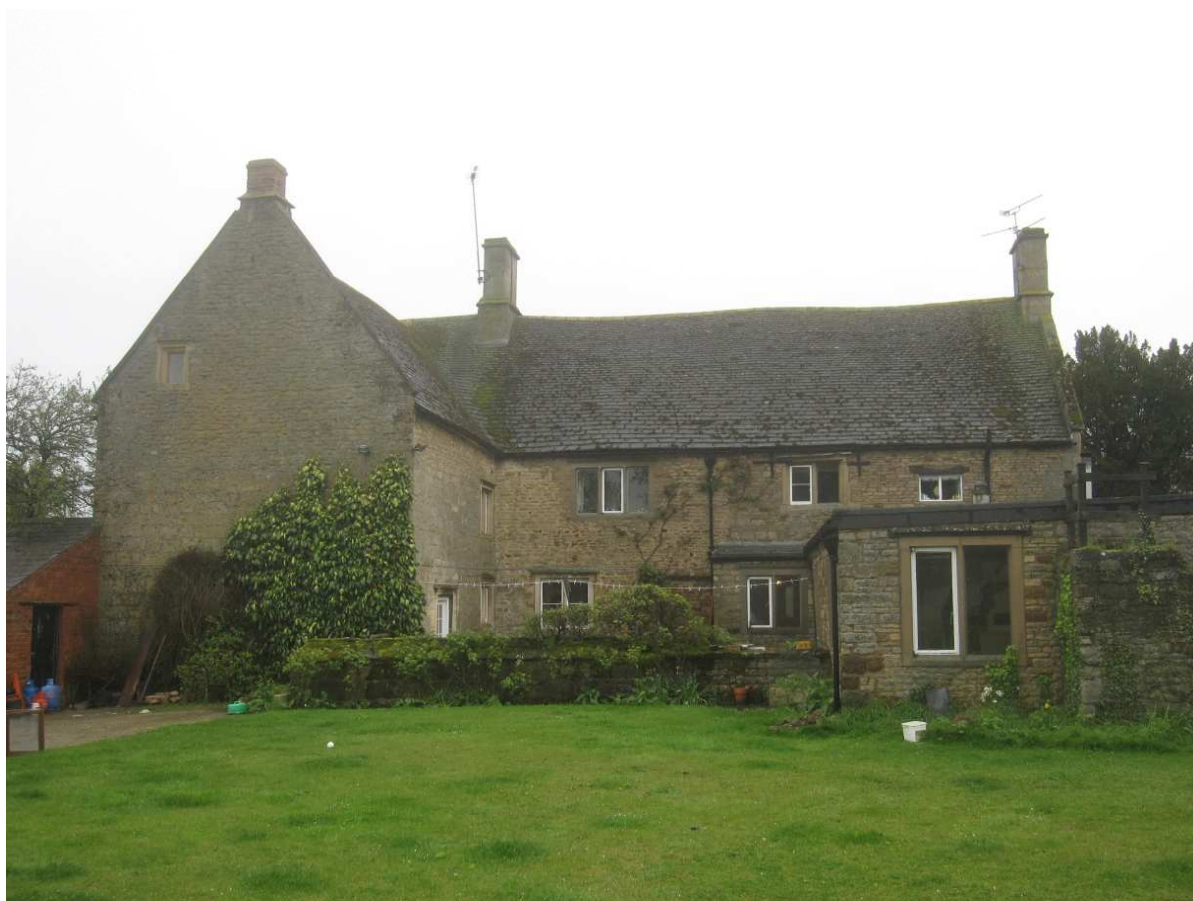
The rear W wing has been much rebuilt, and is now of a single storey, with a flat roof. It is shown in a derelict condition with the first floor missing in a photograph thought to date from around 1965. The E wall has a modern doorway and two modern windows, together with an older slit window with large limestone jambs. The N wall has two modern windows and a good set of external stone steps, which led up to the former first floor. The W wall has a wide modern opening to the N, in place of two smaller openings visible on the c.1965 photo. Next comes a doorway, now with ironstone quoins and a flat, moulded brownstone head, though all this has probably been much rebuilt. To the S of this doorway is a wide opening, visible on the photo of c.1965, but now spanned by a re-set oak beam. This is a re-used fireplace beam, as indicated by its recently exposed internal face, deeply chamfered and sooted. It must have come from the fireplace to the central ground floor room, as measurement proves is an exact fit (2530mm wide). The outer face has a very shallow, moulded 4-centred arch, with right-angled returns to the moulding at each end. To the S of this is a single-light moulded stone window with an ogee cornice. The rear wing abuts the gable of the main block with an irregular straight joint, indicating it is a later addition.

View from the north, with cut-down north-west wing

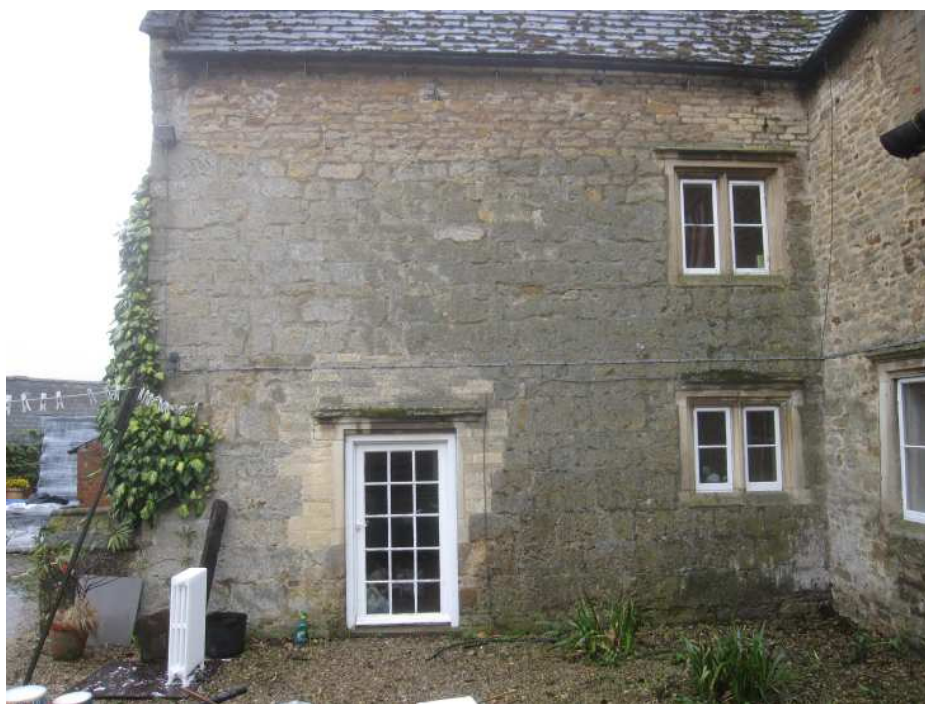
The W face of the rear E wing has a 2-light mullion window to the ground floor, with a second to the N, altered in recent times to a doorway. There is another 2-light mullion on the first floor, and all three openings have cavetto-moulded cornices. As to the other walls of the rear wing, the walling is of the unusual large-size blocks, except for the top 1m or so. Around the N ground floor opening the stonework is of smaller, well-coursed rubble, as if this was a later insertion.

The west side of the rear north-east wing

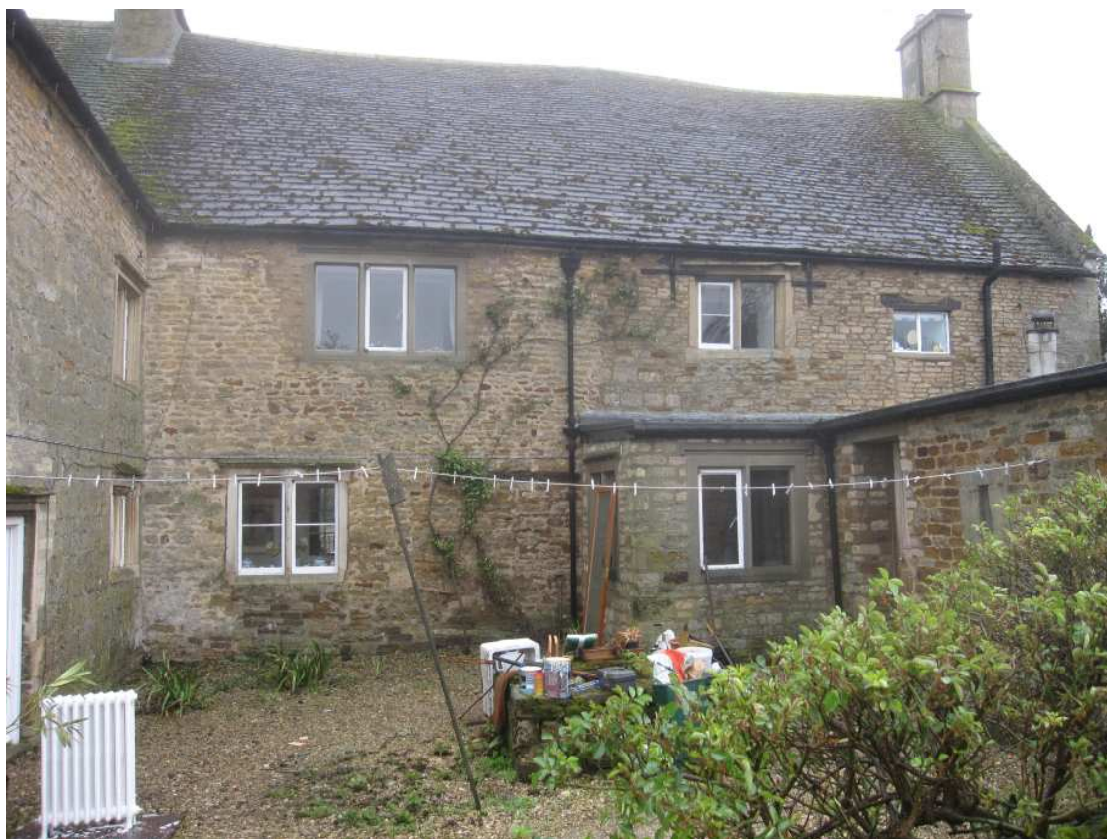
The rear N wall of the main block is of the same irregularly coursed rubble to the central section, but has regular coursing to the W. The centre ground floor has a 2-light mullion window with ogee cornice and a former window or door opening to its W, blocked some time ago, and spanned by an old oak lintel. The rest of the ground floor was concealed by the modern porch and the rear W wing. The first floor has a modern cast stone 3-light mullion to the E, a 2-light mullion with quadrant cornice to the centre and a blocked doorway, now a window, to the W, with timber lintels. The doorway clearly used to lead into the missing first floor of the rear W wing. The 2-light central window shows the line of the former wing roof, which cut across the W jamb and cill. This indicates that the W wing roof had a somewhat lower ridge line than the front block.

The main block from the north

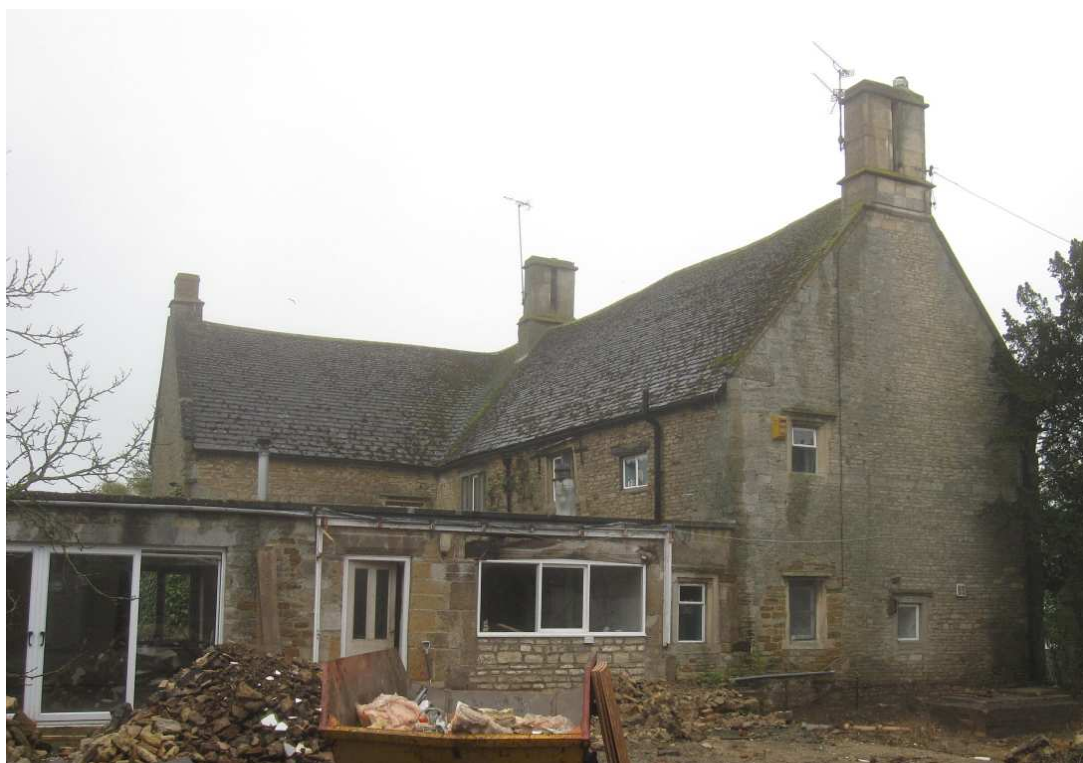
View from the north-west

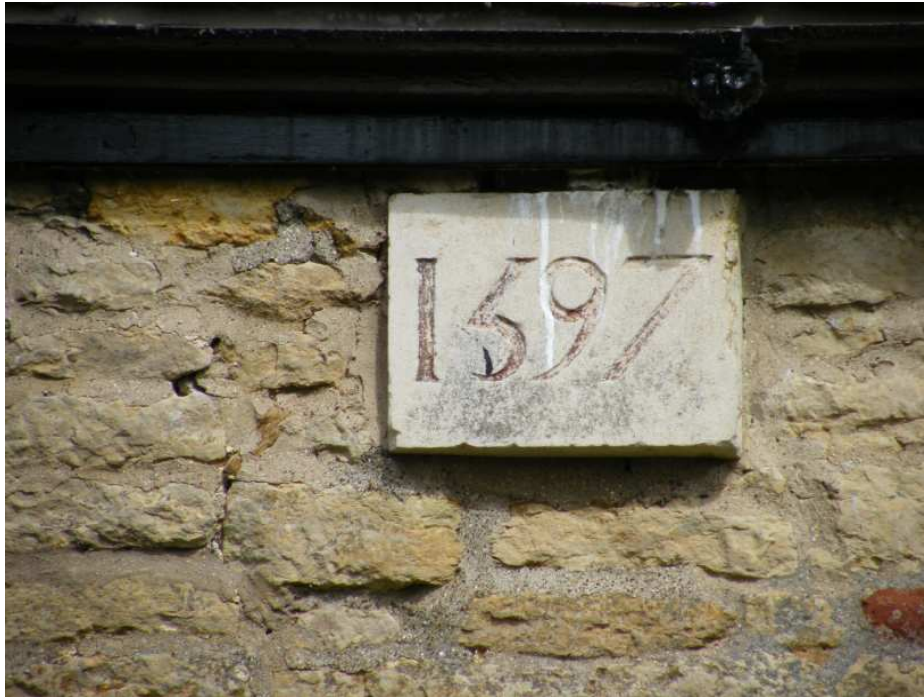
Re-set date-stone to front wall

The tree-ring dating and the surviving date-stone indicate that the house underwent major alterations in 1597. The rear east wing was added and the front block was heightened, with the addition not only of an extra storey at attic level, but taller ground and first floors. The windows of this phase have cavetto-moulded cornices, and the roofs were built as a single, integral structure. This phase included the oak spiral stair, placed at the junction of the front and rear blocks, and carefully arranged to serve the differing floor heights. The ground and first floor rooms in the front block now both had tall ceilings, the ground floor mullioned windows perhaps lengthened at this time to suit. The less important rooms in the rear wing had lower ceilings, including the unheated ground floor room which was probably used as a buttery/pantry. The attic floor had three useable rooms, each lit by dormer windows. The 1597 date-stone may originally have been set in the gable of a front dormer window, and been re-set in the upper part of the front wall when the dormers were removed. The various four-centred arched fireplaces and floor structures with ogee-moulded stops to the main beams (with taller ceiling heights than the earlier building) all date from this phase. The four-centred arched front doorway, with its cavetto-moulded cornice, probably dates from this phase, though its position may have been moved. For such a fine, lofty house, with a rear wing, one would again expect the front range to have extended to three rooms, not two. If it was only two rooms long, the doorway may have been in the west gable, or even at the rear, where there is evidence for a former door. This phase, dated fairly firmly to 1597, is rather earlier than most similar stone houses in the area.

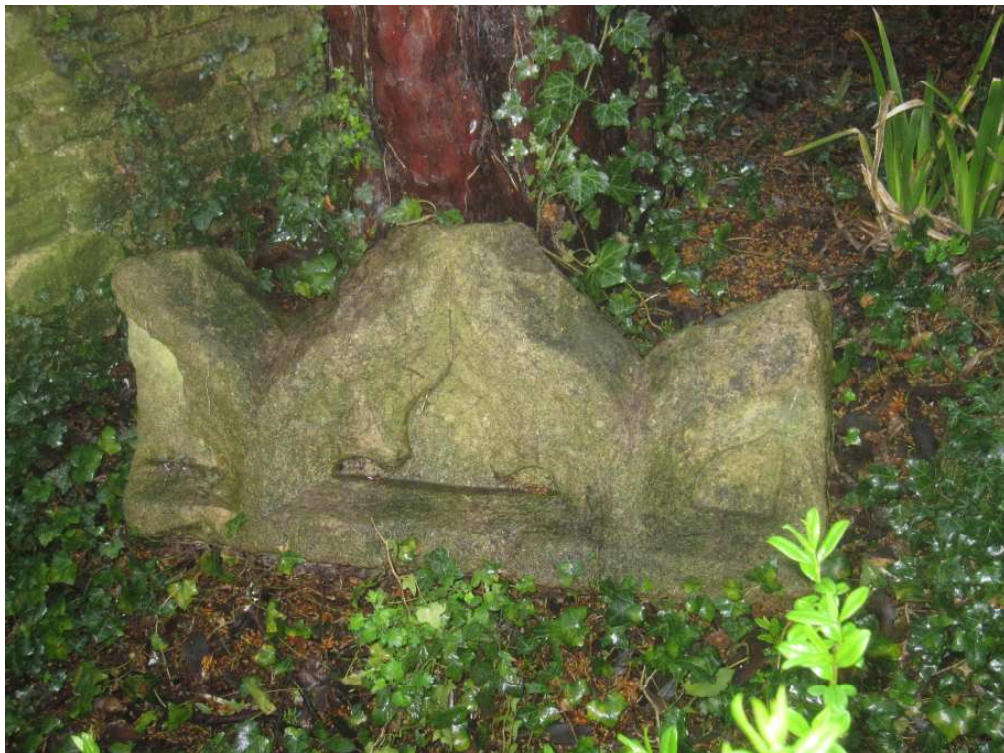
Fragment of 14-15<sup>th</sup> century window lying in the front garden

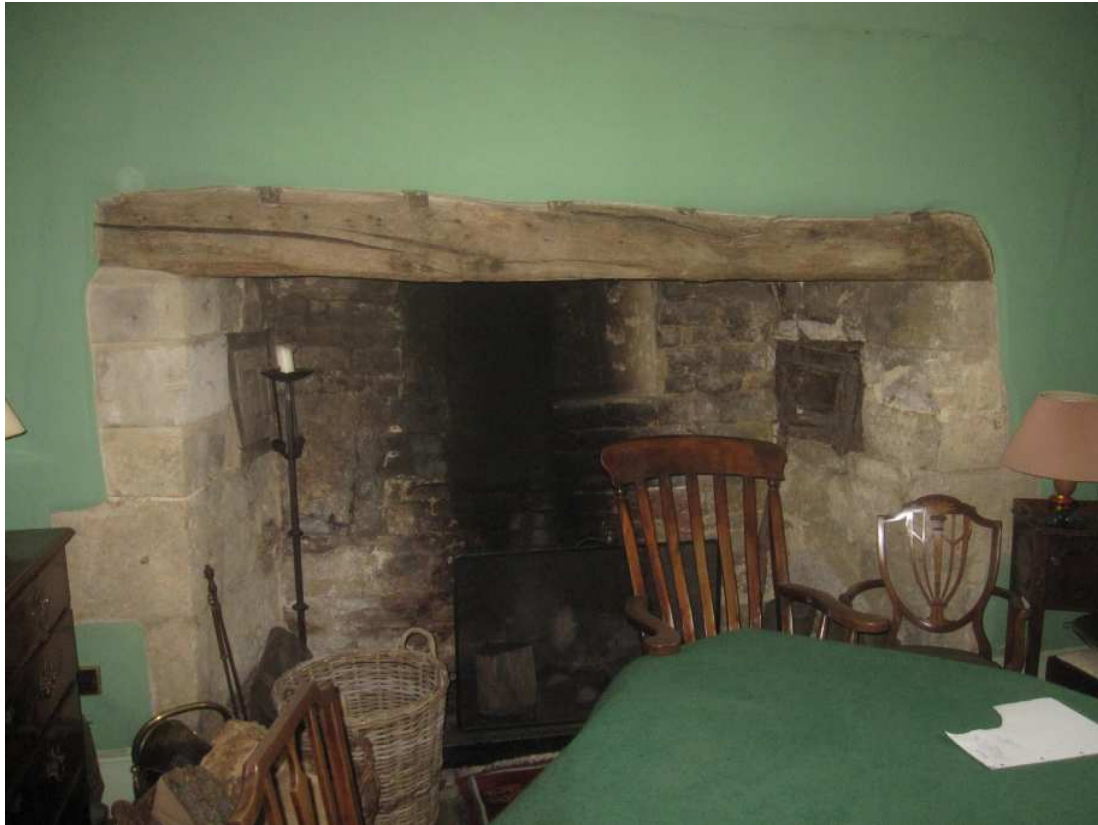
The central (dining) room has a wide inglenook fireplace with stone jambs, chamfered with high-set moulded stops. Plain imported beam over – originally, the moulded shallow 4-centred arch beam now in the W wall of the rear W wing was located here, as noted above. The notebook of the listed building recorder in 1985 notes a Victorian marble fireplace here, of c.1840-50. To the splayed fireplace reveals are two original cupboard recesses. Oak surrounds and later pine doors, with nailed long H-hinges. Spine beam with big ogee stops to E, no stops visible to W. A later partition wall provides a corridor to the N of the dining room, with borrowed light from a sash window.

Fireplace to dining room (central room of main block, with recently inserted beam)

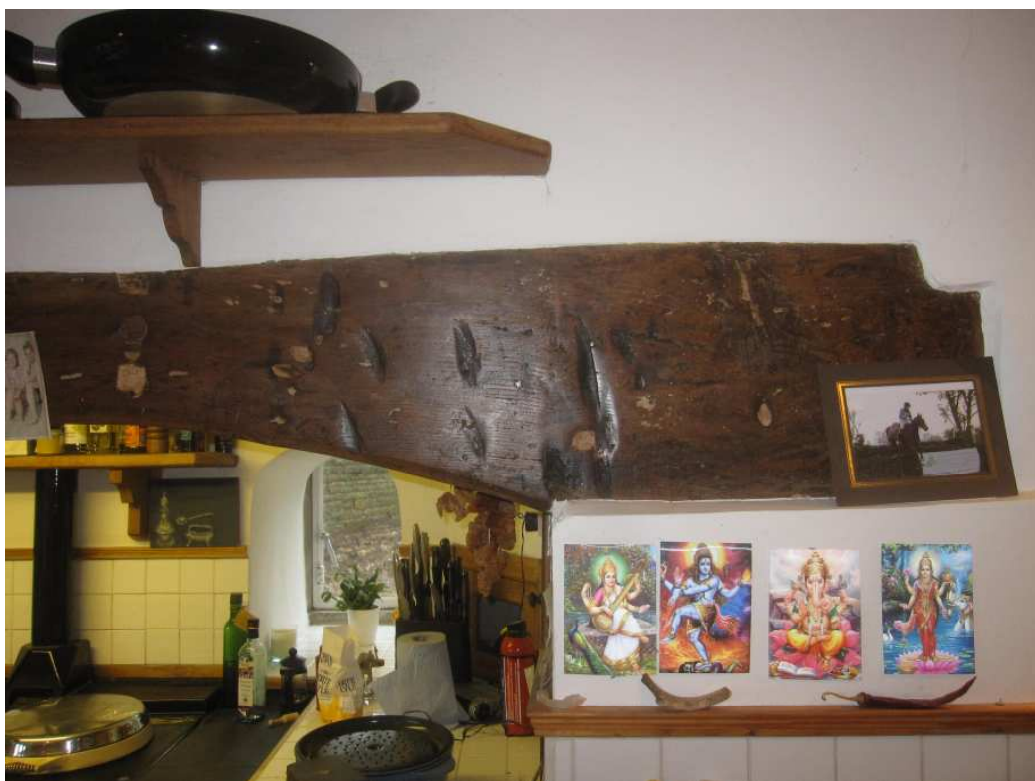
The W room (kitchen) has a wide inglenook fireplace with a beam over, with shallow plain arch to the underside, chamfered. There is a group of burn marks to the right side of the beam, and one in the central section. Several of the burn marks are distinctly angled to the L, showing they have been affected by a draught, though others are vertical. Spine beam with step or ogee stops to W end (the E end of the beam, in the entrance passage, is cased in). To the N wall, the W door jamb has two re-used quoins with C12th roll-mouldings; four blocks of the same type are built into the wall to the W. The recent demolition of the porch and removal of some of the plaster from the outer face of the N wall (inside the rear W wing) revealed an old lintel over the doorway, and plain square jambs to the W side. Continuously coursed walling to the W of the N doorway indicates there was never a window here. Fine pine C18th corner cupboard: upper section with arch-top doors, dentil cornice, H-hinges and shaped shelves; lower section with square doors. Stone-paved floor of limestone, with some later Yorkstone. A thick (870mm) stone wall separates the entrance passage from the central room. This wall never contained any fireplaces on either the ground or first floors. Such cross-walls are usually built as thin partitions, so the thick wall here may have formed an earlier gable end.

Beam to kitchen fireplace with multiple burn marks

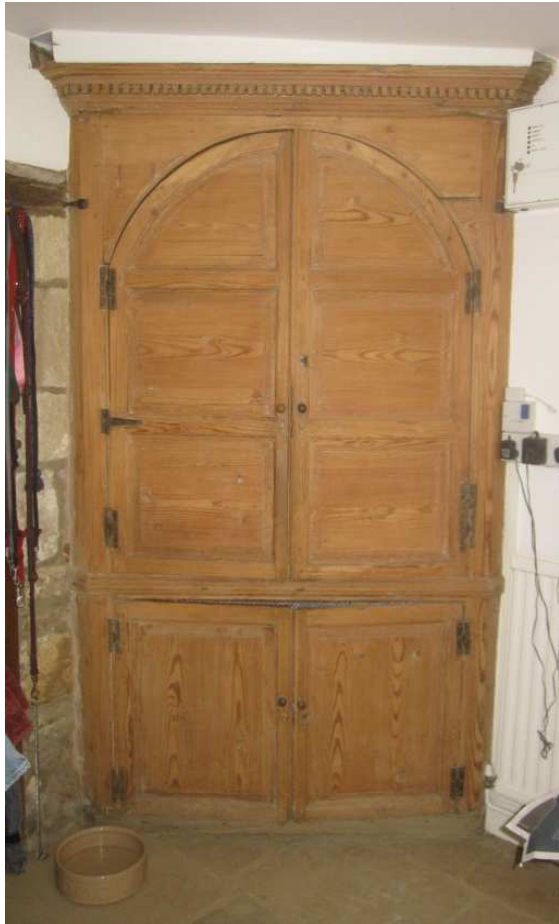
18<sup>th</sup> century fitted pine  
cupboard to kitchen

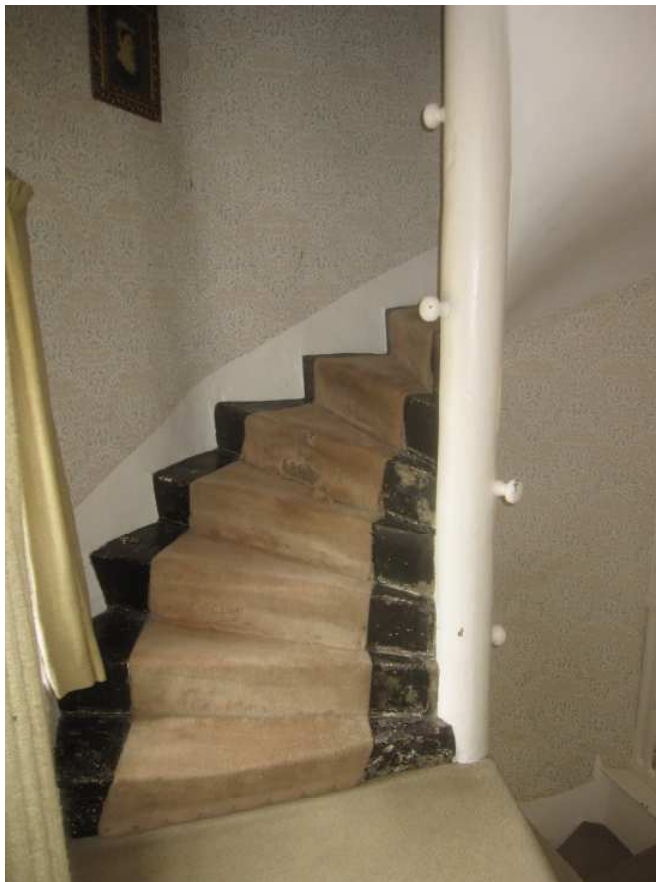
Set in the SW corner of the rear E wing is a fine spiral stair, rising to the second floor. Central round oak newel, with solid oak treads. The rear wing contains the former dairy (said to have had low stone shelves), with a lower ceiling (1.9m, as against 2.5m to front block). Chamfered spine beam, one ogee stop visible. Rectangular oak joists with haunched soffit tenons.

The rear E wing has the continuation of the solid-tread oak spiral stair, with modern knobs added to the newel. The circular newel has a horizontal scarf joint just below 1<sup>st</sup> floor level, with a through-peg visible (presumably for a tenoned joint). There is another scarf joint just above 2<sup>nd</sup> floor level. The E wing floor is set several steps lower than the front block floor. The rear bedroom has another 4-centred arch fireplace with moulded jambs, lower plan stops and no cornice. Transverse beam with ogee stops. A small closet (now a bathroom) to SE of this room, with an old pine

Solid-tread oak spiral  
stair of 1597
