**Lyddington Manor History Society**  
**Historic Building Survey**

**Tudor House**  
**Thorpe by Water, Rutland**

# **HISTORIC BUILDING SURVEY REPORT**

## **TUDOR HOUSE, THORPE BY WATER**

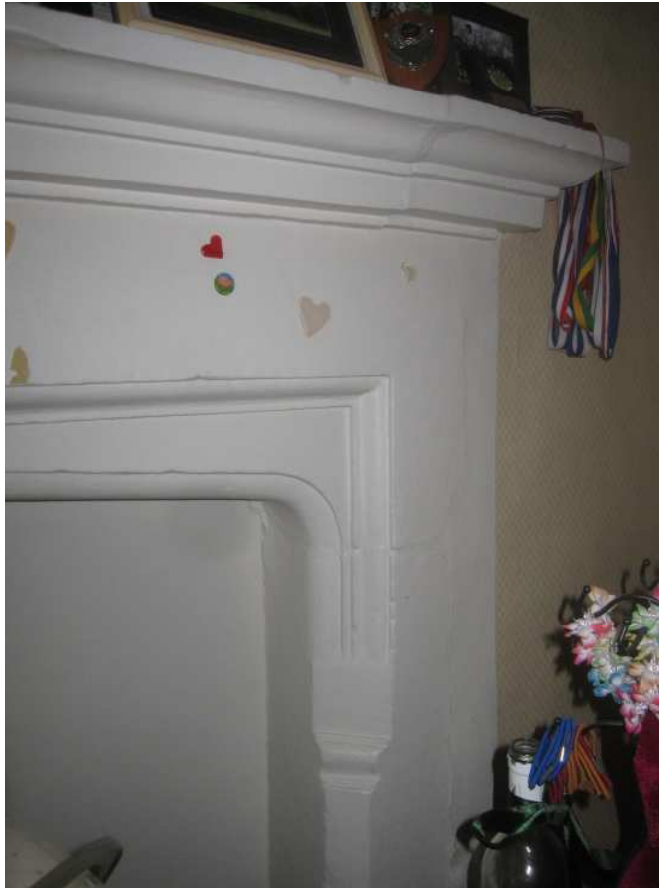
Detail of the fireplace to the  
central bedroom of the first floor

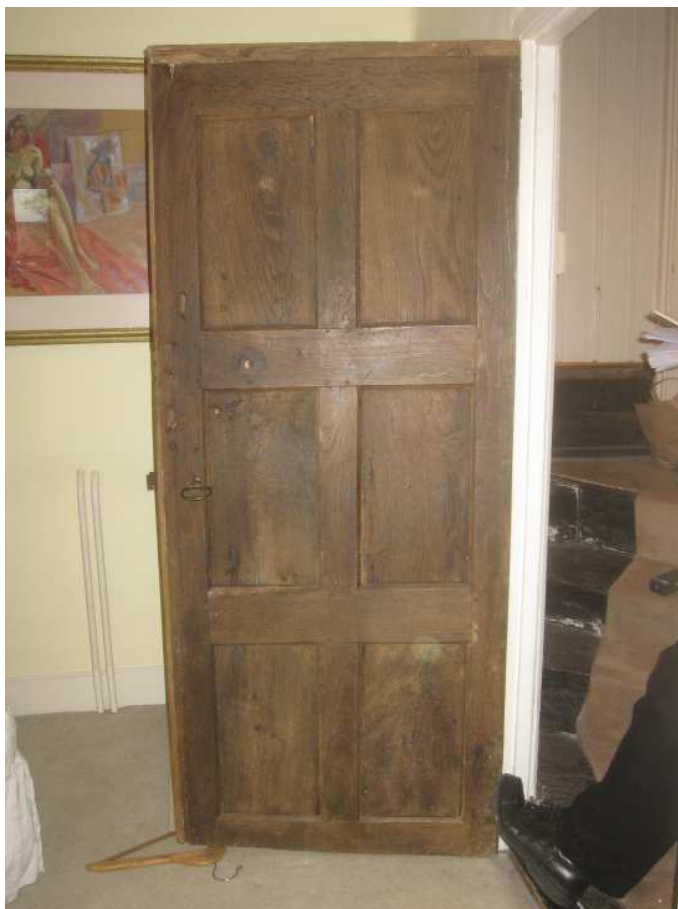
The oak spiral stair leads up to the second floor of the rear E wing, then continues up to the attic of the front block, with a flattened ball finial to the top and a short section of solid-infill balustrade. The attic bedroom of the rear wing has, unusually, a fireplace: 4-centred stone arch, moulded jambs with high-set stops, no cornice. Over the fireplace is a relieving beam of oak, with a neat, single burn mark to L of centre. The door into this room from the stair is of early type (probably late C17/early C18): 6-panelled, oak, double-pegged tenon joints, plain panels with chamfered rails/stiles to the front and back. One early butterfly hinge survives, and an iron latch with brass drop-handle.

Late 17<sup>th</sup>/early 18<sup>th</sup> century oak door  
to the second floor bedroom of the  
north-east wing

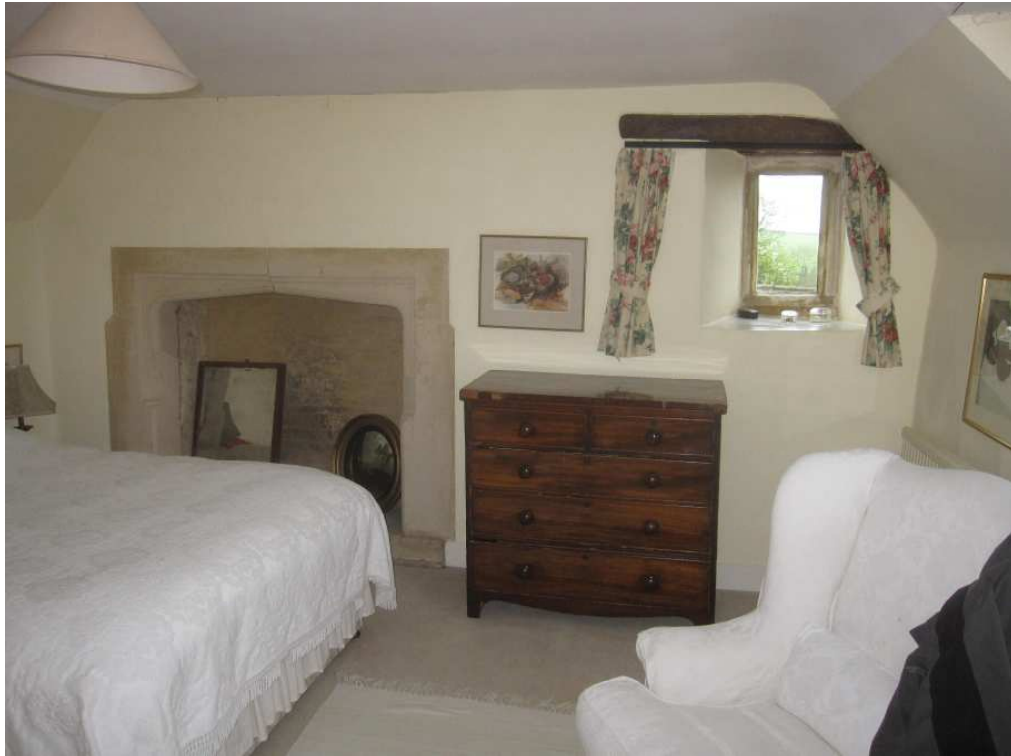
Second floor bedroom to  
north-east wing

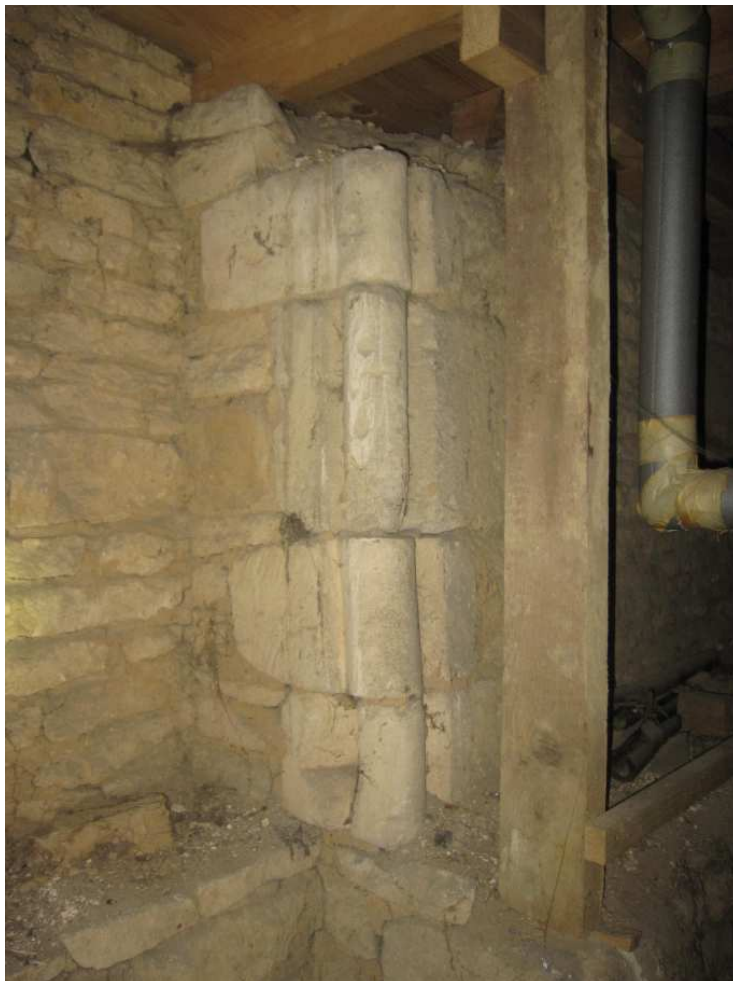
The next major phase, undertaken in c.1678, was the building – or more probably rebuilding – of the west end. This has different stonework from all previous phases, and has quadrant-moulded cornices to windows, an unusual local type. This phase also re-uses roll-moulded quoins in several locations, which must have come from a high status building of around late 12<sup>th</sup> century date in the locality. A chapel is documented at Thorpe, and may have been disused by this time, providing a convenient source of stone. This may also have been the origin of the large-size blocks used in the rear wing. Also perhaps linked to the chapel is a fragment of moulded stone lying in the front garden, near the SW corner of the house. The stone formed part of the head of a high-status window of 14<sup>th</sup>-15<sup>th</sup> century date, with evidence for two moulded lights with ogee arches under a flat head. Unlike the earlier building, the west end uses a spine beam (not a transverse beam). The roof structure is also different, of clasped purlin type. This form of roof is found locally (though quite rarely) in the 15<sup>th</sup> or 16<sup>th</sup> centuries, and was replaced in the 17<sup>th</sup> century by tenoned purlin roofs. It is therefore quite unexpected to find it here in this late 17<sup>th</sup> century context. Like the other roof structures, it was designed with a high-set collar, allowing clear headroom. It seems likely that a second stair was fitted, beside the chimneybreast to the west gable, of which a doorway survives at attic level. Soon afterwards, a rear wing of one or two storeys was added (or rebuilt) to the north-west, probably housing a back kitchen.

Re-used 12<sup>th</sup> century roll-  
moulded quoins to  
chimneystack of west gable

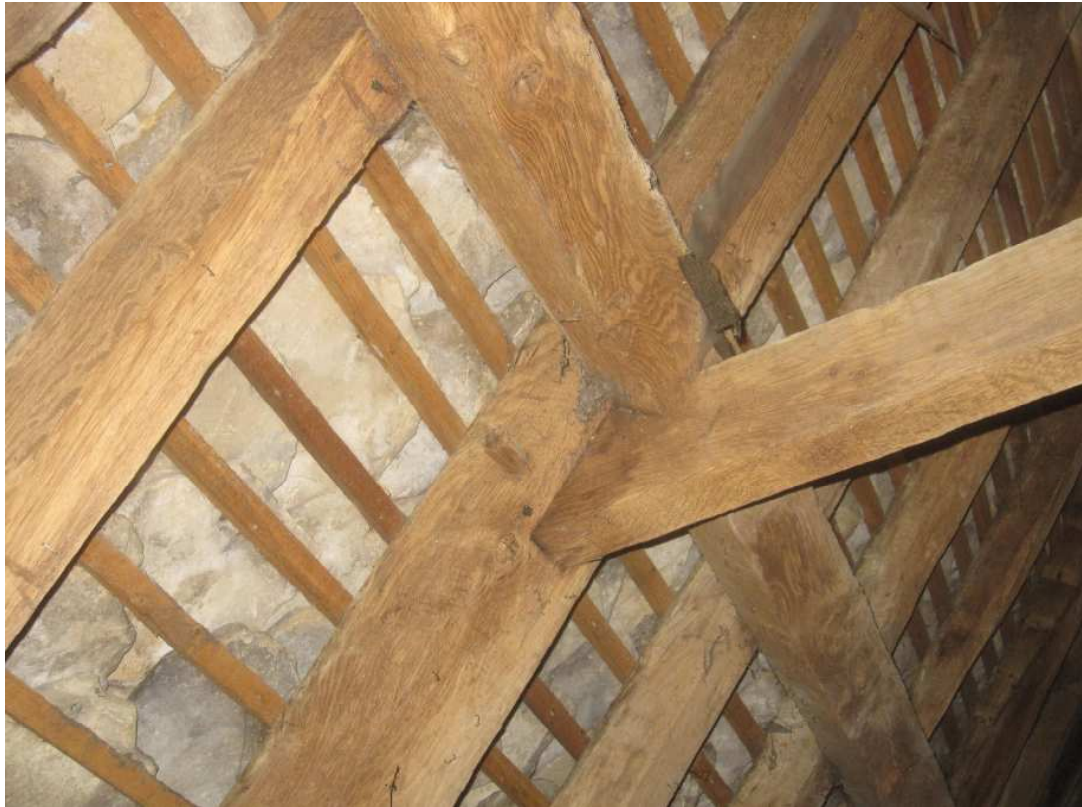
The roof structure to the W end of the front range has two quite slender A-frame trusses (T1 and T2) without original tiebeams and two sets of high-set tenoned collars which carry two sets of clasped purlins. Timbers are very neatly square-cut and without chamfers. Bridle joints at apex, with no ridge. Purlins have straight-splayed scarf joints. The W truss (T1) has chiselled carpenter's marks: 'II' to the lower collar S side and 'I' to the upper collar S side. But T2 has no carpenter's marks to the N, though the S side is covered by plating. The feet of the principal rafters are tenoned into heavy wall-plates. The high-set collars suggest that the roof was designed to allow clear headroom. Oak ceiling joists are nailed on top of the lower collars, though may not be original. As noted above, the rafters to the central bay (T1/T2) on the S side are cut at the lower purlin height, indicating a former dormer. Evidence of dormer boxing and cheeks on the S side does not survive, though there is a cill and early oak ashlar studs all along the N side. A very odd detail is that all 5 rafter couples to the E bay have straight-splay scarf joints to the rafters, towards one end, with multiple nailing. This is clearly an original feature of the roof, not a later alteration, and suggests some re-use of timber or alteration in design intent. The rafters in other bays (except the former dormer position) are in single, unusually long lengths.

East face of roof truss T1 (dated 1678) to west end of main block, with carpenter's mark 'I'.

Tree-ring dating was carried out by Robert Howard of Nottingham Tree-Ring Dating Laboratory in 2012. Eight samples from trusses T3-T7 had a felling date range of 1586-1611. Samples came from the principal rafters and collars, with parts of all five trusses dated. Six samples from trusses T1 and T2 had a felling date of 1678. These samples came from the principal rafters and lower collars.

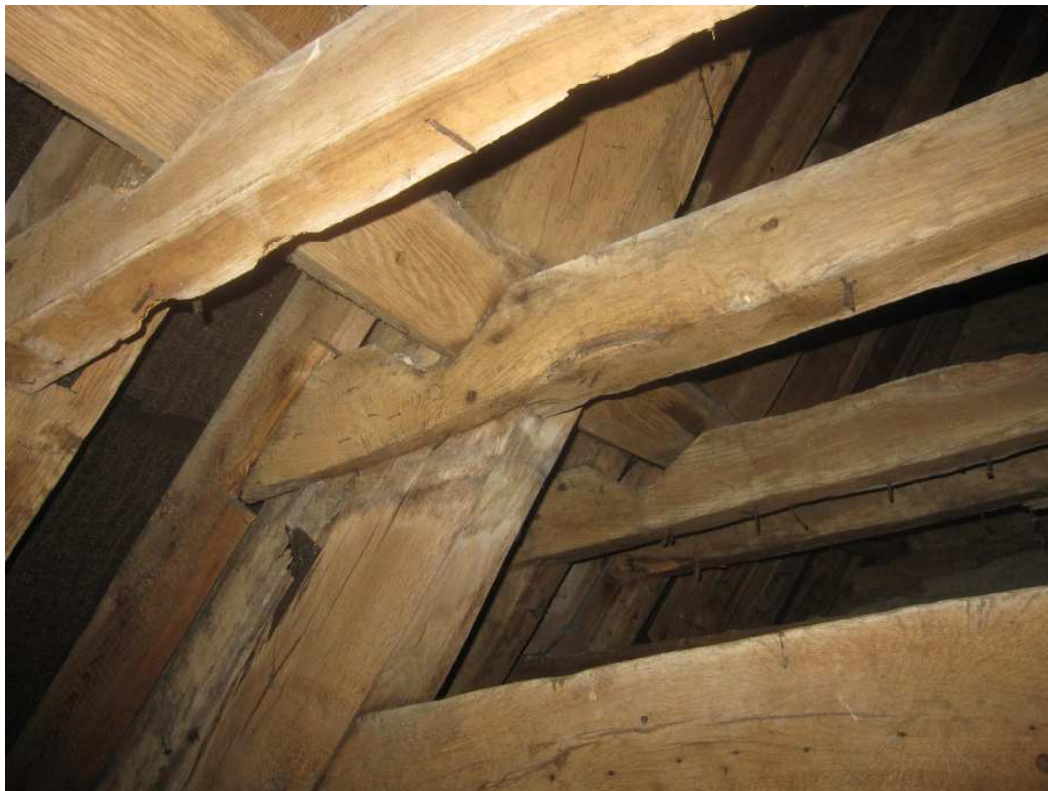
The roof structure to the rest of the front block and to the rear wing is of different type. The central section has two trusses (T3 and T4), the E section two trusses (T5 and T6) and the rear wing has a single truss (T7) at the junction with the front block, then rafter couples, without trusses. The trusses have a high-set, slightly arched collar tenoned to the principal rafters. Trusses T3 and T4 are of A-frame type, without tiebeams, though it is possible that the other trusses have tiebeams. Tenoned purlins, set high up at collar level to the S bays between T3/T4 and T5/T6 for former dormer windows and to crosswall/T5 bay for doorway from spiral stairs, but set lower elsewhere. Bridle joint to apex, no ridge. T3 and T4 have the face side to the W, but with no carpenter's marks in the three joint locations where evidence is visible. T5 has the mark 'II' and T6 the mark 'I'. Neat chamfers to the underside of the principal rafters and collar, with ogee stops. At the level of the upper purlins a higher oak collar has been nailed onto the rafters to support a ceiling – perhaps original. Cranked wind-braces are tenoned to the principal rafters, but simply lapped and nailed to the upper side of the lower purlins. The nailed joint detail is unusual, but clearly original. The continuity of the roof structure from the front block into the rear wing, including the valley construction, shows that both roofs are of the same date. The S section of the rear wing roof has slightly arched ceiling joists to the rafter couples, with flat joists to the N half. The rafter couples are simply supported on a long-span purlin, and have a plain-lapped upper collar, fixed only with nails – an original detail.

West face of truss T4 (dated 1586-1611) with tenoned purlin and lapped, nailed ceiling joists

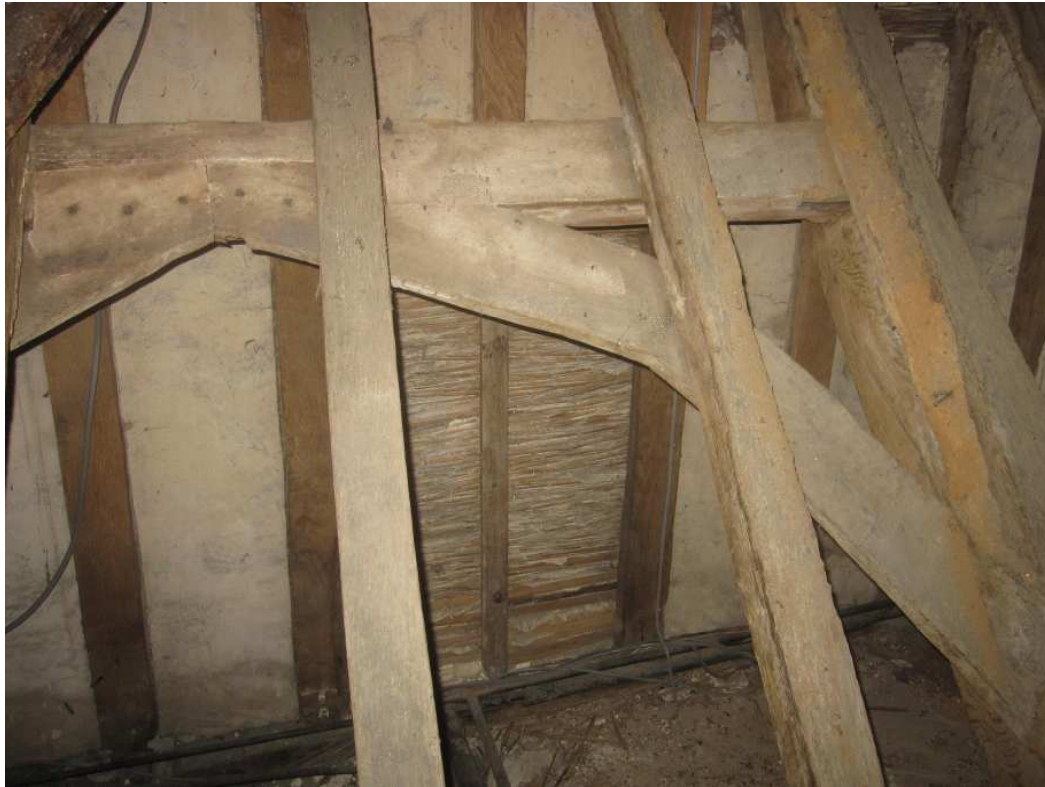
Bay T5/T6 (dated 1586-1611) from north, with cranked and nailed wind-braces

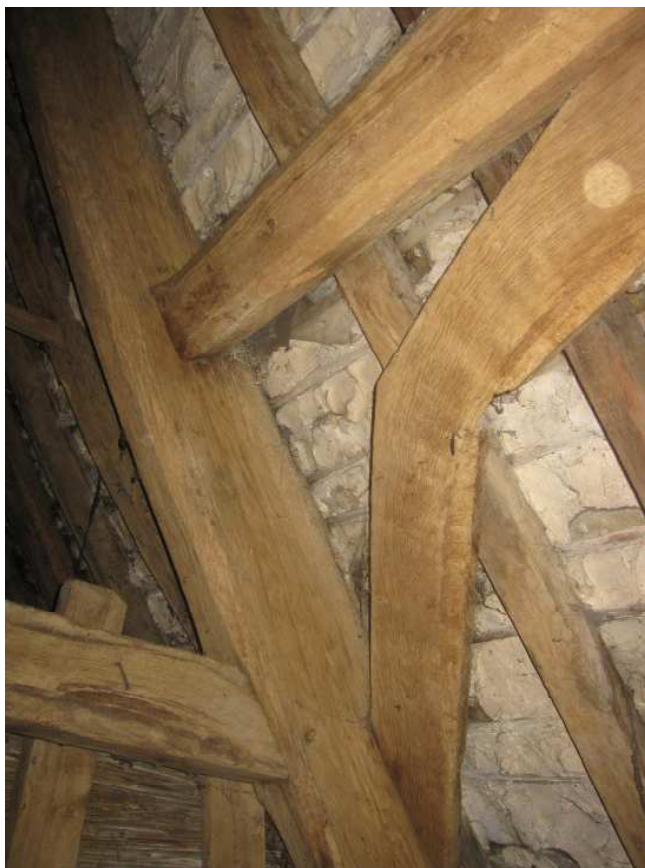
South face of truss T7 (dated 1586-1611) with tenoned purlin and cranked wind-brace

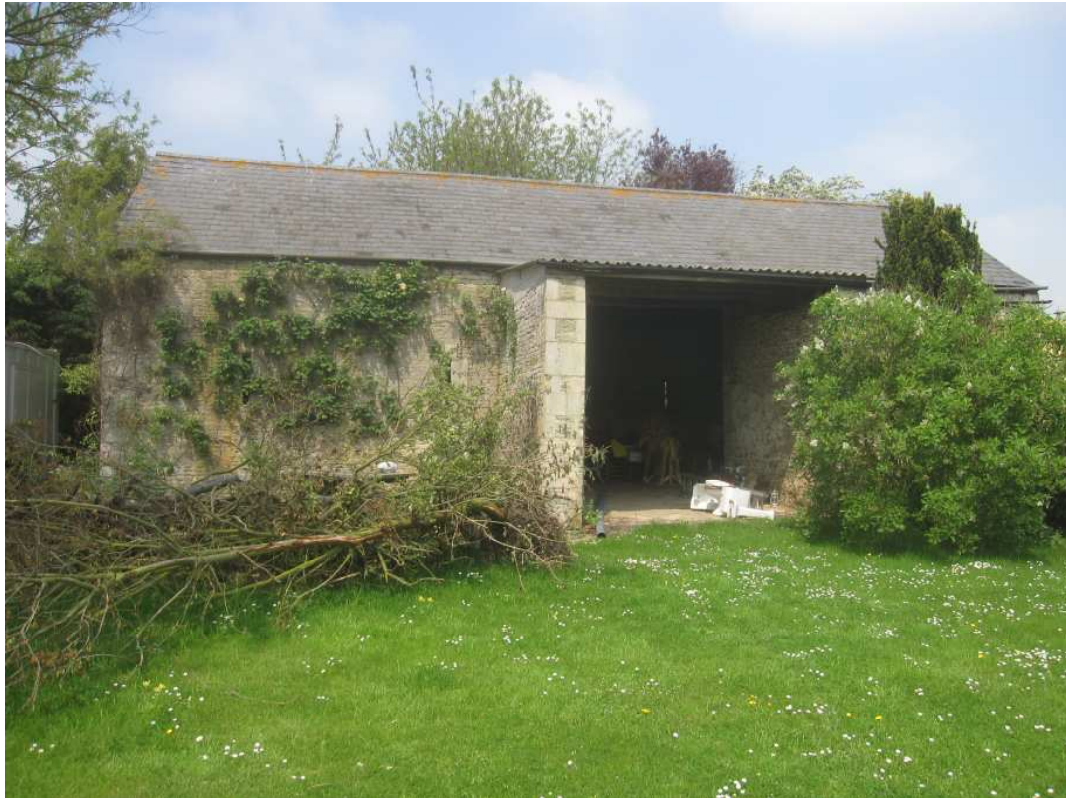
In the rear yard is a well-preserved barn, probably of C18th date. Of well-coursed limestone rubble with some ironstone, neat limestone quoins. Central projecting porch – an unusual original feature for the area, the masonry walls of the porch being integral with the main S front wall. Opposite the porch, with its wide doorway, was a smaller doorway (now blocked) with timber lintel, to create a threshing floor. To either side, 2 sets of slit vents, on both front and back walls, with a single slit to the W gable. The E gable has been refaced in modern brick internally. The upper W and E gables are built of C18th or earlier C19th brickwork, probably a later rebuilding. Loading hatch to upper W gable. Roof of late C19/early C20th softwood, with Welsh slates. The porch roof has been cut down, and now has a low pitch with profiled sheeting. The original barn probably had stone gables and a steeper pitched roof.

The barn, with projecting front porch, probably 18<sup>th</sup> century

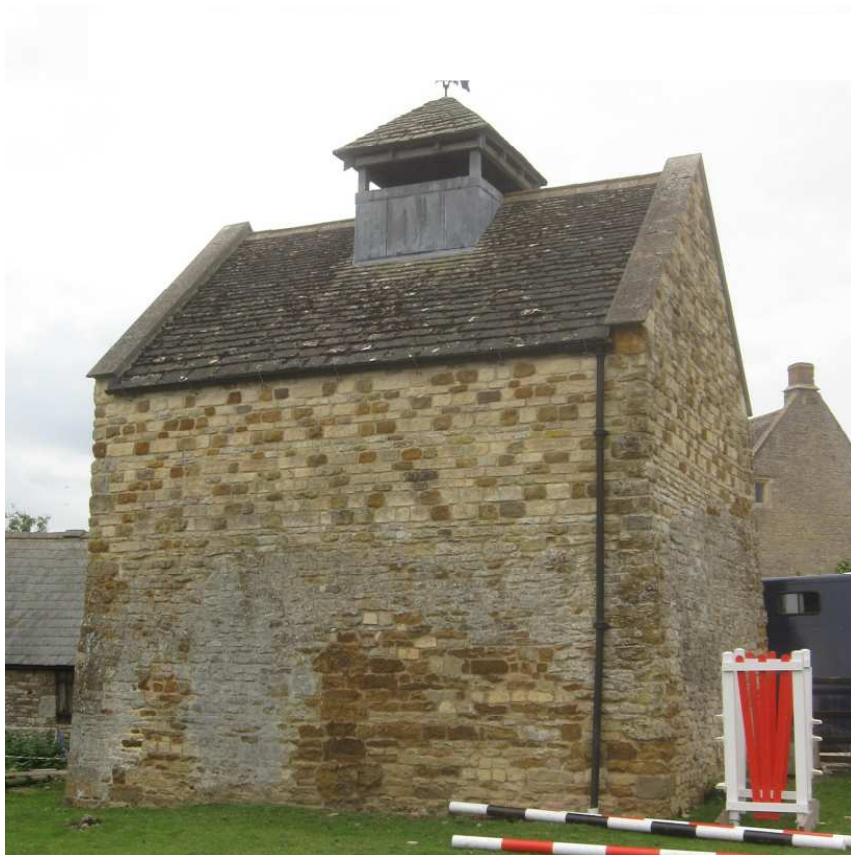
S of this range is a dovecote of C17-18<sup>th</sup> date. The four main walls survive, but the upper part and roof have been rebuilt in recent decades, and a larger door inserted in the front W wall (it served as a 'carriage house' in 1935). Inside there are nesting boxes to all 4 walls, with projecting alighting ledges, which extend down to near ground level.

The dovecote, with upper parts rebuilt

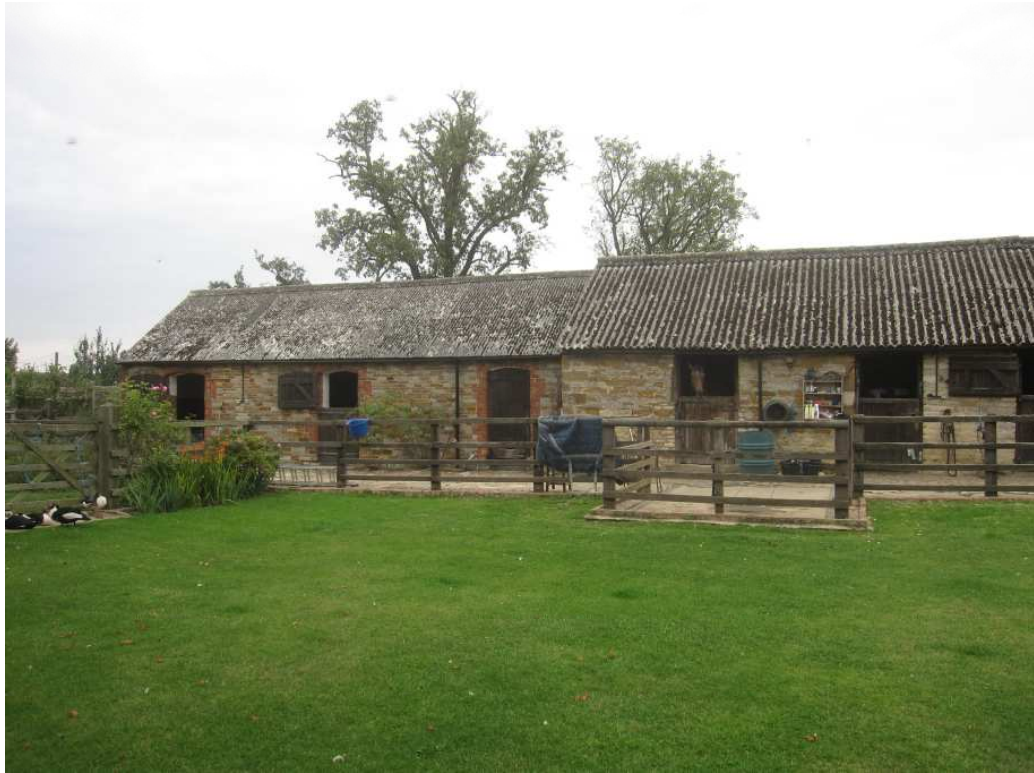
North end of stables range

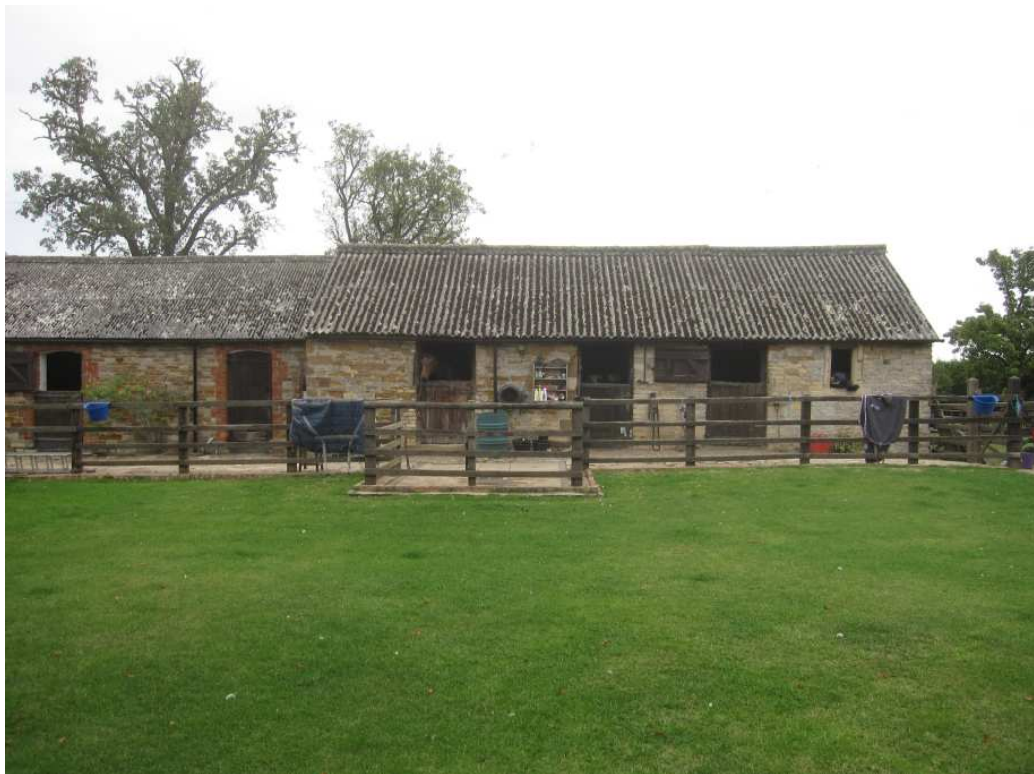
South end of stables range

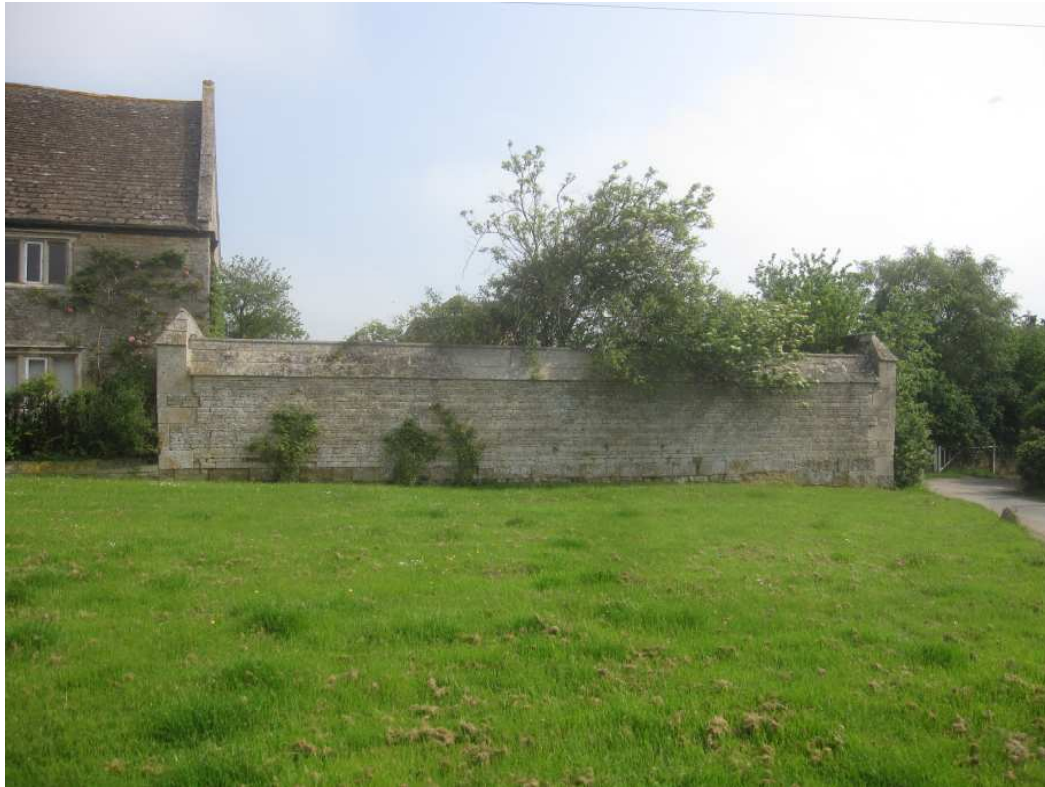
To the E of the house is a small formal garden, surrounded by a very fine stone wall, ashlar faced to W and of finely coursed limestone rubble to S. Fine coping of pitched ashlar with roll mould to apex. In the W wall is a finely moulded doorway with a flat head and pintle hinges.

The walled garden from the south

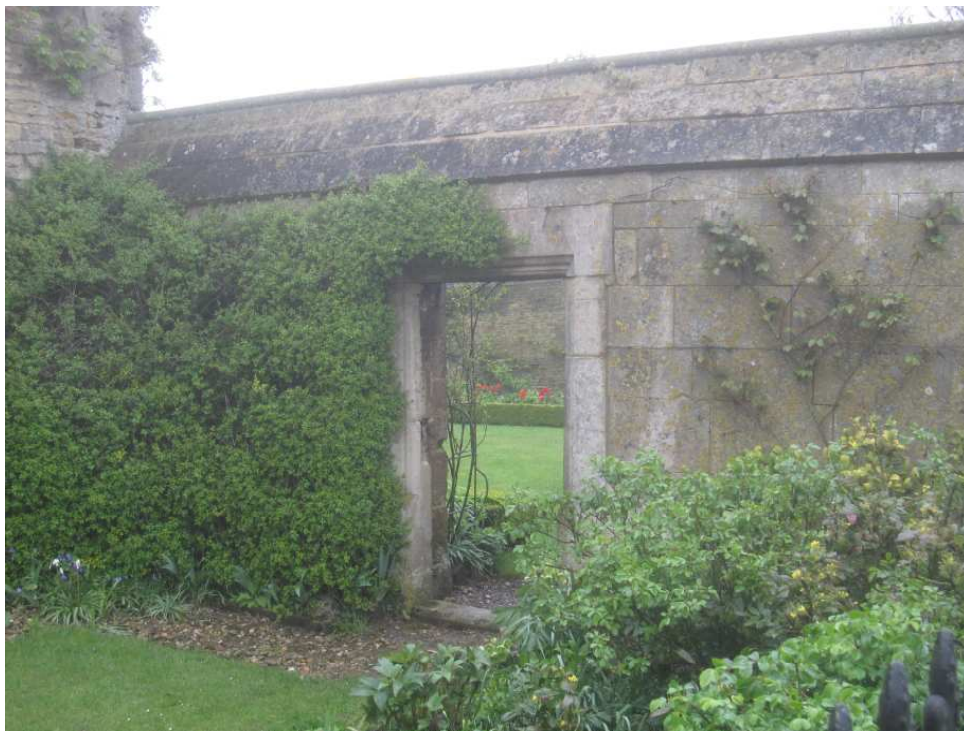
Doorway into walled garden
