**Lyddington Manor History Society
Historic Building Survey**

**The Old Plough, 41 Main St.
Caldecott, Rutland**

HISTORIC BUILDING SURVEY: BRIEF REPORT

THE OLD PLOUGH, 41 MAIN ST, CALDECOTT

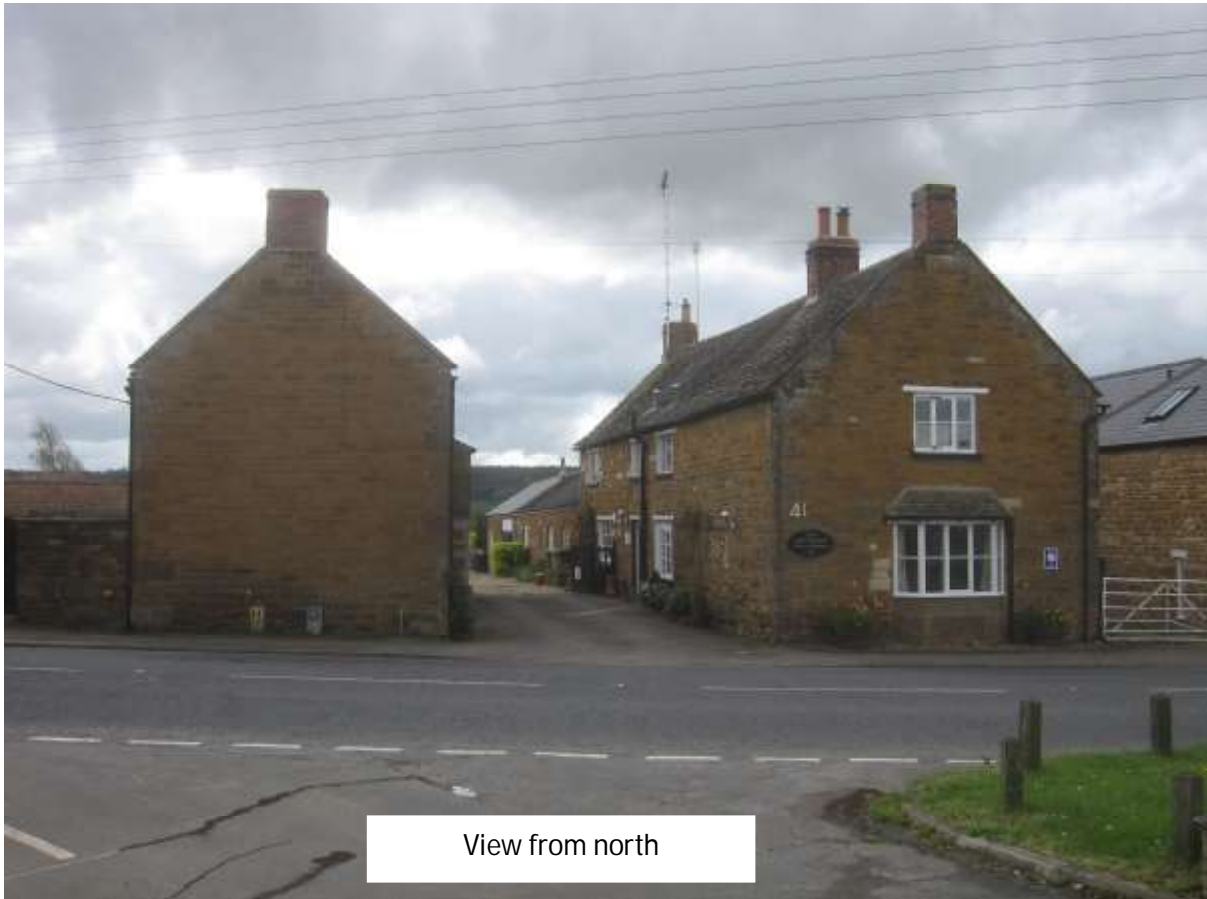
View from north

The main house gable end to the street has a stone-coped parapet with plain kneelers and seating for a single brick stack; C19 bay window to ground floor, 3-light casement window to 1st.

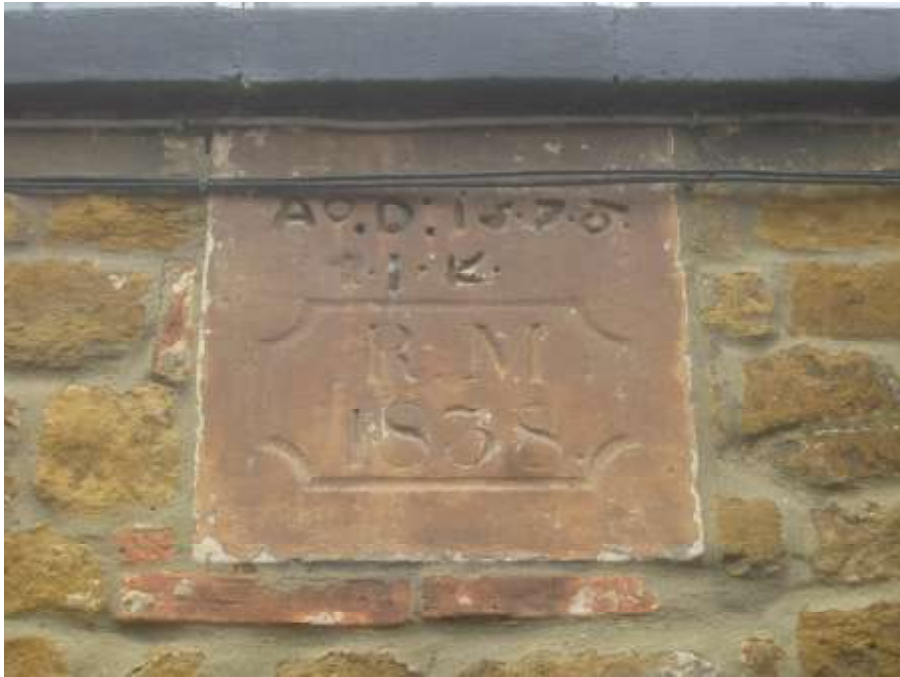
Date stone of 1838 and 1575 over front door

The E (entrance) front has two 3-light casements to the ground floor, with doorway between. Two old blocked doorway openings towards the N. Over the front door, a date-stone: 'RM 1838' in neat lettering and above, crudely and deeply incised 'AoD 1575 I(?) I K'. Of limestone, but painted reddish-brown. To the first floor are three

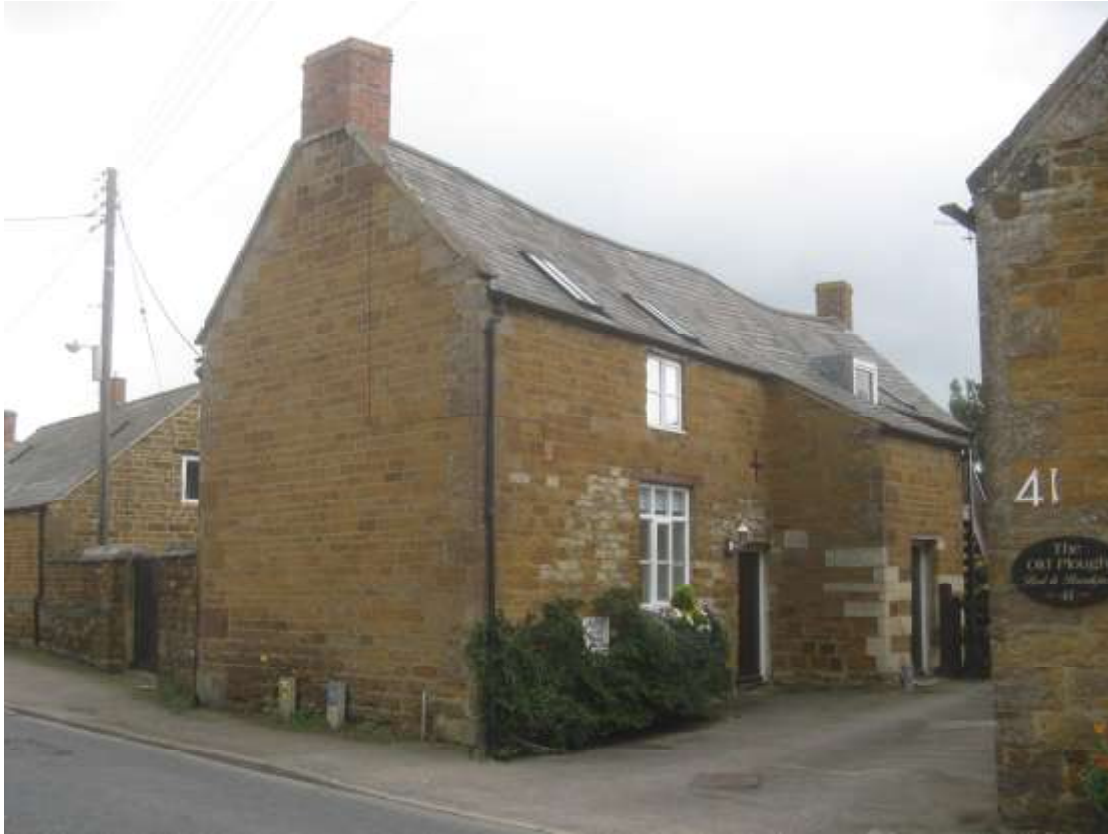
East outbuilding from north-west

The E outbuilding probably served as a brew-house/laundry/scullery to the inn. It has a blank N gable to the street, with stone coping and single brick stack. The W front has a projecting porch, with a doorway in it and further doorways to each side. A timber stair, now modern but indicated on the 1886 map, leads up to the first floor. The S gable has a second brick stack, and beyond this is a further single-storey block, with a wide opening to the front.

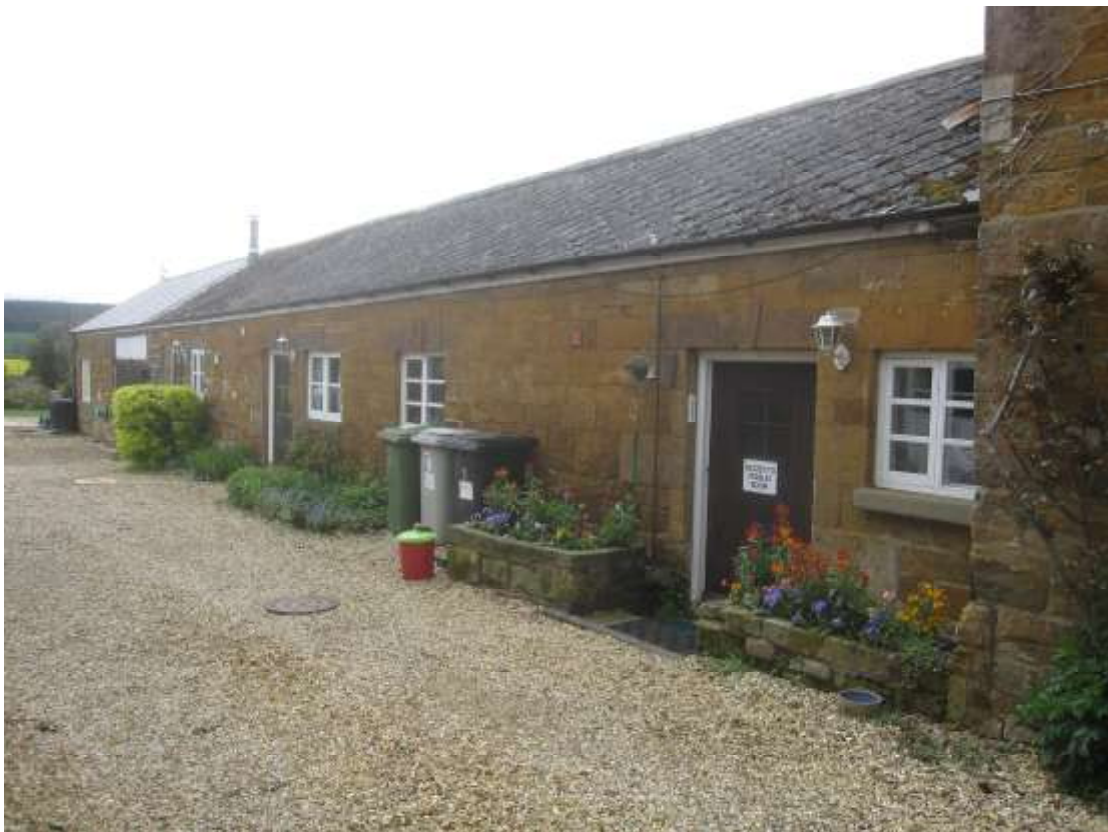
Stables and coach house range

The former stable block has a long, low front wall of finely-jointed ironstone. A wide doorway is set at each end, with two windows between – no doubt reflecting a former division into two stable sections. All four openings have good quality flat brownstone lintels with projecting keystones. To the L of the L doorway is a straight joint, with a less regular area of stone facing beyond. The final section of this long range was probably a coach house, with a wide opening which has good quality brownstone quoins and a beam over. To the L of this is another area of quite good quality masonry. The S gable and rear W wall are of coursed rubble. A door to the rear of the coach house suggests this may have previously been a barn, with an opposing door for cross-draught.

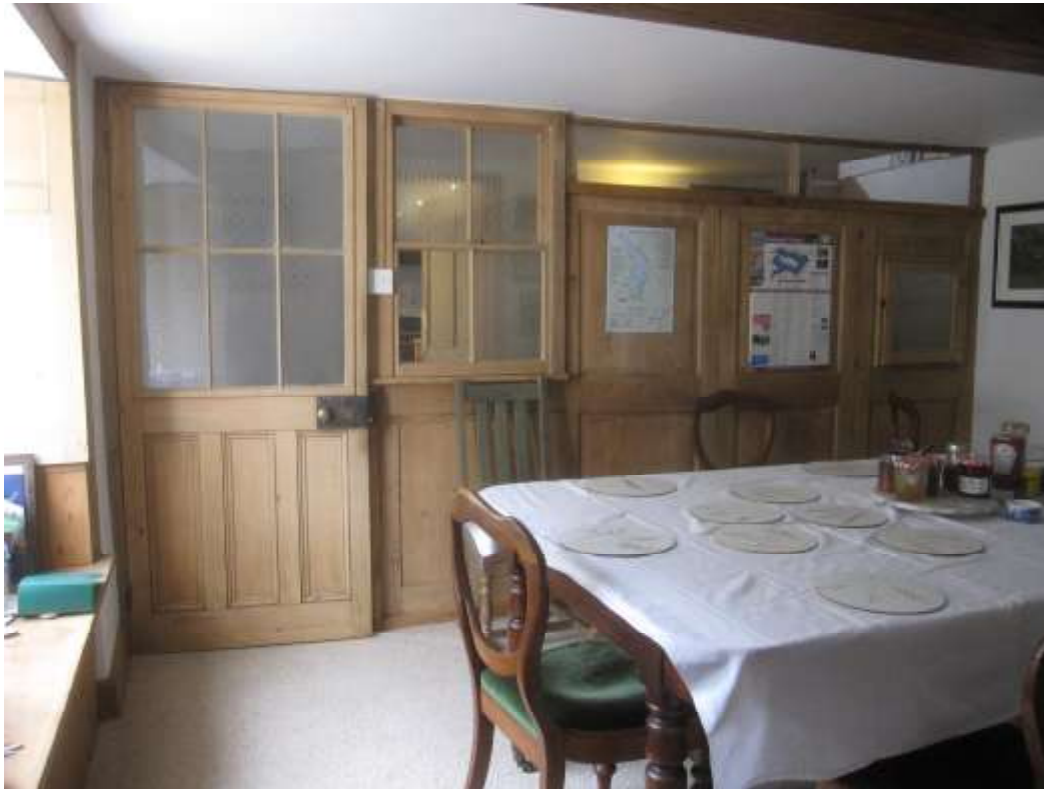
Pine partition, with doors and serving hatches; entrance passage beyond

The front door leads into a narrow entrance hall. To the N side of this is a pine panelled partition, part of the pub fit-out. It has a half-glazed door to the E, then a sash window (for serving), a double folding set of doors (for a wide, clear opening) and another window/hatch, which looks like a later adaptation.

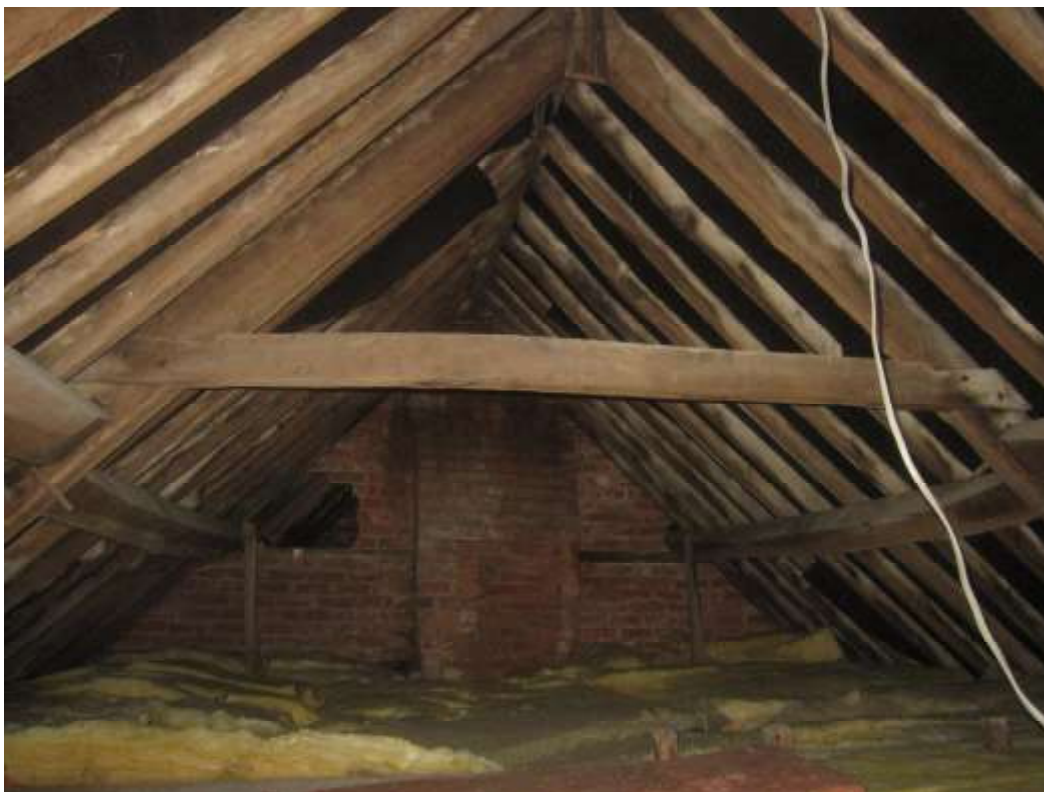
Roof structure to house: central room looking north, with lapped and nailed collar

The house roof, set at around 40° pitch, is of oak, using a mix of traditional and later techniques. Two trusses have a tie-beam bolted to the principal rafters with a square not and threaded bolt – typical of the earlier C19. Purlins with staggered, tusk tenon joints, and ridge board. Dovetail-lapped collar fixed with two big nails, not pegs. Rafters are also all of oak, not pine. Cross wall of C19 larger size bricks, and bricks also to the inner face of the N gable. Old-style reed/plaster finish on rough studs to part of the S truss, enclosing a taller 1st floor ceiled space over the S room.

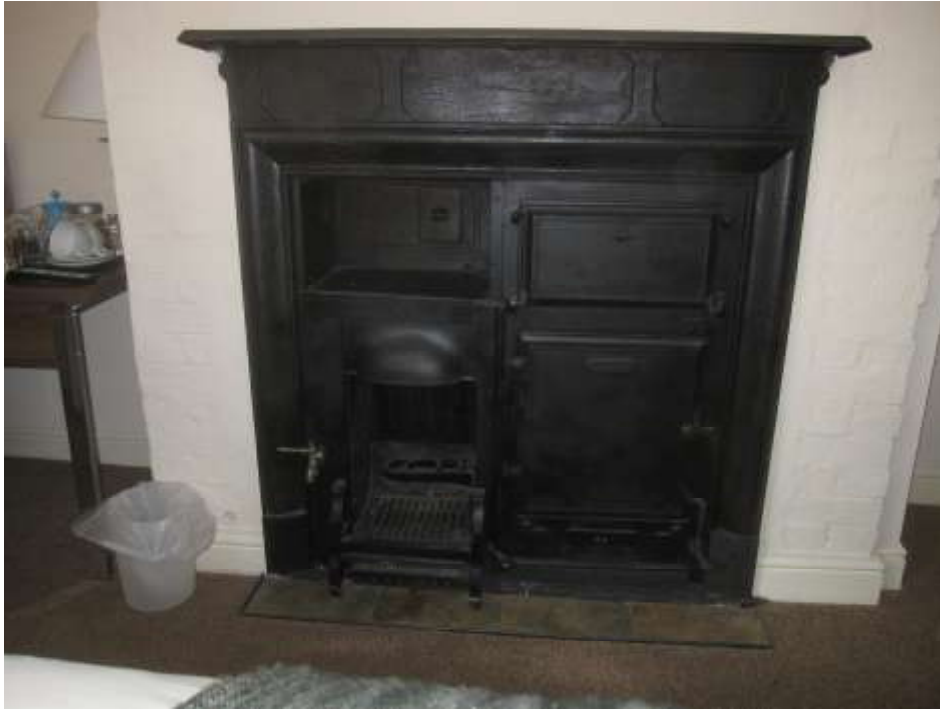
Early 20th century range to east outbuilding

This was also surveyed briefly in September 2000, before alteration works. On the ground floor, the N room has an iron range to the N gable, named 'The Bakewell'. It is of closed range type, with a back boiler, a hot plate and two ovens, probably of early C20 date. Evidence of a copper water boiler was noted to the R of this in 2000, and for beer barrel racks in the space opposite the porch. In 2000, the first floor had a large room, now subdivided to the N and a smaller room to the S. The roof structure here is of the same type as the main house, with lapped collars, fixed with a threaded nut/bolt, and tusk-tenoned purlins. Both rooms had an old red/pink distemper type paint finish in 2000. The chimneystack at the N end is built of C19 size brick, as is that to the S. The S room has a fireplace with small hob grate, with reeded side panels, of earlier C19 type. Over the fireplace is a timber shelf on shaped brackets. This room clearly functioned as a servant's bedroom.

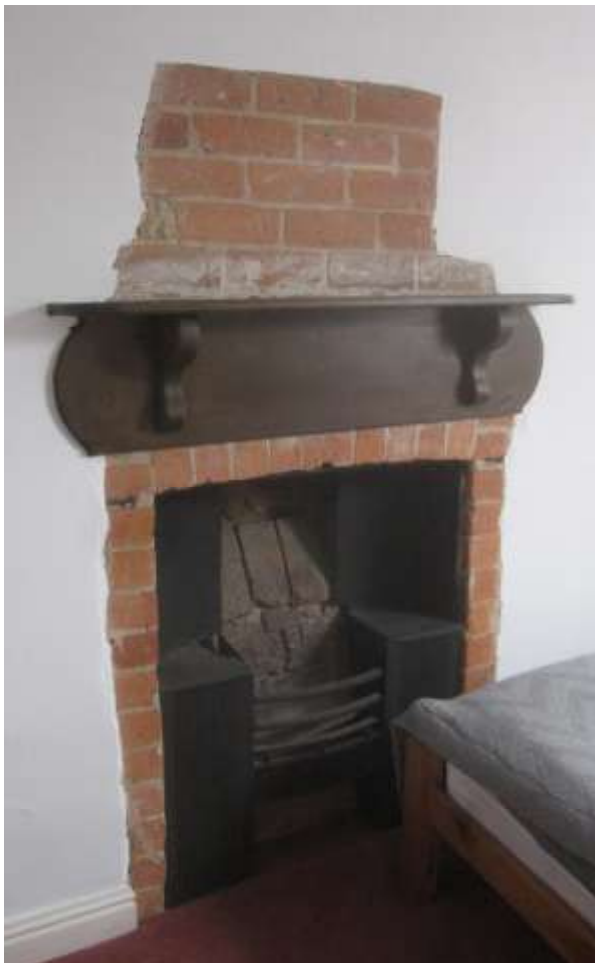
Fireplace with hob grate and shelf, to first floor servant's bedroom in east outbuilding
