**Lyddington Manor History Society  
Historic Building Survey**

**5 The Green  
Lyddington, Rutland**

## LINCOLN HOUSE, 5 THE GREEN, LYDDINGTON, RUTLAND

### Summary

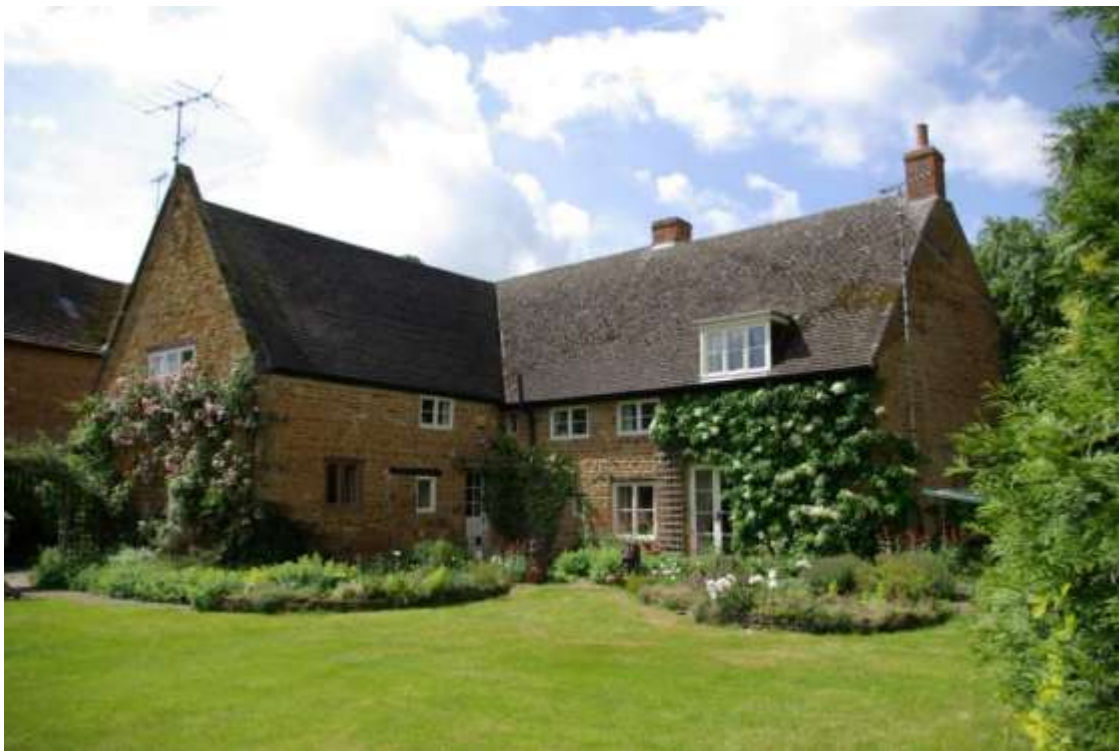
Rear view in 2009 (before addition of conservatory)

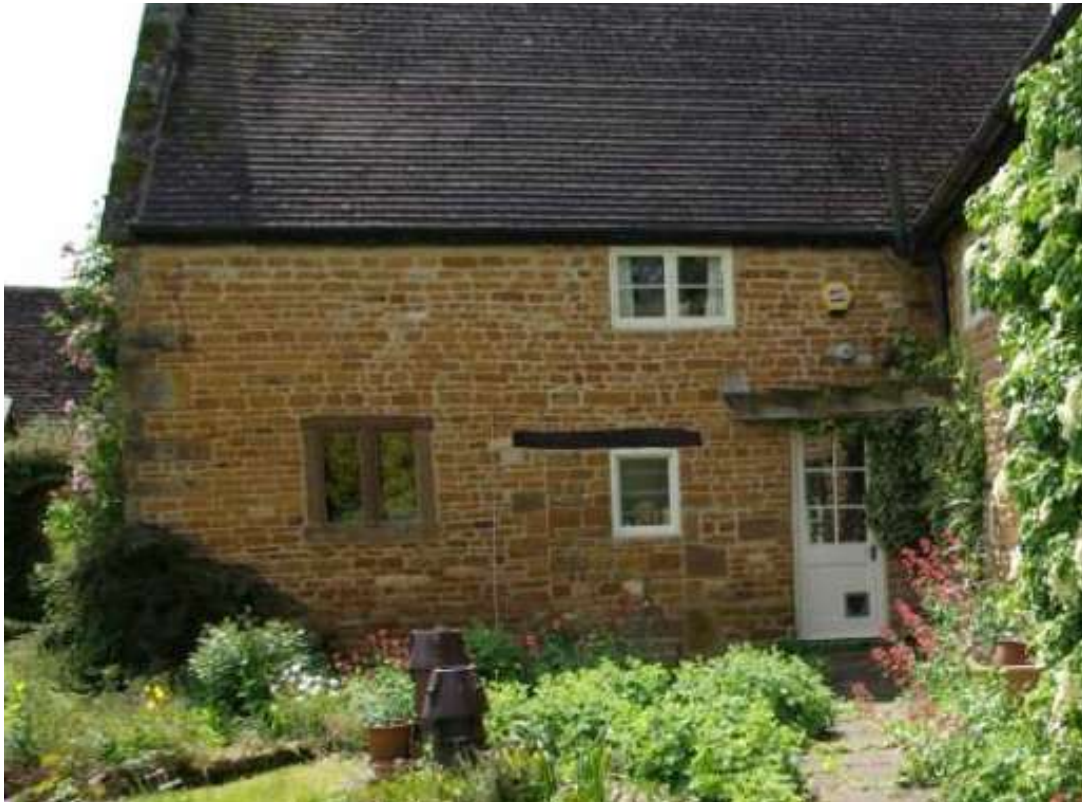
View of west side of rear wing in 2009 (before addition of conservatory)

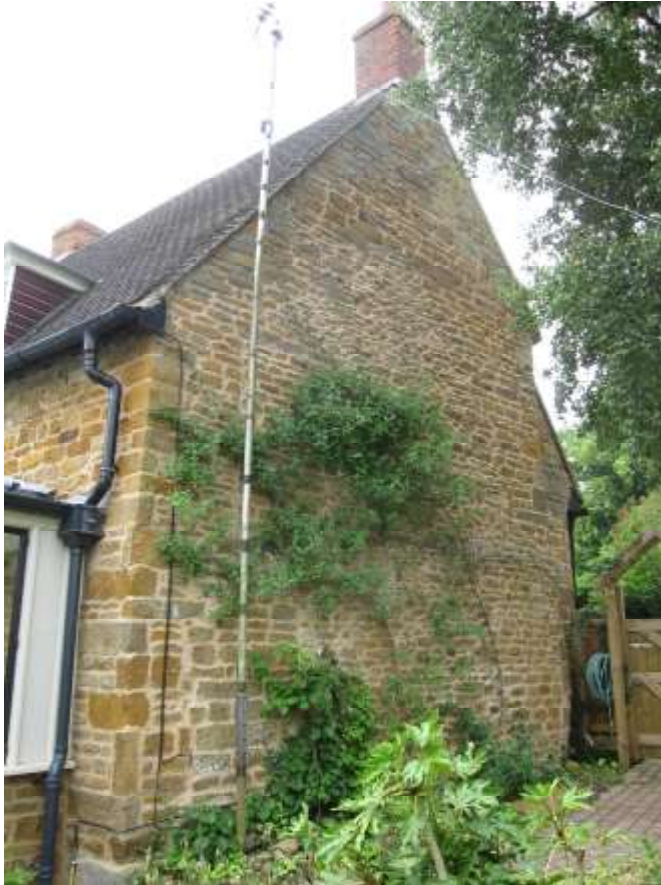
The irregular west gable of the front range, with evidence for former additional block

The kitchen has a large inglenook fireplace for cooking, lit by a small ingle window. The irregular masonry of its west gable wall indicates that there was a further section of the original building here, an unusual feature. It was probably an ancillary space to the kitchen, with a connecting doorway, though it seems it also had a low first floor, probably for storage use only. The first floor of the main range probably had three chambers, but they were originally poorly lit, without fireplaces and had low headroom, so they may also have been used largely for storage.

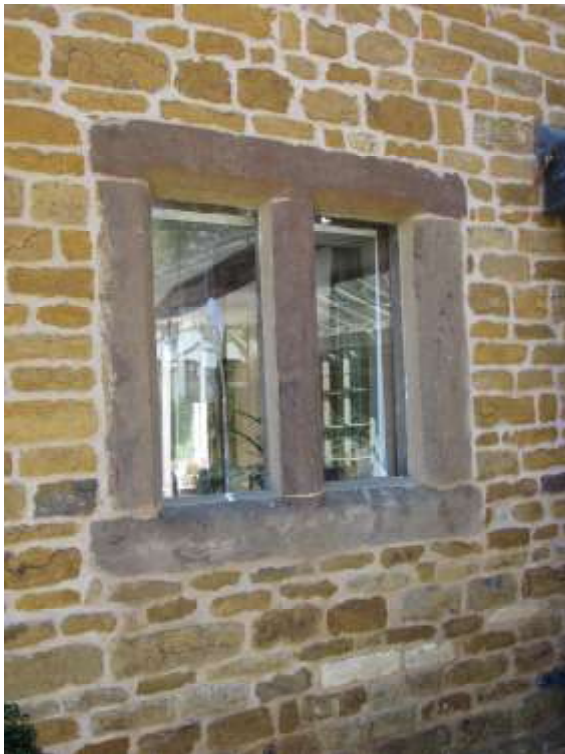
Stone window to rear wing, of unusual plain type

This is an unusual structure, in that it is attached to the main house but appears to be non-domestic in function, having no original chimneystacks for heating. It seems there were no connecting doorways originally to the front range. The form of the windows also suggests a utilitarian building, and the two wall niches on the inside and outside faces of the west wall are like those often found in agricultural buildings (though not on the outside face). Its general character and the nature of the junction to the main range indicate that it is a later addition to the main front range. It seems unlikely that it is a domestic range pre-dating the front range, as it has no chimneystacks. The ground floor clearly formed a lofty, single space and there was probably a loft over for storage. The doors and windows indicate that it was not a barn or cow-house. It might have been built as a stable, with a hayloft over, though one would not then expect a rear door, nor good windows to both the front and rear walls, which leave rather little space for stalls. It may have been an unusually capacious dairy or scullery (though that would seem more appropriate attached to the kitchen, rather than the parlour), but it seems more likely that it had some other ancillary use for the adjoining farmyard, or was constructed as a multi-purpose building.

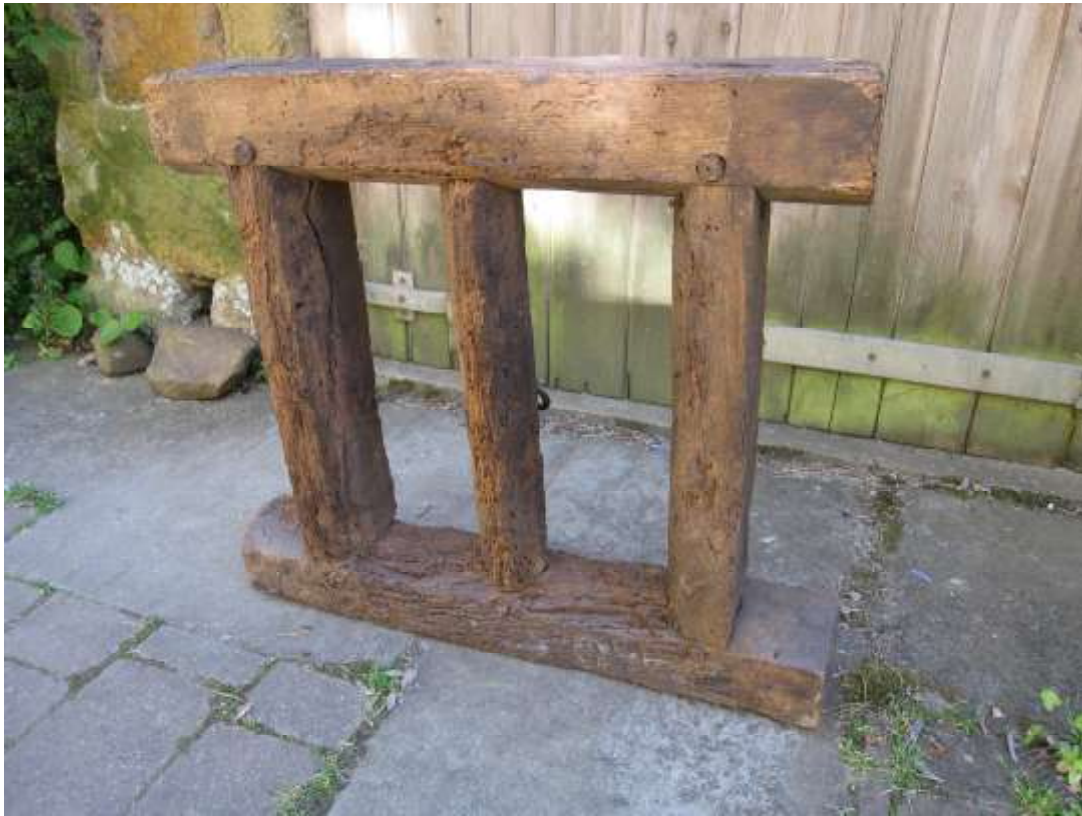
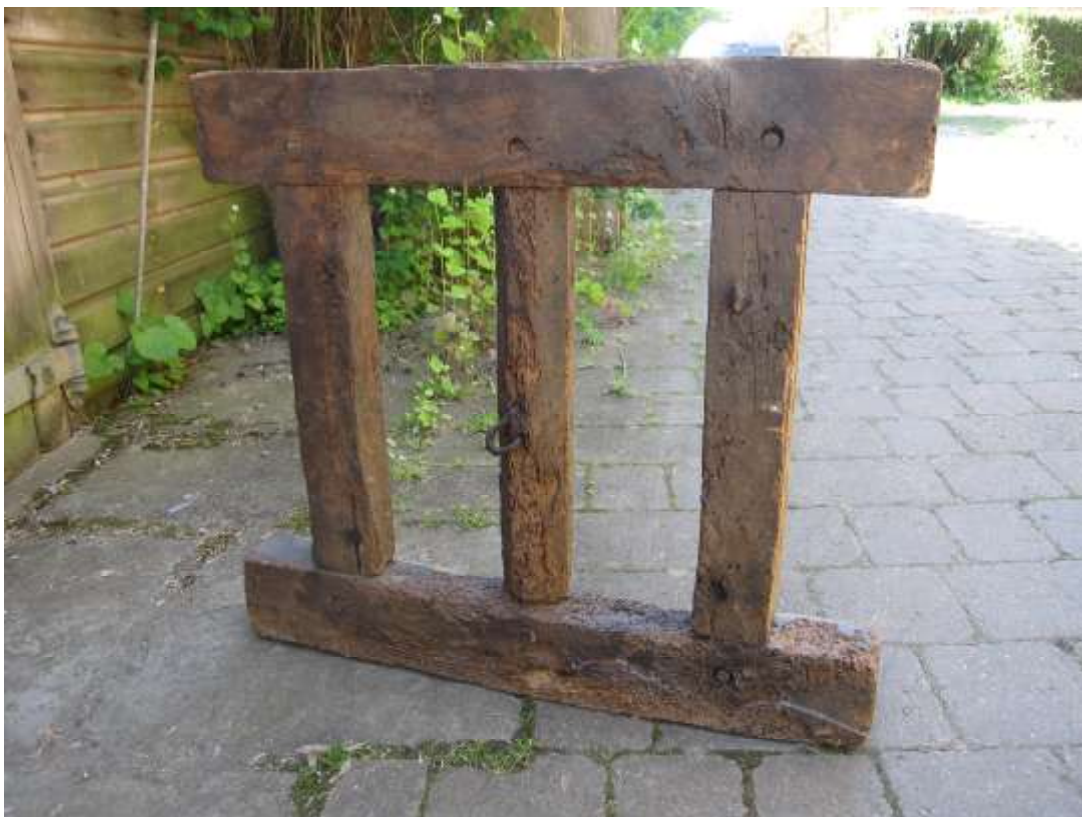
External and internal views of the C17th unglazed oak window from the parlour

A particularly interesting discovery was made when the current doorway was inserted in the east gable of the parlour, when a timber window was revealed, clearly part of the original early 17<sup>th</sup> century structure. This has been preserved *ex situ* and survives in quite good condition. It has a plain oak frame of two lights, with chamfering. The particular feature to note is that there is no rebate or groove for glazing. Instead, there was an internal shutter, for which evidence of the pintle (hook) hinges survives, together with an iron staple on the central mullion, for fixing the shutters closed. Such windows are rare survivals in this stone-built area. It is especially interesting in this context, where a fine ovolo-moulded window (presumably glazed) was provided to the front wall of the parlour, but an unglazed timber window was still considered sufficient for the side wall.

The unglazed window in the gable wall of the parlour must have been blocked up at an early date, before glazing became *de rigueur*. A second flue was added, probably during the 18<sup>th</sup> century, to the chimneystack of the east gable to provide a fireplace in the east bedroom. The section of building attached to the west gable may have been lost in the same period. Timber windows with leaded lights and iron casements were also installed around this time to the front wall of the kitchen and two bedrooms. A proper first floor structure may have been inserted in the north wing during the 18<sup>th</sup> or 19<sup>th</sup> century, with various alterations also to windows and doorways. The major alterations of the 1960s for Mr and Mrs Nichols are documented on a surviving plan. Subsequent to this, the front doorway was blocked up and a new door made in the east gable by the current owners, Mr and Mrs Stokes. The most recent alteration has been the addition of a conservatory to the north side.

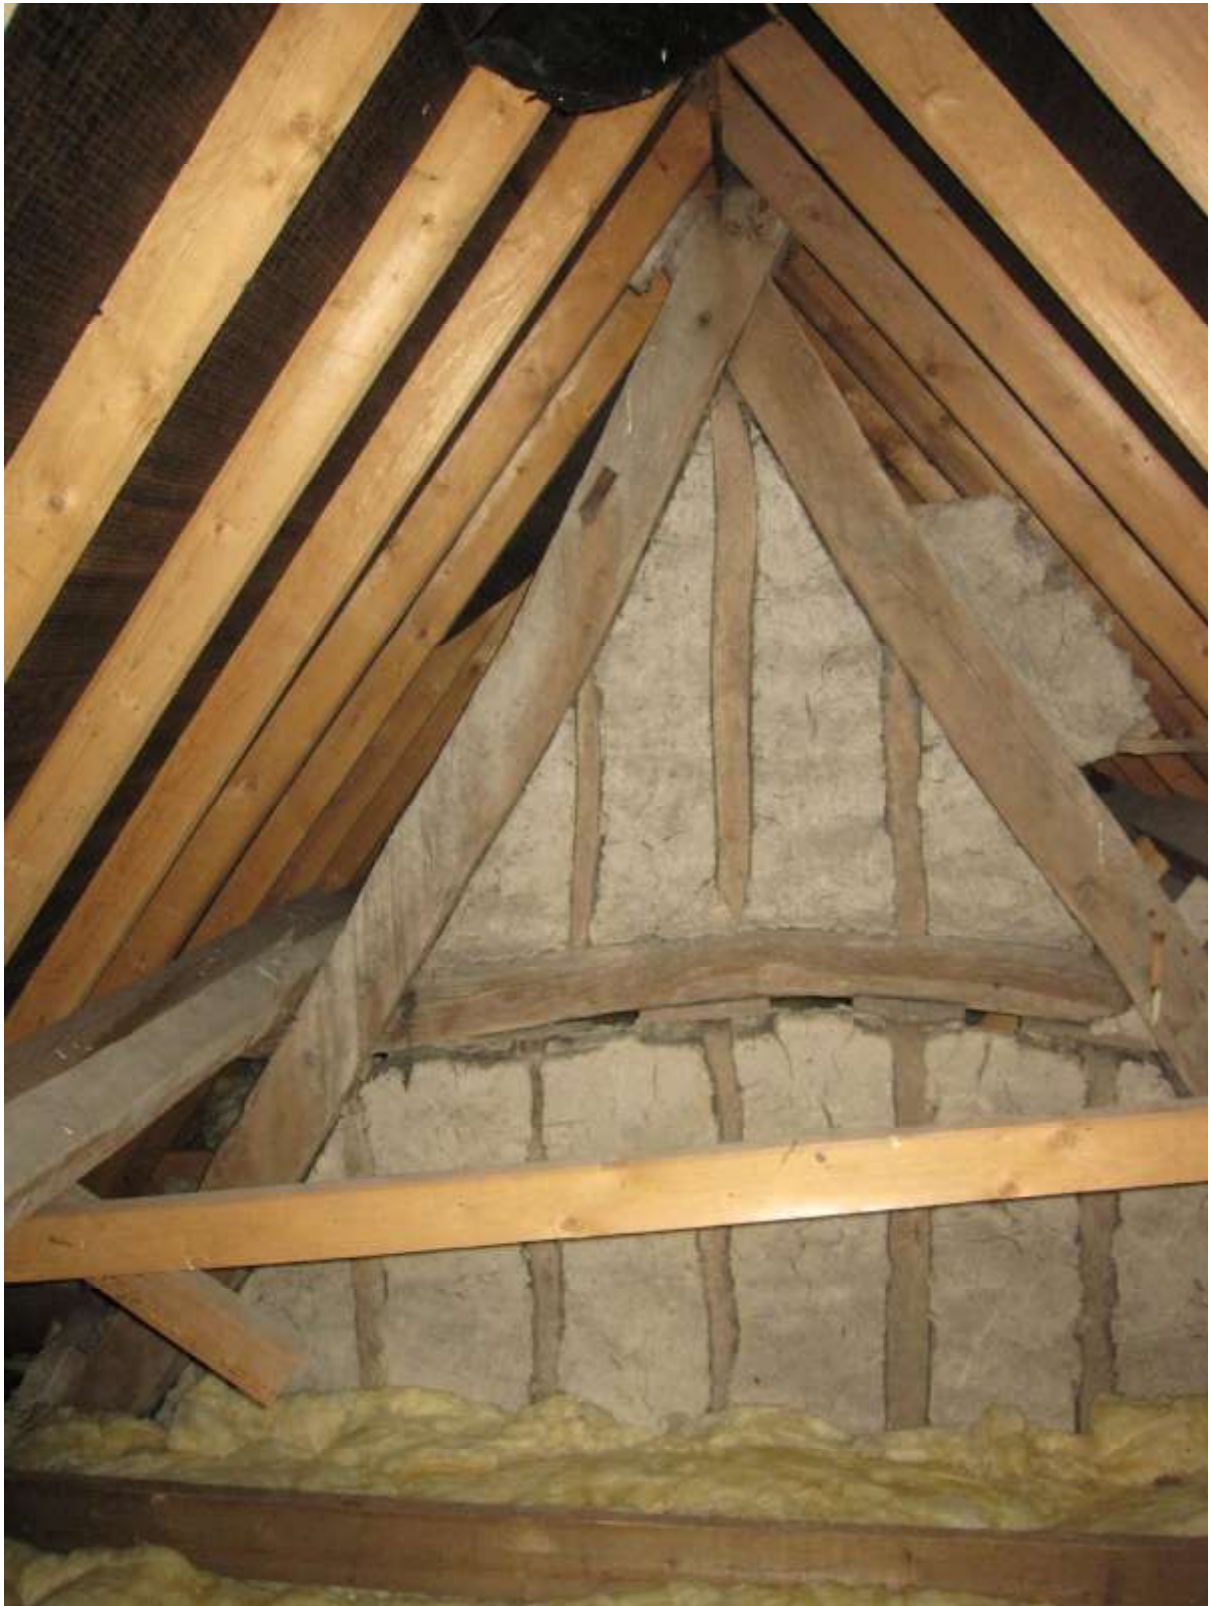
South face of truss T1 to rear wing, dated 1691-6.

The north wing is a well-built ironstone structure, with a roughly chamfered plinth and good quality north gable, with gable parapet and roll-moulded apex. Its side walls are around 500mm thick, as against 640mm for the front range. Much altered in the 1960s, it had a front and back door and two stone-mullioned windows. One of these windows is still in situ, but the other was re-set in the east gable of the front range in the 1960s. The windows are of unusual pattern, plain chamfered, with a stout, rectangular and chamfered central mullion. The ground floor formed a single space, with two rather crudely shaped ceiling beams, quite high-set. There was a low first floor or attic, which now has a later inserted floor structure above. The original roof structure survives, with two trusses of A-frame type, and has been tree-ring dated to 1691-96. The principal rafters have a scissors crossing at the apex to support the ridge (now missing), with two plain, lapped collars carrying two sets of side purlins.

The rafters have been replaced in recent times, but mortices remain to show that there were two oddly placed wind braces to the north and south of the central truss (T1), though on different sides of the building. Both trusses have ash pole and mud infill to the upper parts. Set high in the north gable was an opening, now blocked.

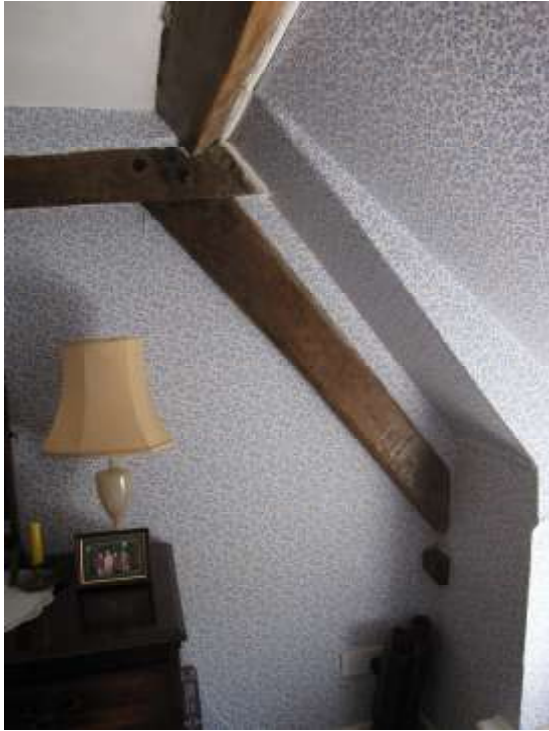
South face of lower part of truss T1

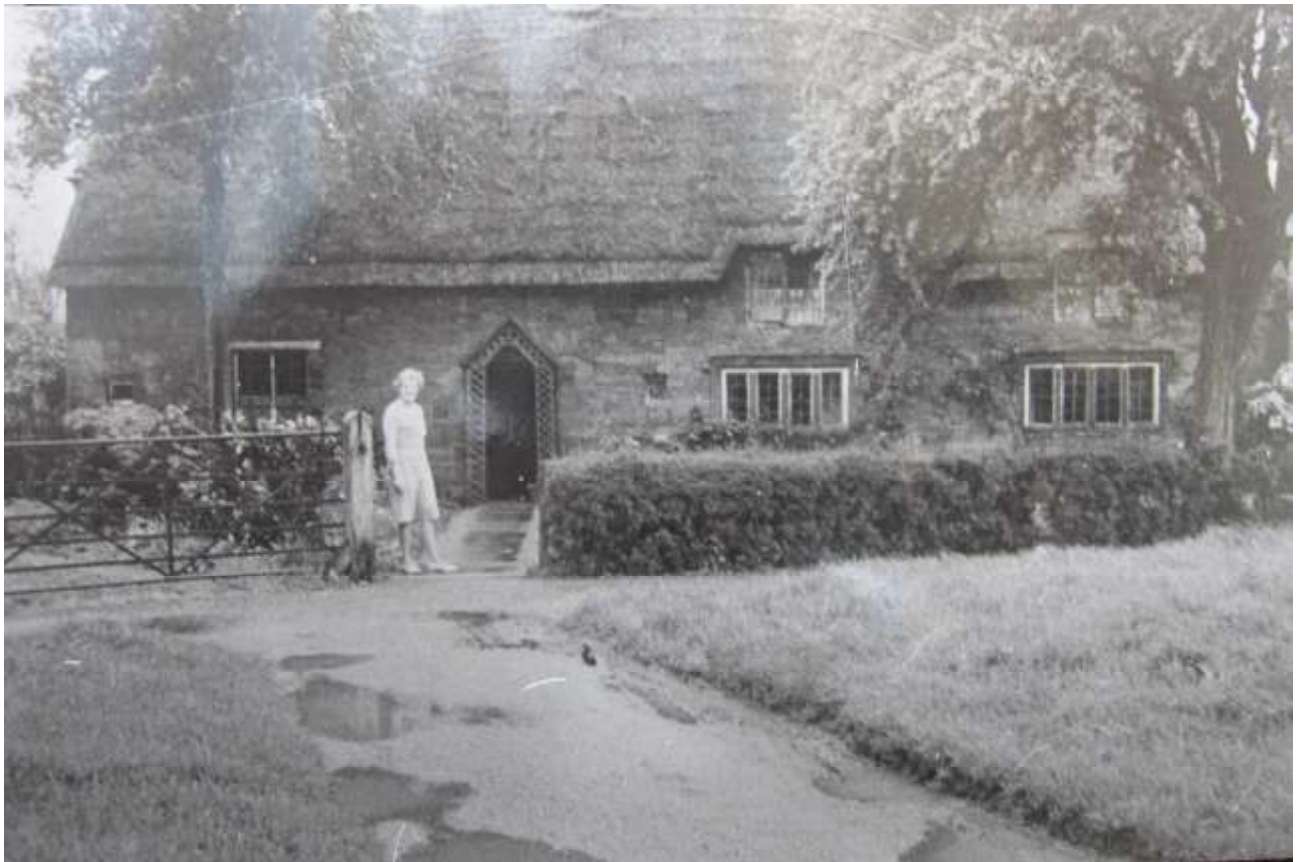
Early photograph showing roof of longstraw thatch, with eyebrow dormer windows
