**Lyddington Manor History Society
Historic Building Survey**

**Slievenanee, 63 Main St
Lyddington, Rutland**

HISTORIC BUILDING SURVEY REPORT

SLIEVENANEE, 63 MAIN ST, LYDDINGTON

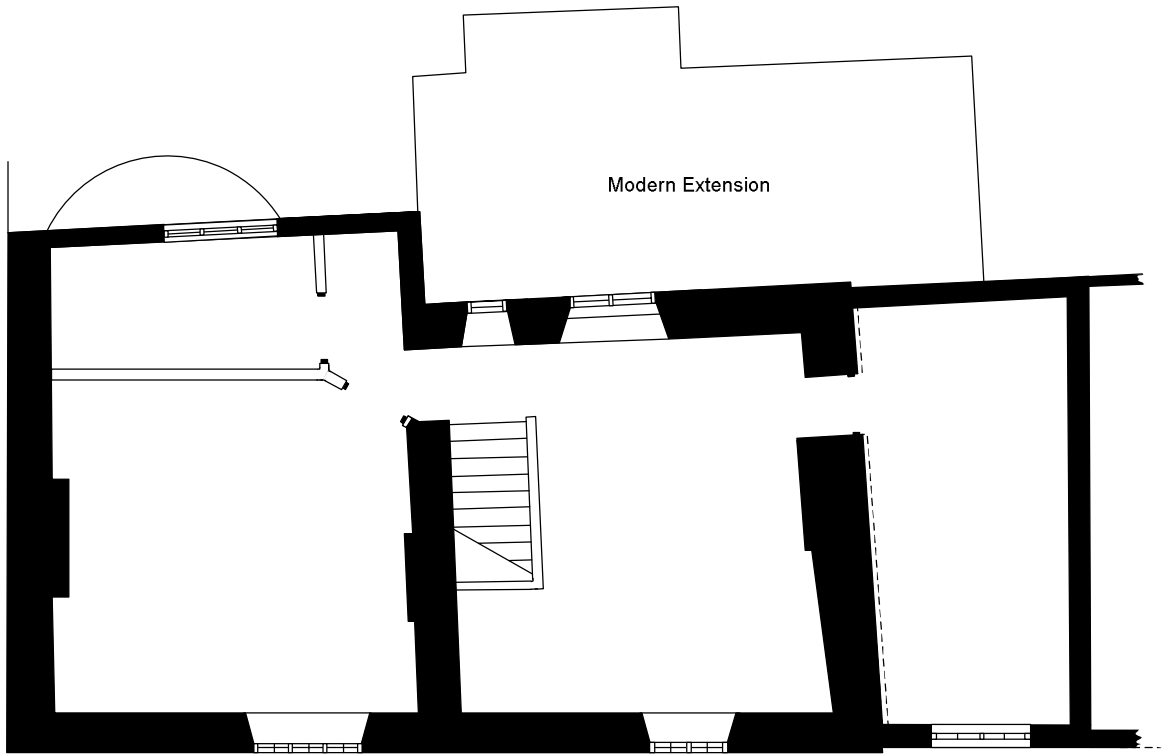
FIRST FLOOR

The N bedroom has a shallow projecting chimneybreast, for a former bedroom fireplace (with two-flue chimneystack to the gable). On the N side of this gable wall, in the modern bedroom over the garage, it can be seen that the stonework of the gable is 140mm thicker up to c.500mm above floor level, after which the wall thins. This suggests that this wall was not built as an exposed gable end, but was internal.

The S bedroom has a shallow chimneybreast and some corbelled brickwork just below ceiling, indicating that a brick flue was inserted into the stone wall here, to provide a bedroom fireplace. The shallow chimneybreast on the S wall must serve only the ground floor fireplace.

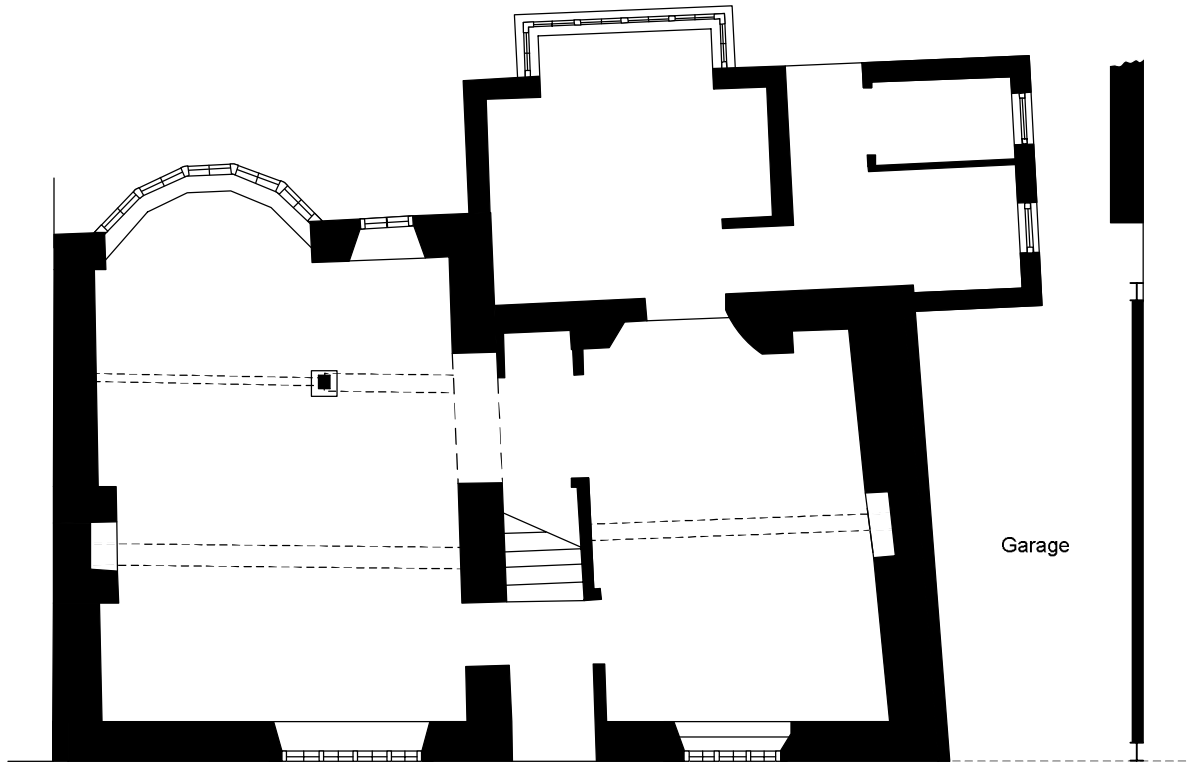
GROUND FLOOR

The entrance door leads into a small central stair hall. The N room has a former window to rear W wall, with a splayed reveal to the N and a cavetto-moulded cornice still in situ on the outer W face. The wall here is very thick, at 790mm; this contrasts with the rebuilt front wall, which is only 500mm thick.. Spine beam, rather roughly shaped (probably re-used), with squared oak joists. Fireplace on N gable, set flush to the wall, with projecting modern surround

The larger S room has a big spine beam, ogee moulded but without stops. Squared oak joists. Shallow projecting chimneybreast to S, with modern fireplace front. To the W side are two altered beams supported on a modern post, representing a removed partition.

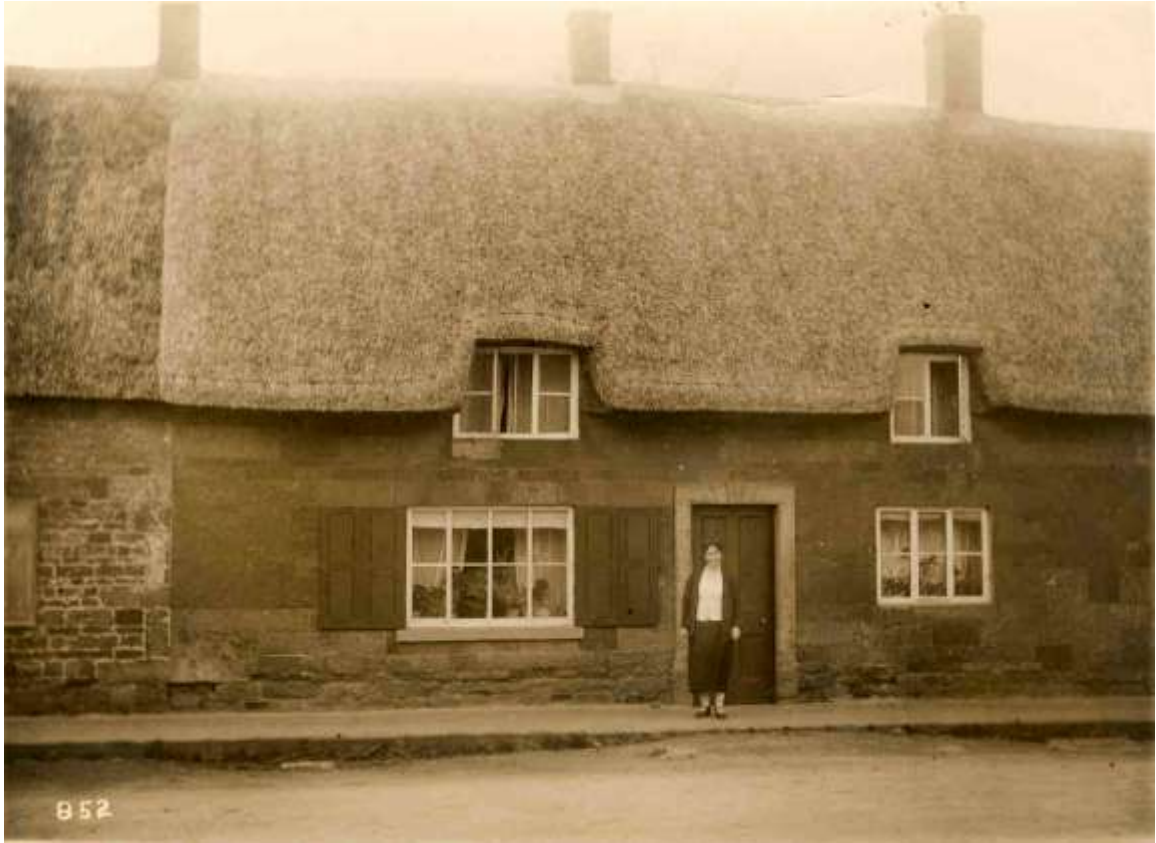
The ground floor windows now have small multiple panes, but an early photograph shows that the windows were formerly of 2-pane casement type. The S window is wider and taller than that to the N. There is now a parapet type coping at the junction of the roof slope with the adjoining house to the S, but this was absent when the roofs were thatched. Three brick chimneystacks, to either end and the centre. To the N is a modern garage, with a bedroom above.

Undated old photograph of the east front

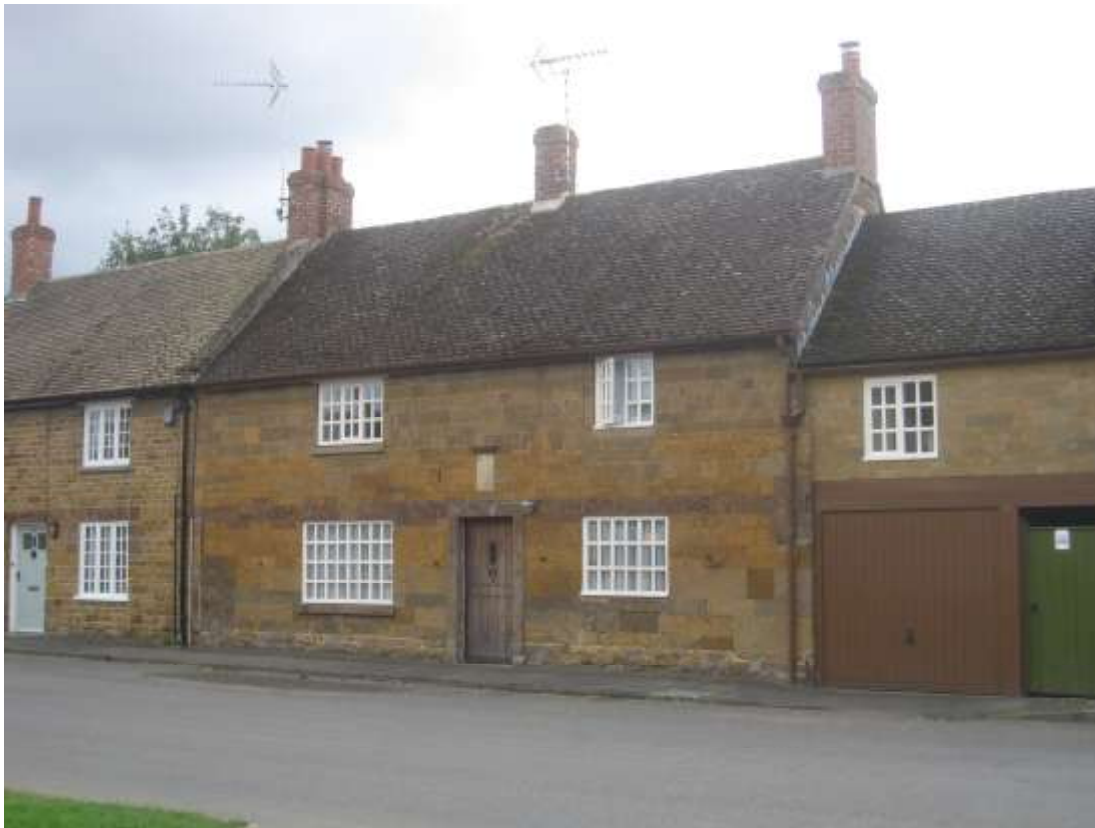
The front has a central doorway with windows set to either side. The main facing is generally of orange Lyddington ironstone ashlar, with a plain platband course of purple Uppingham ashlar at first floor level. The upper storey used to have eyebrow dormers with a thatched roof, but the wall has been built up in ironstone. The doorway has a plain ironstone surround with bead moulding, and a triple keystone to the head, the central part with fluting. Over the door is a limestone date-stone with a cyma-moulded ironstone cornice over. Within an inscribed diamond lozenge, the date-stone has the lettering: DRA MDCCLXIII in well-cut script, dating the front to 1763. The last part of the lettering is somewhat squashed together, so that the toe of the L runs past the base of the X; it is however definitely an L, with a well-cut serif, not a I.

View from north-east

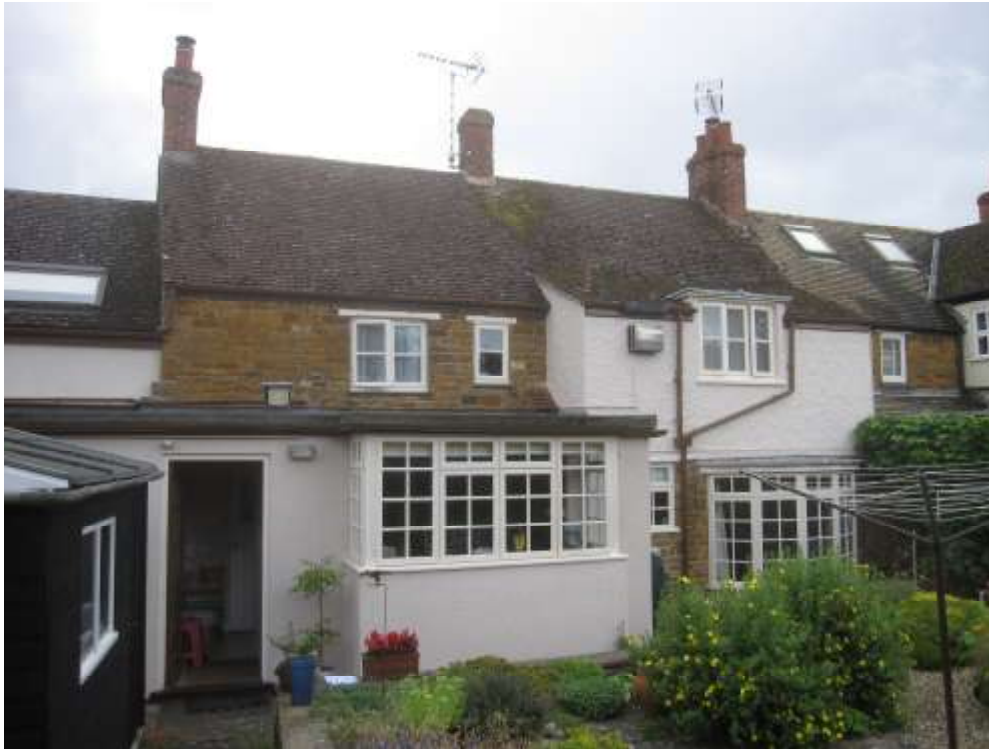
The rear wall has coursed ironstone where not covered by later extensions or render. The N part has a single storey flat-roofed modern extension, with ironstone above. A

straight joint between the two first floor windows indicates some previous alteration. The S half projects outwards, and also has a modern bay window to the ground floor.

The rear west side

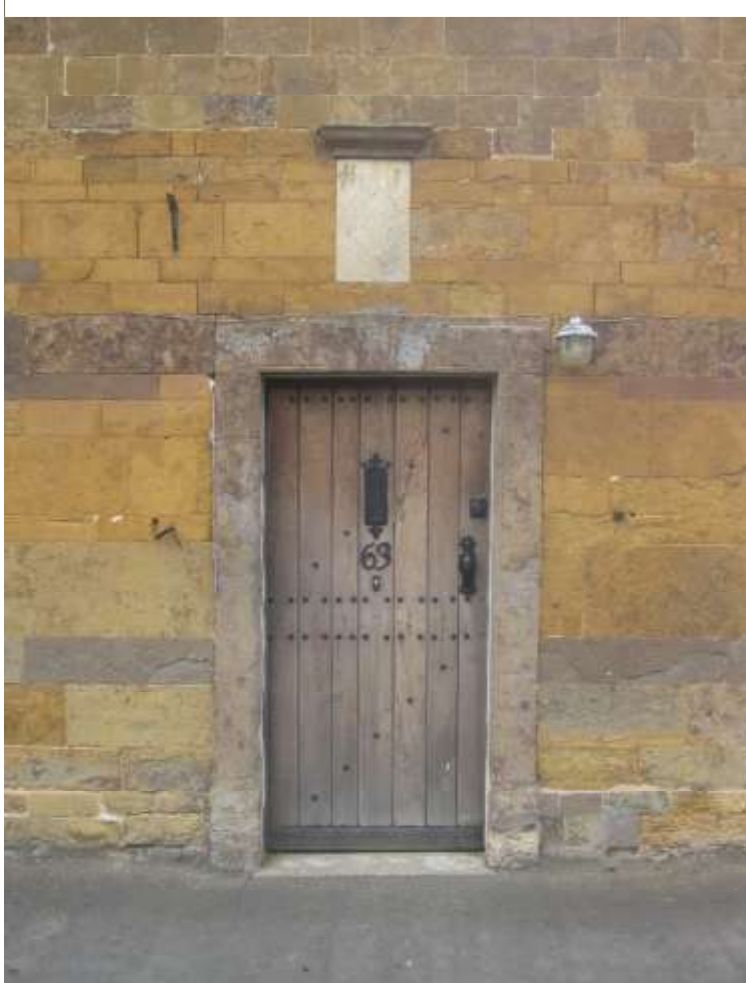
Front doorway and date-stone

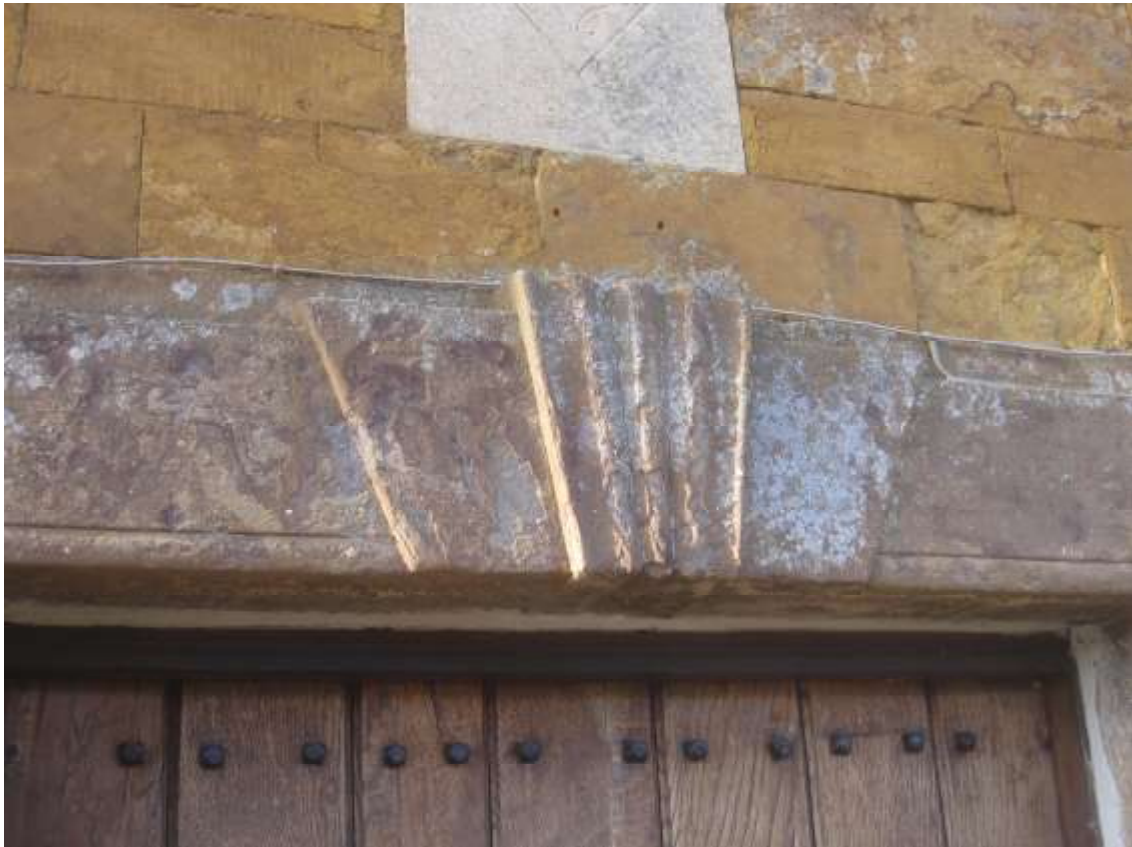
Fluted keystone to the front doorway

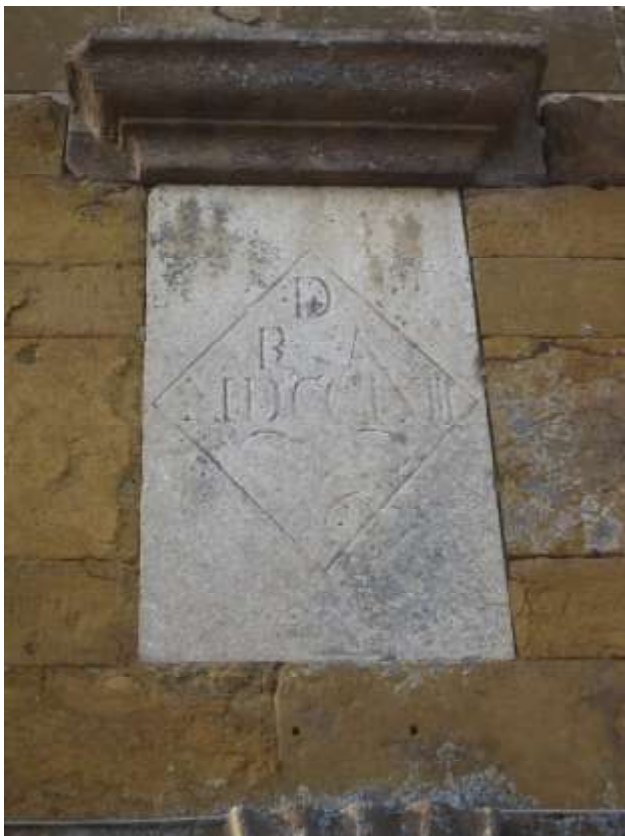
The date-stone:
D
R A
MDCCLXIII

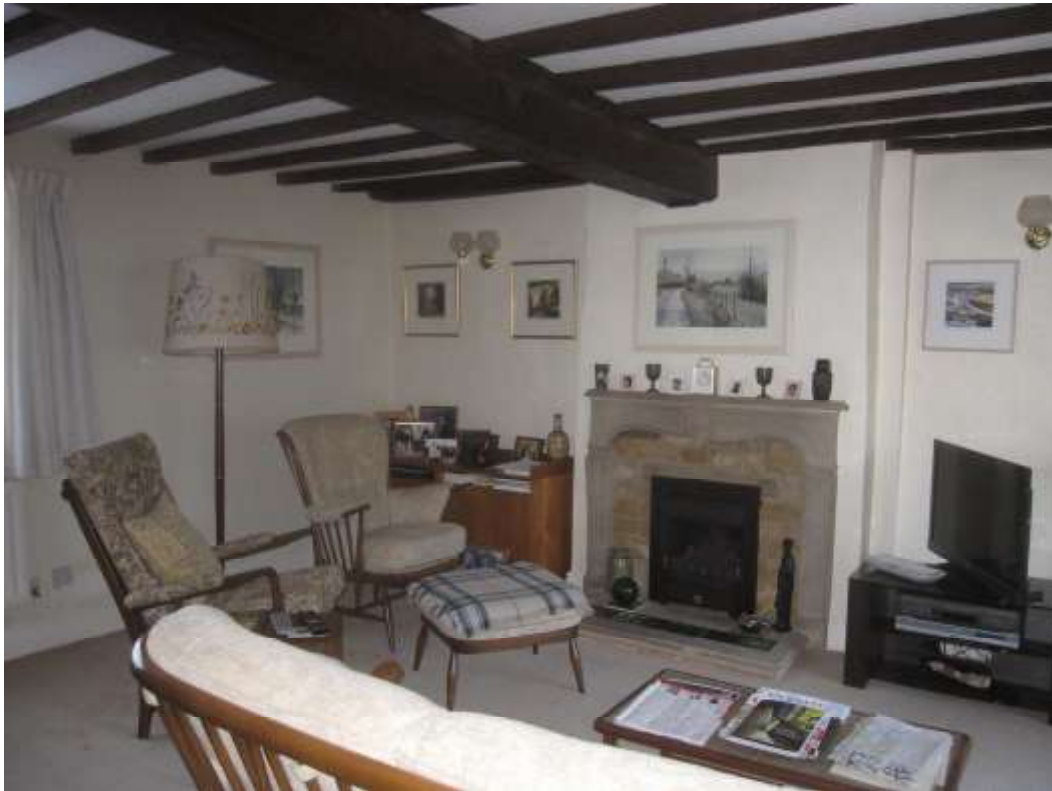
The south room

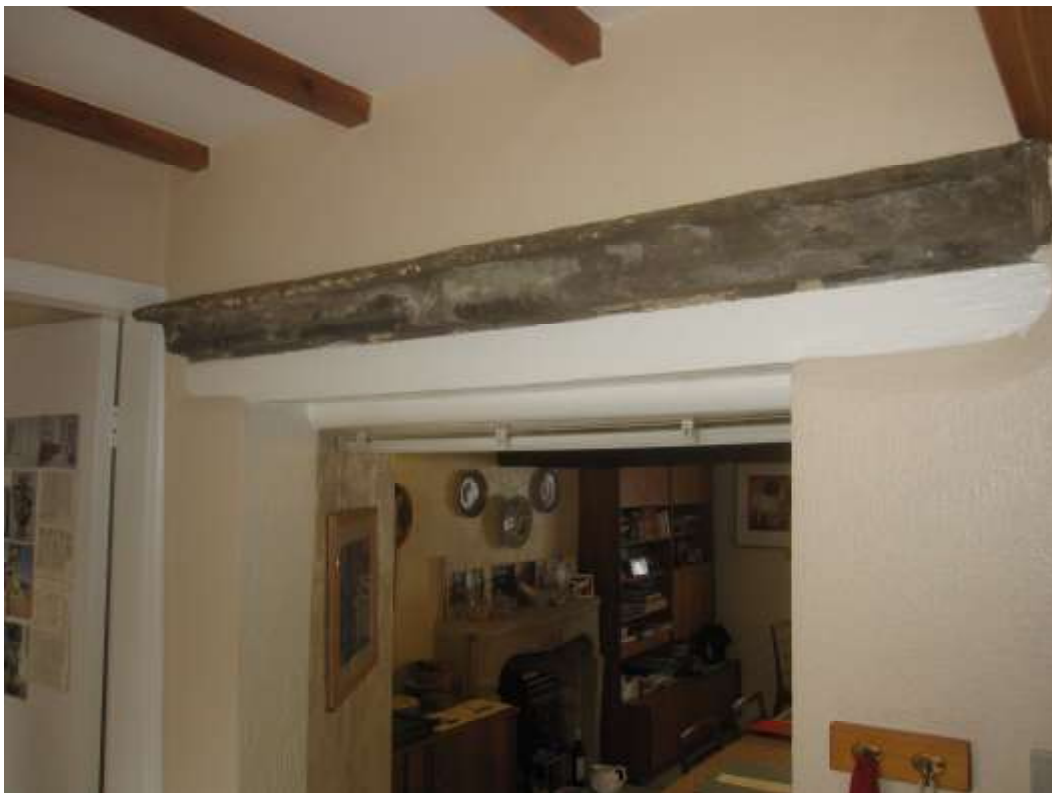
The thick wall to the rear and surviving cavetto-moulded window cornice indicate that there was an earlier house here, dating from around 1620-50. The form of this house cannot be deduced, but it may have extended N into no 65 or S into No 61. The building was later re-fronted, and probably much reconstructed in 1763, taking its current basic form of a two-room house. The first floor had dormer windows under a thatched roof until its replacement in the later 20th century.

17th century moulded cornice over former window in west wall of north room

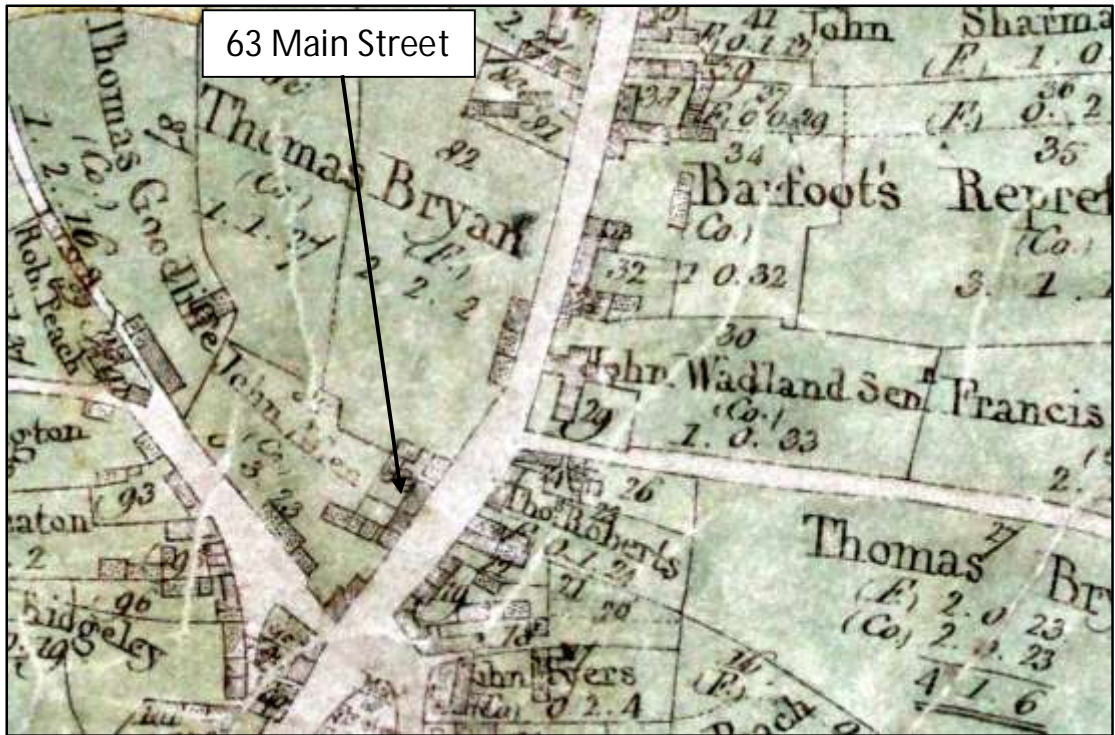
The small rear garden now has no outbuildings, but the 1886 and 1904 maps show a rectangular building against the W boundary, with a small square building to its N. The rectangular outbuilding is also indicated on the 1800 enclosure map. In the boundary wall, quoins survive which appear to mark the NE and SE corners of the rectangular building, indicating that the plot boundary has moved E since 1904. In the NW corner of the plot are the remains of a brick-built copper, which is likely to have been the small square building shown on the maps. It is said that this house was used as a laundry for Uppingham School. It is also noticeable that there is no dividing

Lyddington Enclosure Map - 1804
