**Lyddington Manor History Society  
Historic Building Survey**

**4 Church Lane  
Lyddington, Rutland**

## 4 CHURCH LANE, LYDDINGTON, RUTLAND

### Summary

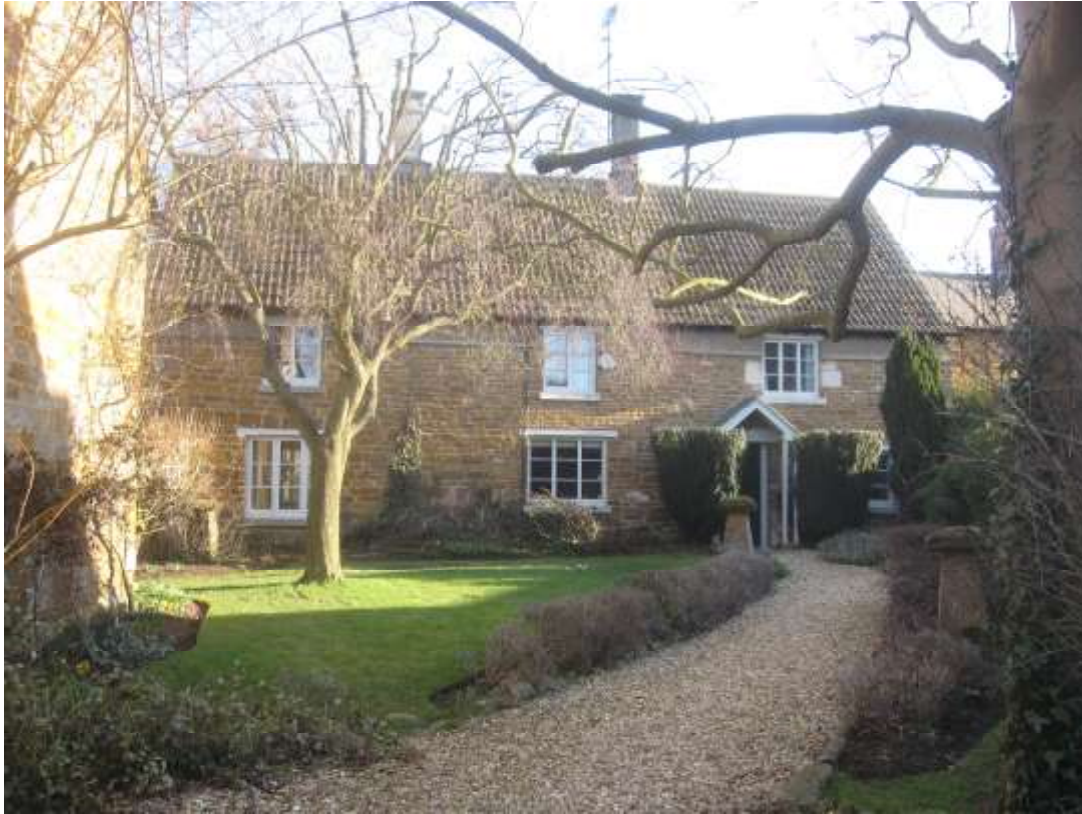
View of the north front

The front north wall is built of ironstone rubble. The central and west sections have rather irregular rubble and only rubble quoins to the north-west corner, though the east bay has been re-faced with larger blocks and good brownstone quoins to the

north-east corner. The window and door openings have 19<sup>th</sup> or 20<sup>th</sup> century chamfered timber lintels. The eaves has been raised in the mid-20<sup>th</sup> century, with brickwork covered by render. The west gable is largely covered by a 19<sup>th</sup> century extension, and the upper gable is rendered.

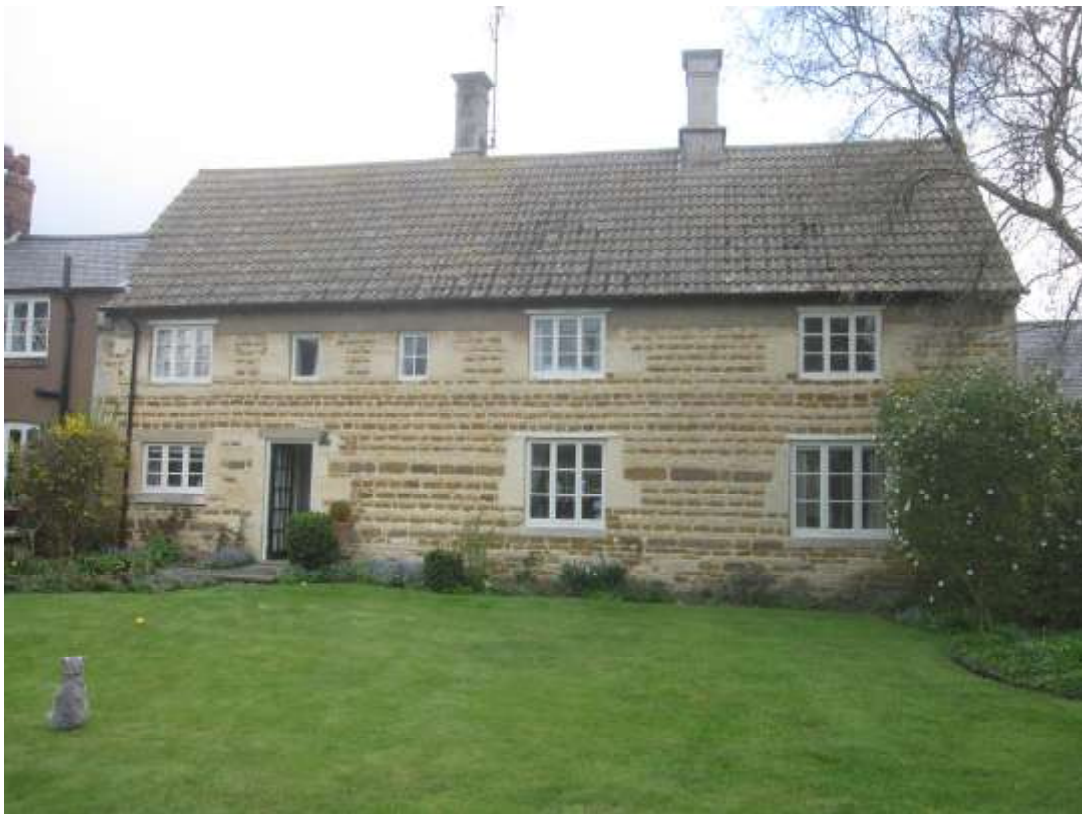
View of the rear from the south

The rear south wall and east gable are of a different character, with alternating courses of limestone and ironstone, and with good limestone quoins to the south-east and south-west.. These walls are only c.540mm thick and have clearly been completely replaced, probably in the 17<sup>th</sup> century. The south wall has a chamfered plinth, mainly of ironstone. Window openings to the south wall have large limestone jambs, perhaps re-used, and timber lintels. The eastern chimneystack is of good 17<sup>th</sup> century type, with a single flue of limestone ashlar with a chamfered plinth, torus/flat string course and cavetto/cyma cornice. The western chimneystack is of similar profile but of 20<sup>th</sup> century cast stone. The roof is of concrete tiles. Windows are of casement type, originally 19<sup>th</sup> century with some 20<sup>th</sup> century replacements.

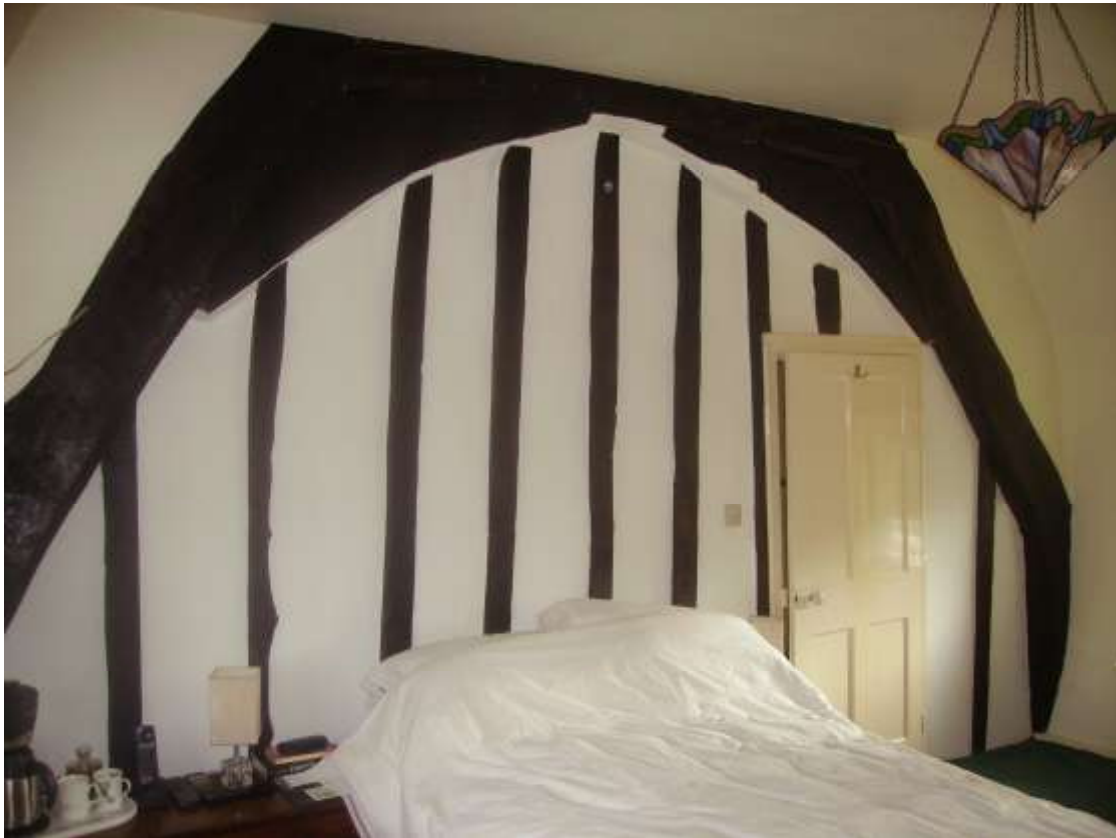
The cruck truss

The central cruck truss is of unusually high quality for the area. It was originally an open truss, as the arch braces show, but was later (probably in the 17<sup>th</sup> century) infilled with nailed oak studs and daub. The truss has blades of sawn, halved oak, with a cranked angle on the visible inner side of the blades, rather than a curving profile. It is unclear if the outer side of the blades was similarly cranked; it may have been more curving or irregular, as the north blade has a section with a large surviving knot which projects outwards. The slightly cambered collar is tenoned and pegged to the blades, rather than the usual local method of a dovetail lap joint. There are good arch braces with long pegged tenons, forming a very well-shaped arch, slightly pointed at the apex. Arch braces in cruck trusses are rare in the area, particularly of such well-shaped quality. At the apex is a deep yoke, into which the blades are tenoned, which is the normal apex type in the area.

The blades, arch braces and collar are chamfered, with a run-out stop just above the blade angle and a mitred chamfer junction at the blade/collar and apex joints. There is a large scribed carpenter's mark 'I' with a long 'tag' on the west face of the north blade and brace, but no other carpenter's marks were seen. The 'I' mark probably signifies that this was truss number one; the missing truss to the east would be truss two, probably the only other cruck truss in the building. The 'tag' signifies the left or right side of the truss. The blades also have long scribed marks just above the angle, which are probably setting-out marks. As often, the blades disappear into the masonry walls at first floor level and are either buried in the wall thickness or lost at lower level. It is probable that, like other local examples, the blades originally extended to near ground level, within the stone/mud walls.

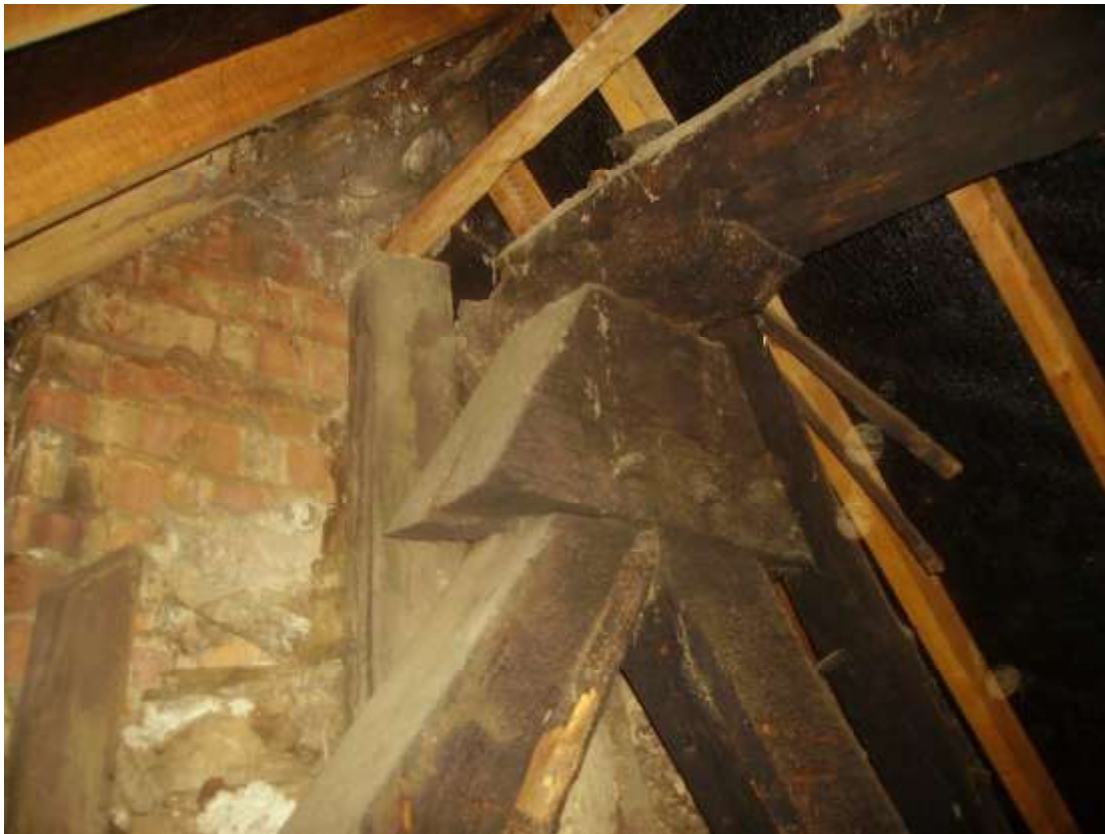
The apex of the cruck truss, with smoke-blackening

The ridge is of well-cut rectangular oak, c.190mm high by 150mm wide, pegged down onto the yoke. The ridge survives in the east and west bays, but is missing in most of the central bay. A section of ridge projecting into the central bay from the east shows the ridge had splayed scarf joints, with under-squinted butts, large face pegs and no trait-de-Jupiter tabling. There is another splayed scarf joint at the central truss. The ridge has a shaped top and pegholes for early rafters. At the west end the ridge bears onto the stone gable wall. The end is irregularly shaped, suggesting a cut-off branch, and no peg holes are visible for fixing to another yoke. This perhaps suggests that the original gable wall may have been of stone, rather than a gable cruck truss. At the east gable, the ridge is much decayed and bears onto a later inserted corbelled chimneystack.

An original, sooted purlin survives on the north side of the central bay, and there is another cut off section to the south-west corner of the east bay. The purlin is c.200x150mm and unchamfered, and seems to sit directly on the back of the blade, without trenching, though this detail could not be fully seen. The purlins to the west bay appear unsooted and probably not original, though the straight-splayed scarfed junctions at the central truss seem convincing. On either side of the central truss are two surviving original rafters of squared oak, c.150x70mm, laid flat. They have survived as part of the later timber smoke hood. The south rafter has an unusual large peg through its top face halfway between the ridge and purlin; it is possible this could be the fixing of an original smoke louvre.

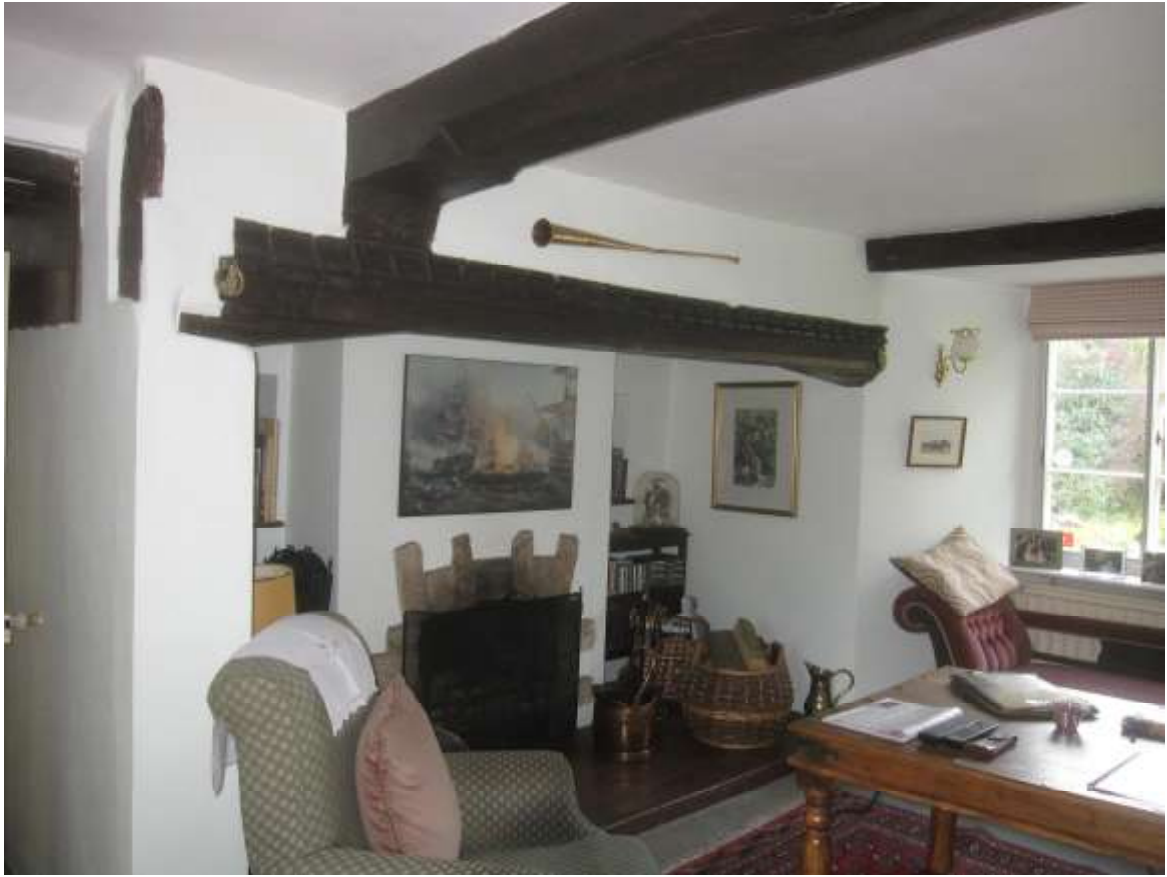
The inglenook fireplace with re-used embattled beam

The 17<sup>th</sup> century alterations included the insertion of a large inglenook fireplace into the former open hall, with a new location for the cross passage at the back of the stack. This central fireplace has a stone-built angle with an unusual re-used beam, which has an embattled type cresting above and cavetto/roll moulding below. The beam is obviously re-used because it has an original moulding mitre, now cut off, to the left end. The lower part of the moulding has also been cut away in the centre. The beam is clearly from a high quality building, probably of late 15<sup>th</sup> century date, presumably taken from some part of the Bishop's Palace after it became the Bedehouse in 1600. Although the ground floor fireplace is built of stone, the upper part was a timber chimney, built with main timbers of squared oak, lesser timber of ash pole and mud infill daub on laths. Parts of this timber chimney survive in the roof space beside the central cruck truss, with heavy sooting to the inside walls. The timber chimney was in use until replaced by the current brick stack around the 1960s-70s.
