**Lyddington Manor History Society
Historic Building Survey**

**The Lilacs,
101 Main St,
Lyddington, Rutland**

HISTORIC BUILDING SURVEY REPORT

THE LILACS 101 MAIN ST, LYDDINGTON

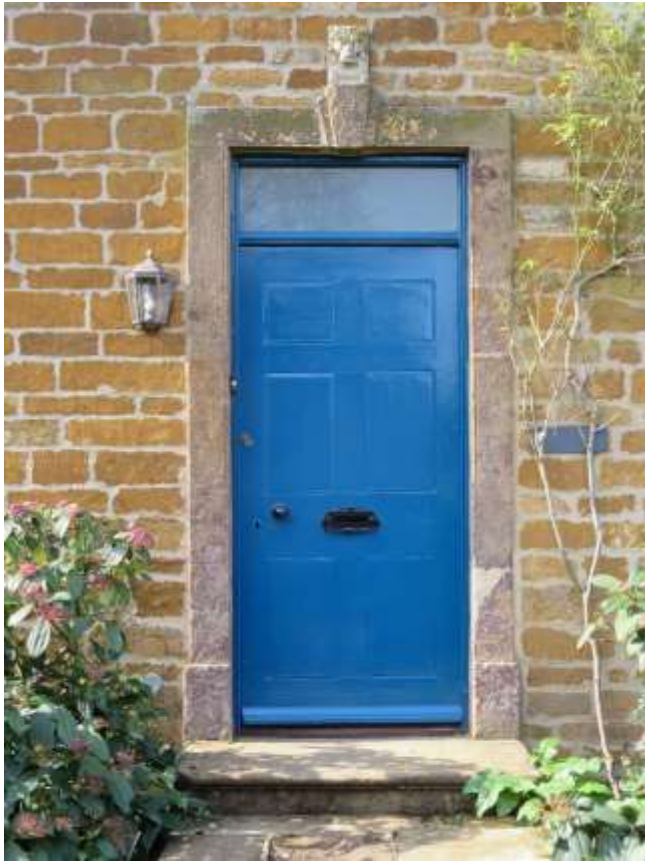
The E front is symmetrical, with a front door and sash windows to either side. Coursed ironstone with well-cut blocks, continuous across the whole façade; small offset at the base of the wall. The doorway and five window openings have slightly projecting brownstone surrounds. The doorway surround is tall, with bead moulding with square-edged plinth blocks and a projecting triple keyblock. The door is of 6-panel, flush-moulded type, with a rectangular fanlight over. Two good brownstone

The front door

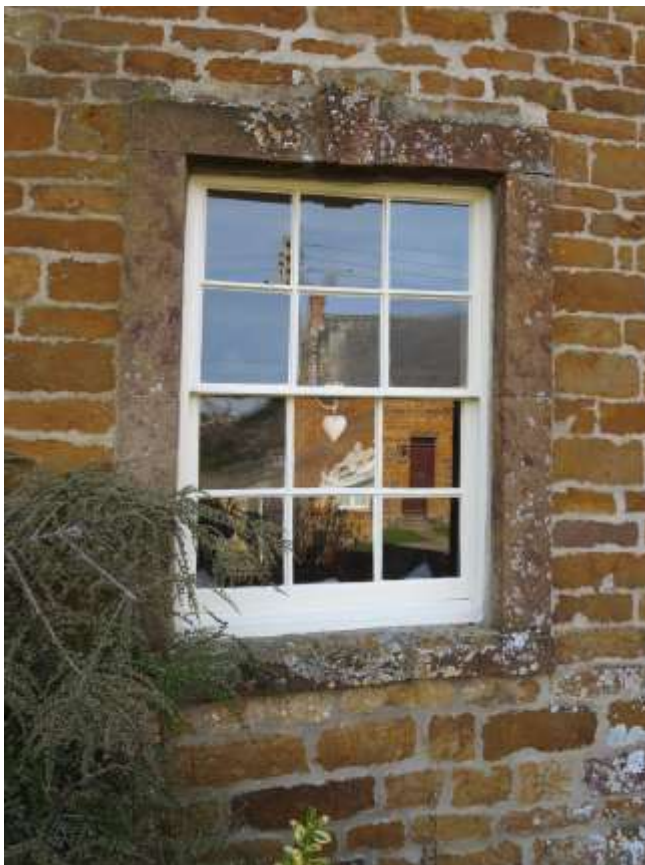
steps lead up to the doorway. Over the doorway is a block of limestone with a carved lion's head and the top of a moulded panel – clearly an inserted feature, probably introduced at a late date. The window surrounds are square-edged, with projecting triple keyblock and square cills. The wall is somewhat distorted to the N of the doorway. The ground floor right-hand window still has early sashes, of 6/6 pattern, without horns; crown glass panes survive, with thin glazing bars, ovolo-moulded internally. The first floor right-hand window upper sash is also of early type without horns, but the remaining sashes are Victorian replacements, with horns.

Sash window to front

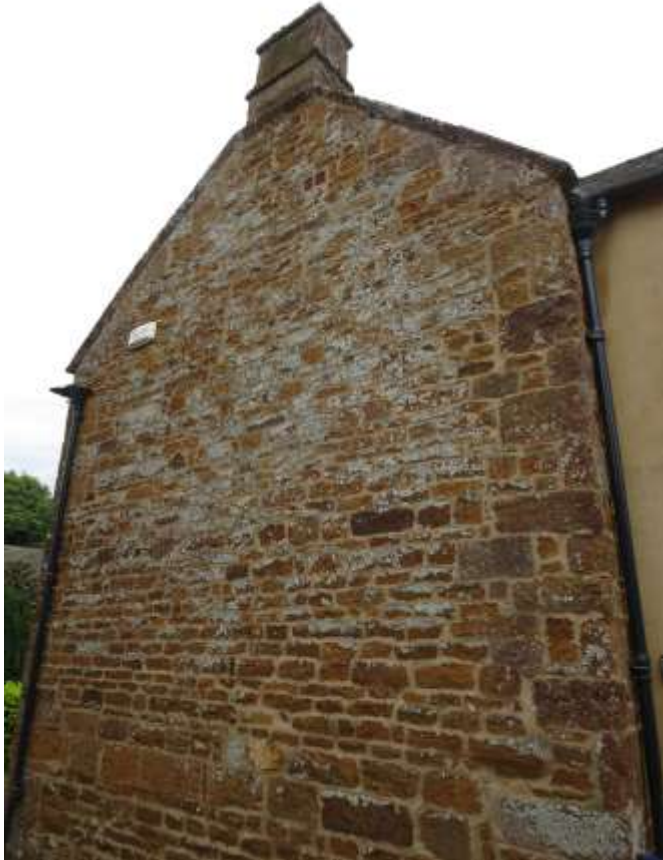
The N gable is now blank, but there is a blocked window at attic level, with a lintel of thin, old oak. Coursed ironstone, less well-cut than the front façade. The masonry coursing is disrupted to the NW, indicating that the NW corner has been rebuilt, with good new quoins. The NE corner has probably also been rebuilt, though the signs of disruption to coursing are less evident. Gable parapet with plain kneelers and seating for a 2-flue stack, of brownstone ashlar, with square-cut plinth and cornice.

North gable with 1st floor opening
blocked by chimneystack

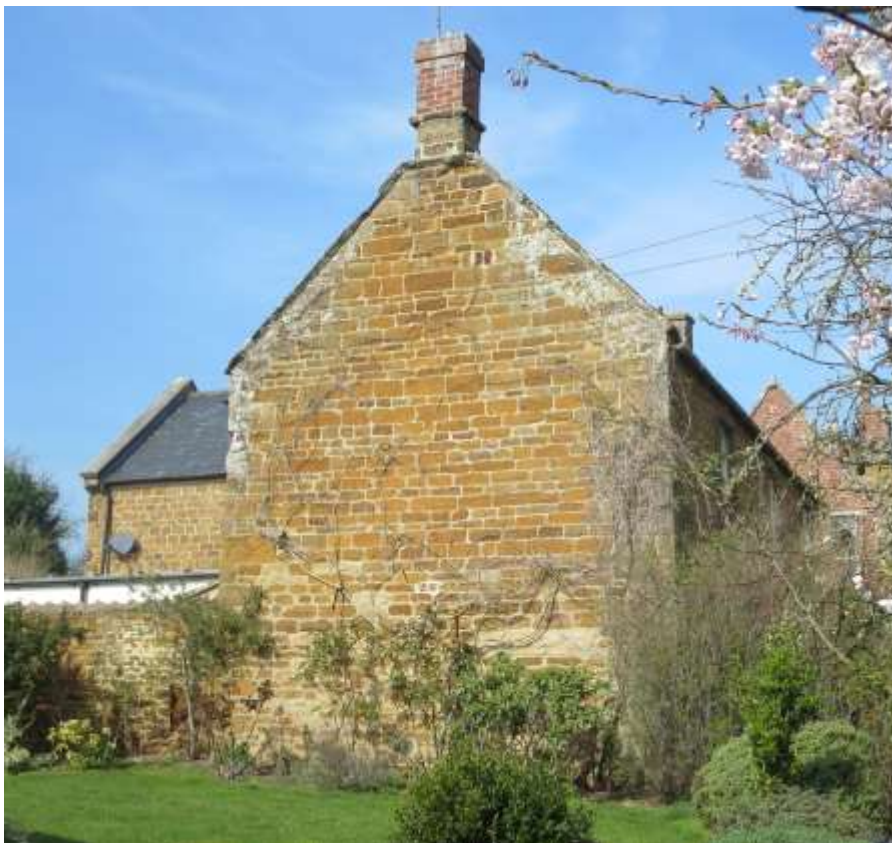
The S gable is blank, of well-coursed ironstone. Gable parapet with plain kneelers and seating for a single-flue stack, which has a brownstone ashlar base and plinth, but the upper section has been rebuilt in C20th brick.

South gable

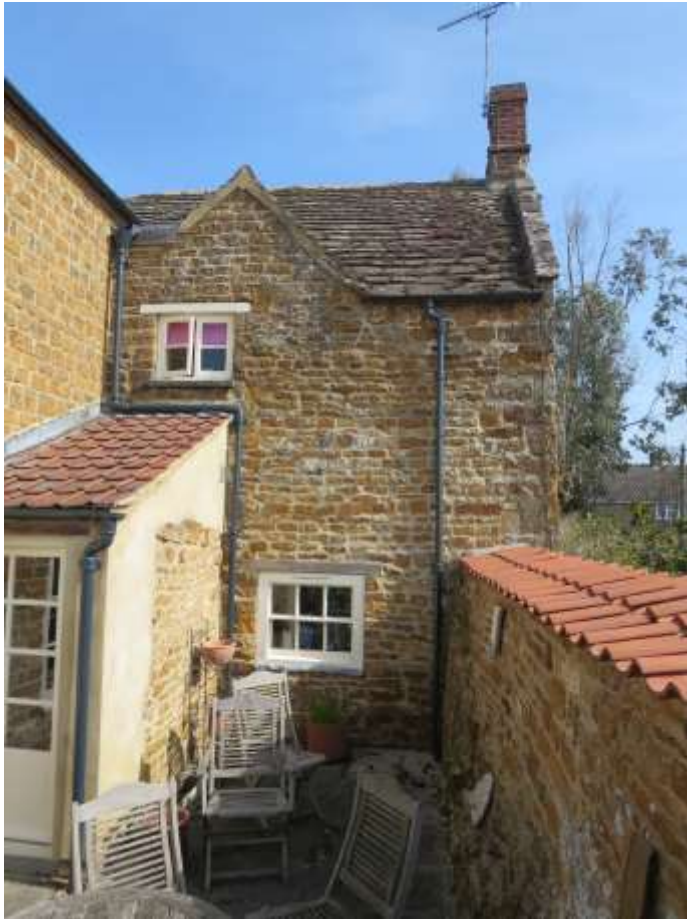
The rear W side is largely covered by modern extensions, but is visible to the S. Rather irregularly coursed ironstone rubble. Modern window with new oak lintel to ground floor. The first floor has a small gabled section at the top, with an offset window below. This seems to be an old opening with good stone jambs and an old timber lintel, but it could have been a doorway (leading into an earlier first floor extension), rather than a window. The scar of the roof line is visible, continuing down to the SW corner.

Rear west side, south end

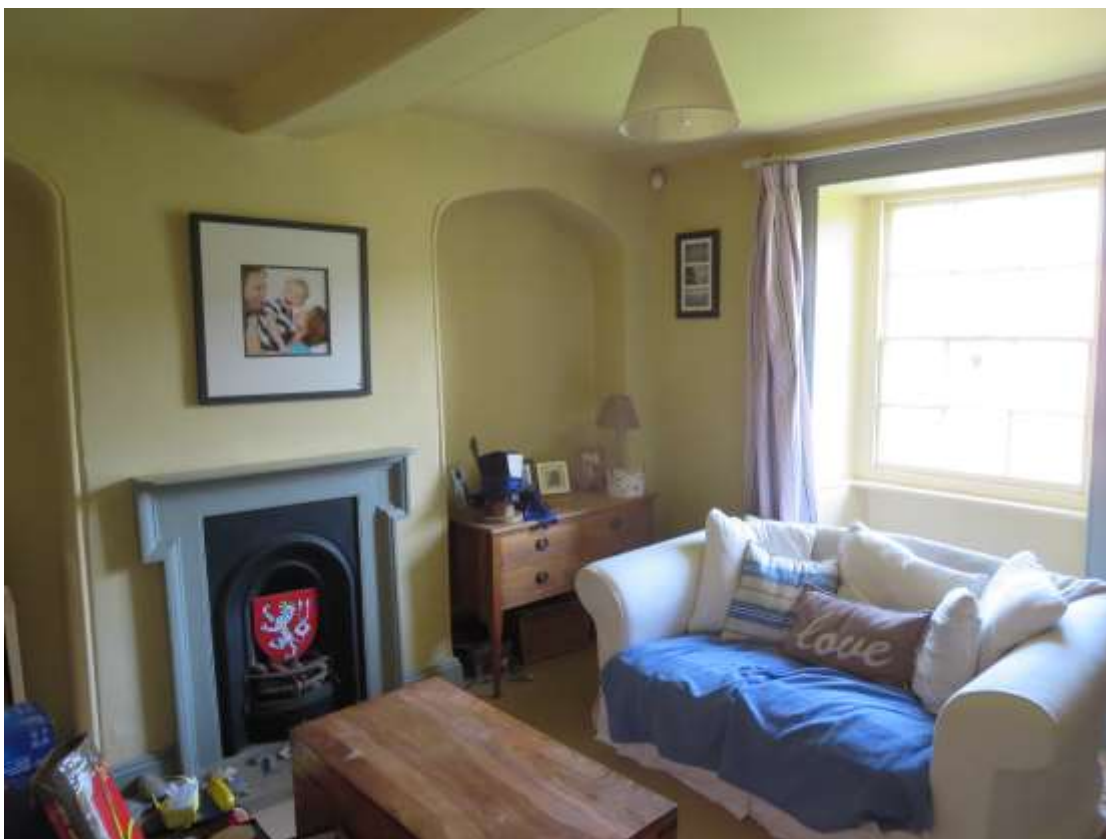
The N room was the parlour, with a cased spine beam. Fireplace set between open alcoves, which have Tudor arched heads, with bead-moulding to the plasterwork. The fireplace has an eared surround of moulded timber (probably Victorian) and a cast iron round-arched grate (probably a modern insertion). The rear W wall has a cupboard recess with panelled doors.

The north ground floor room

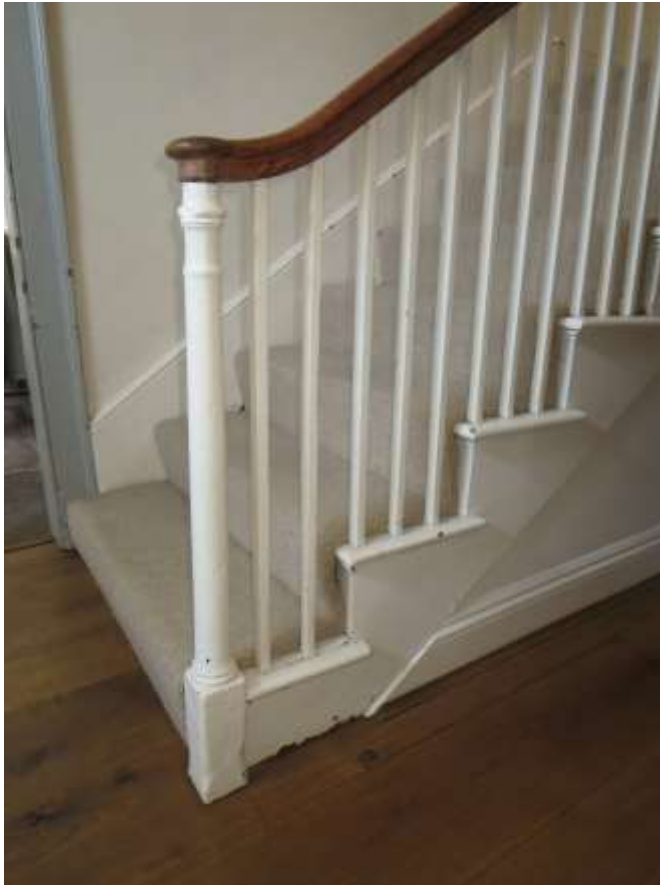
Central entrance hallway, with cased spine beam and a stair of generous width (890mm between the side wall and balusters). The stair has a plain, open string with thin stick balusters and a moulded pine handrail, which ramps up at the mid-way and top newels. The stair is of L plan, though it has two winder treads rather than a quarter landing. The bottom and top newel are turned and moulded, with white paint finish. The mid-way newel and the first floor newel around the stair landing are a later insertion of Victorian date, of square form with chamfered corners and straight stops. The balustrade along the E side of the landing is also later, with slightly thicker balusters. In the stair cupboard, the underside of the lower part of the stair structure can be seen. This has old oak bearers under the first flight and an old oak trimmer beam at mid-height. Roughly cut oak brackets are nailed to the sides of the bearers to support the treads. The treads and risers are of pine, though these may have been renewed. The wall (only 185mm thick) which separates the stair hall from the kitchen can be seen under the stairs to be, unexpectedly, of ironstone ashlar.

The staircase

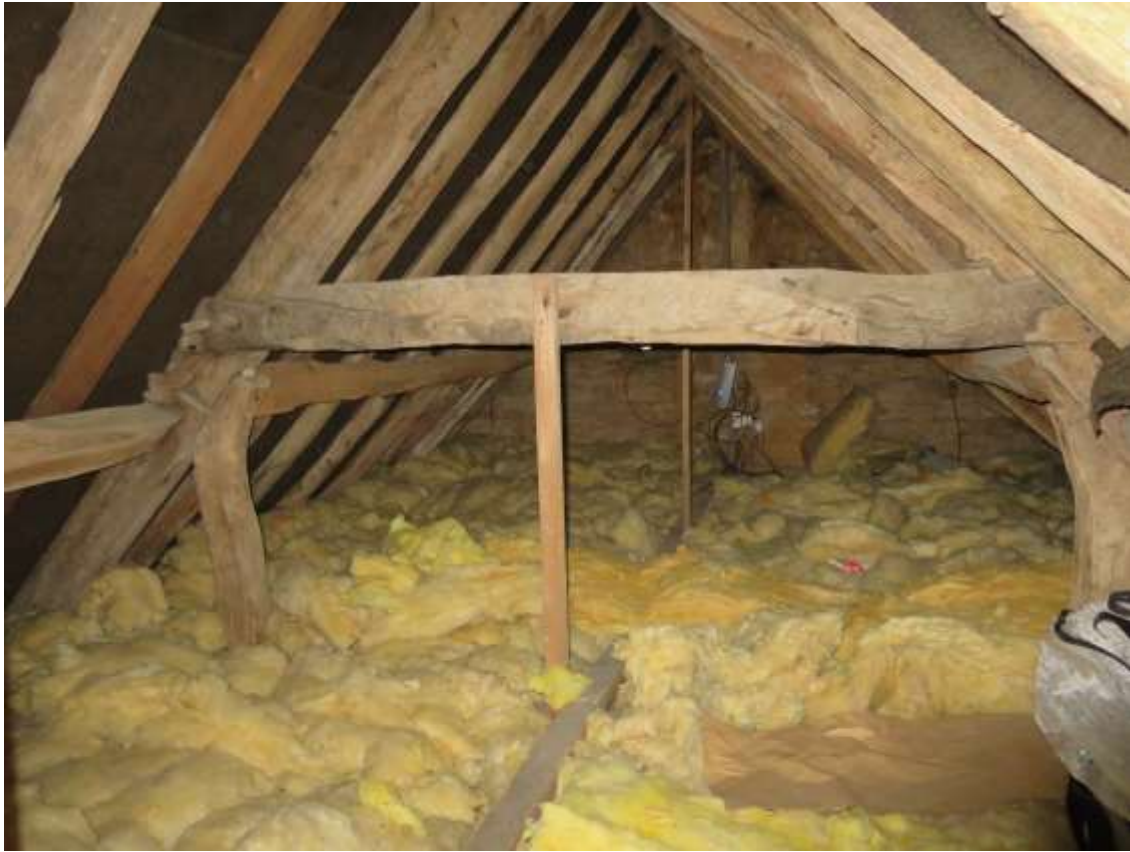
The central truss T2 has re-used principals with an unusual half-circle (50mm diameter) recess cut into one face. The upper collar is re-used, of oak painted light blue. The W strut is re-used, with a row of mortices for studs. The E strut is also probably re-used, of large, square-cut oak. The S truss T1 has re-used principals, one a former ridge beam (like T3) and the other with a row of through mortices. The collar here is roughly shaped, but may be original not re-used. The struts are re-used, with curved heads from some particular former use. The purlins to all 4 bays are of roughly shaped timber, but may well be original. Beside the W side of truss T1 there is a dormer-type roof projection (as seen externally), whose rafters are also of roughly shaped or re-used oak (indicating that the roof projection might be original).

Truss T1 north side, with re-used curved struts

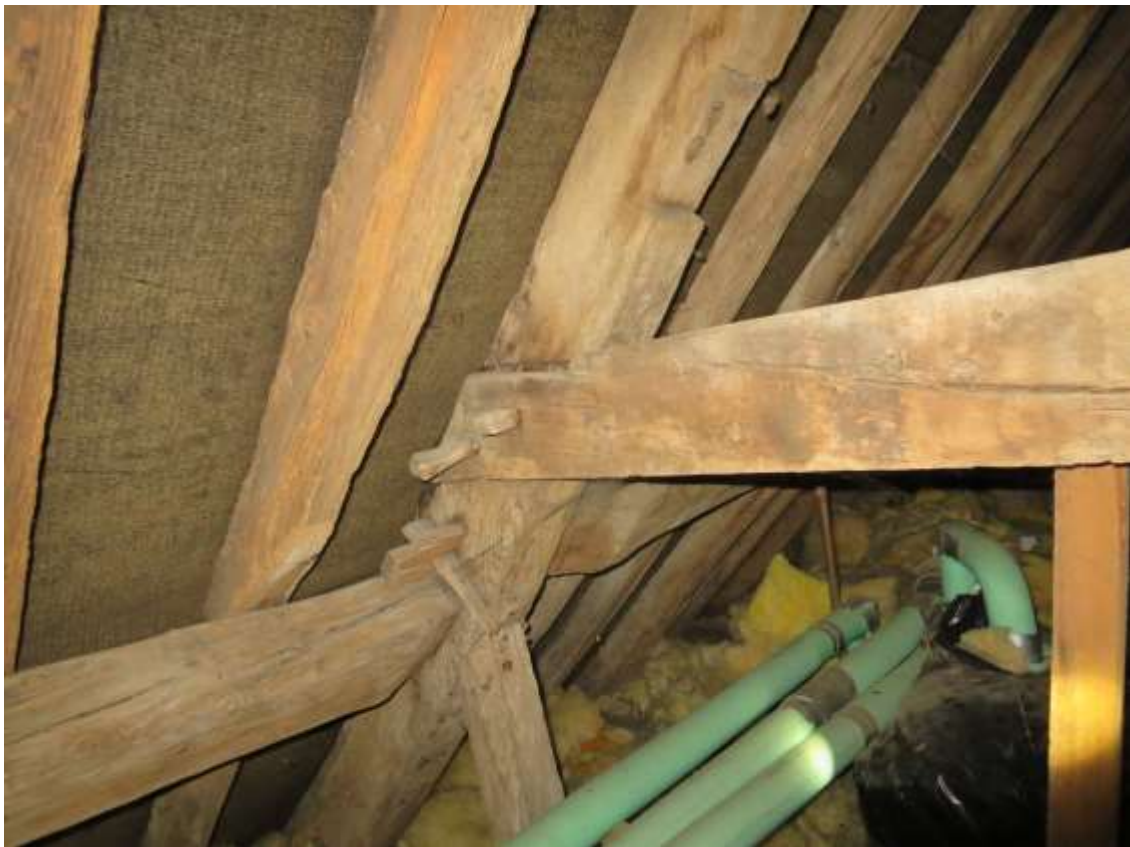
Truss T3 to the N has a lower tie of re-used timber of irregular shape, with a slot cut out of its top face from a former use. The W principal rafter has a chamfer to both lower corners and a series of old peg-holes, which show it was originally a ridge beam, with pegs to fix rafters. The E principal also has a slot with pegs to its underside and a partly cut off chiselled carpenter's mark 'II' to its S side, so is also re-used. The upper collar has a whole series of old peg-holes, showing re-use, and there are also old peg-holes to both struts.

Detail of truss T3, south side

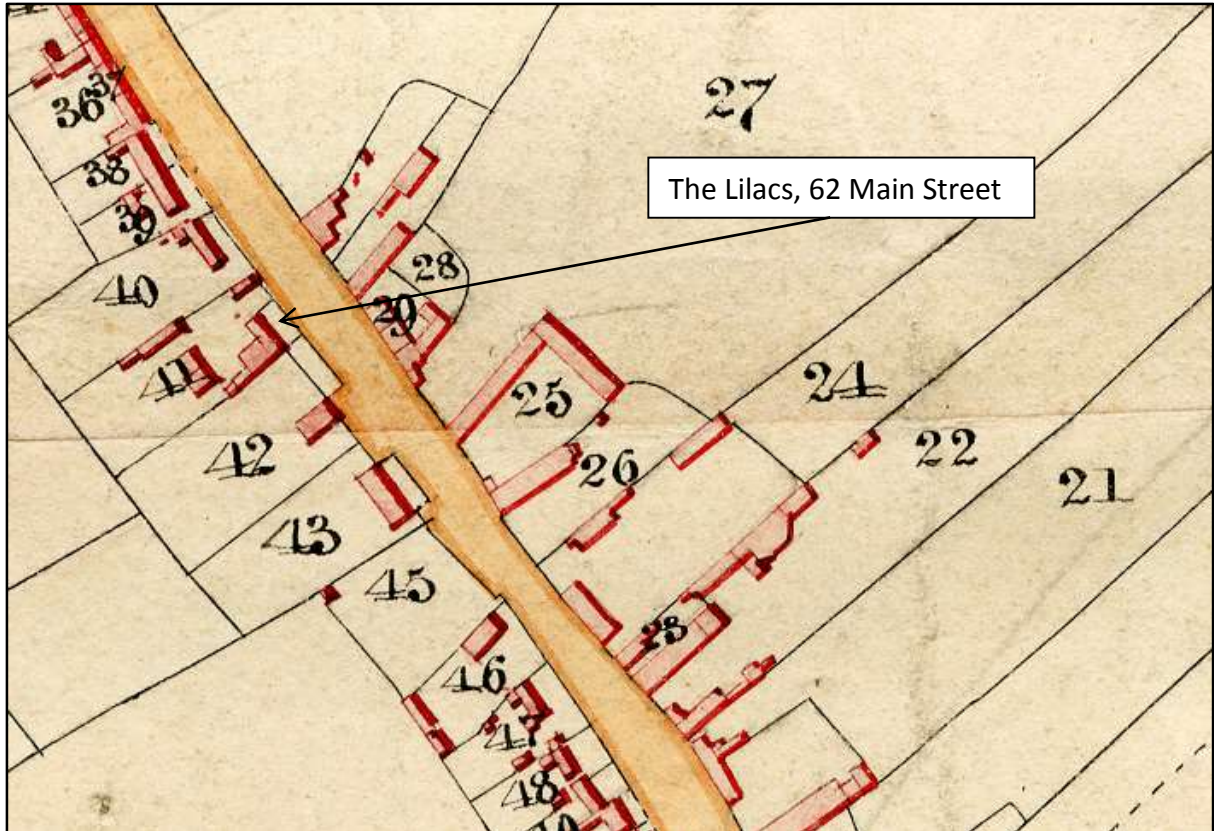
The 1848 estate map shows the house as plot 41. The house was still L-shaped, but the SW outbuilding is shown with a narrower width. There was now an outbuilding in

the centre of the plot, and the N outbuilding extended further W. The copyhold owner and occupier was Robert Clarke, with a description in the schedule as 'Farm house barn stables sheds yard garden and orchard' and a plot area still of 1 rood 6 perches.

Lyddington Estate Map, 1848 (Burghley Archives)
