**Lyddington Manor History Society
Historic Building Survey**

**Ivy House
Thorpe by Water, Rutland**

HISTORIC BUILDING SURVEY REPORT

IVY COTTAGE, NO 4, THORPE BY WATER

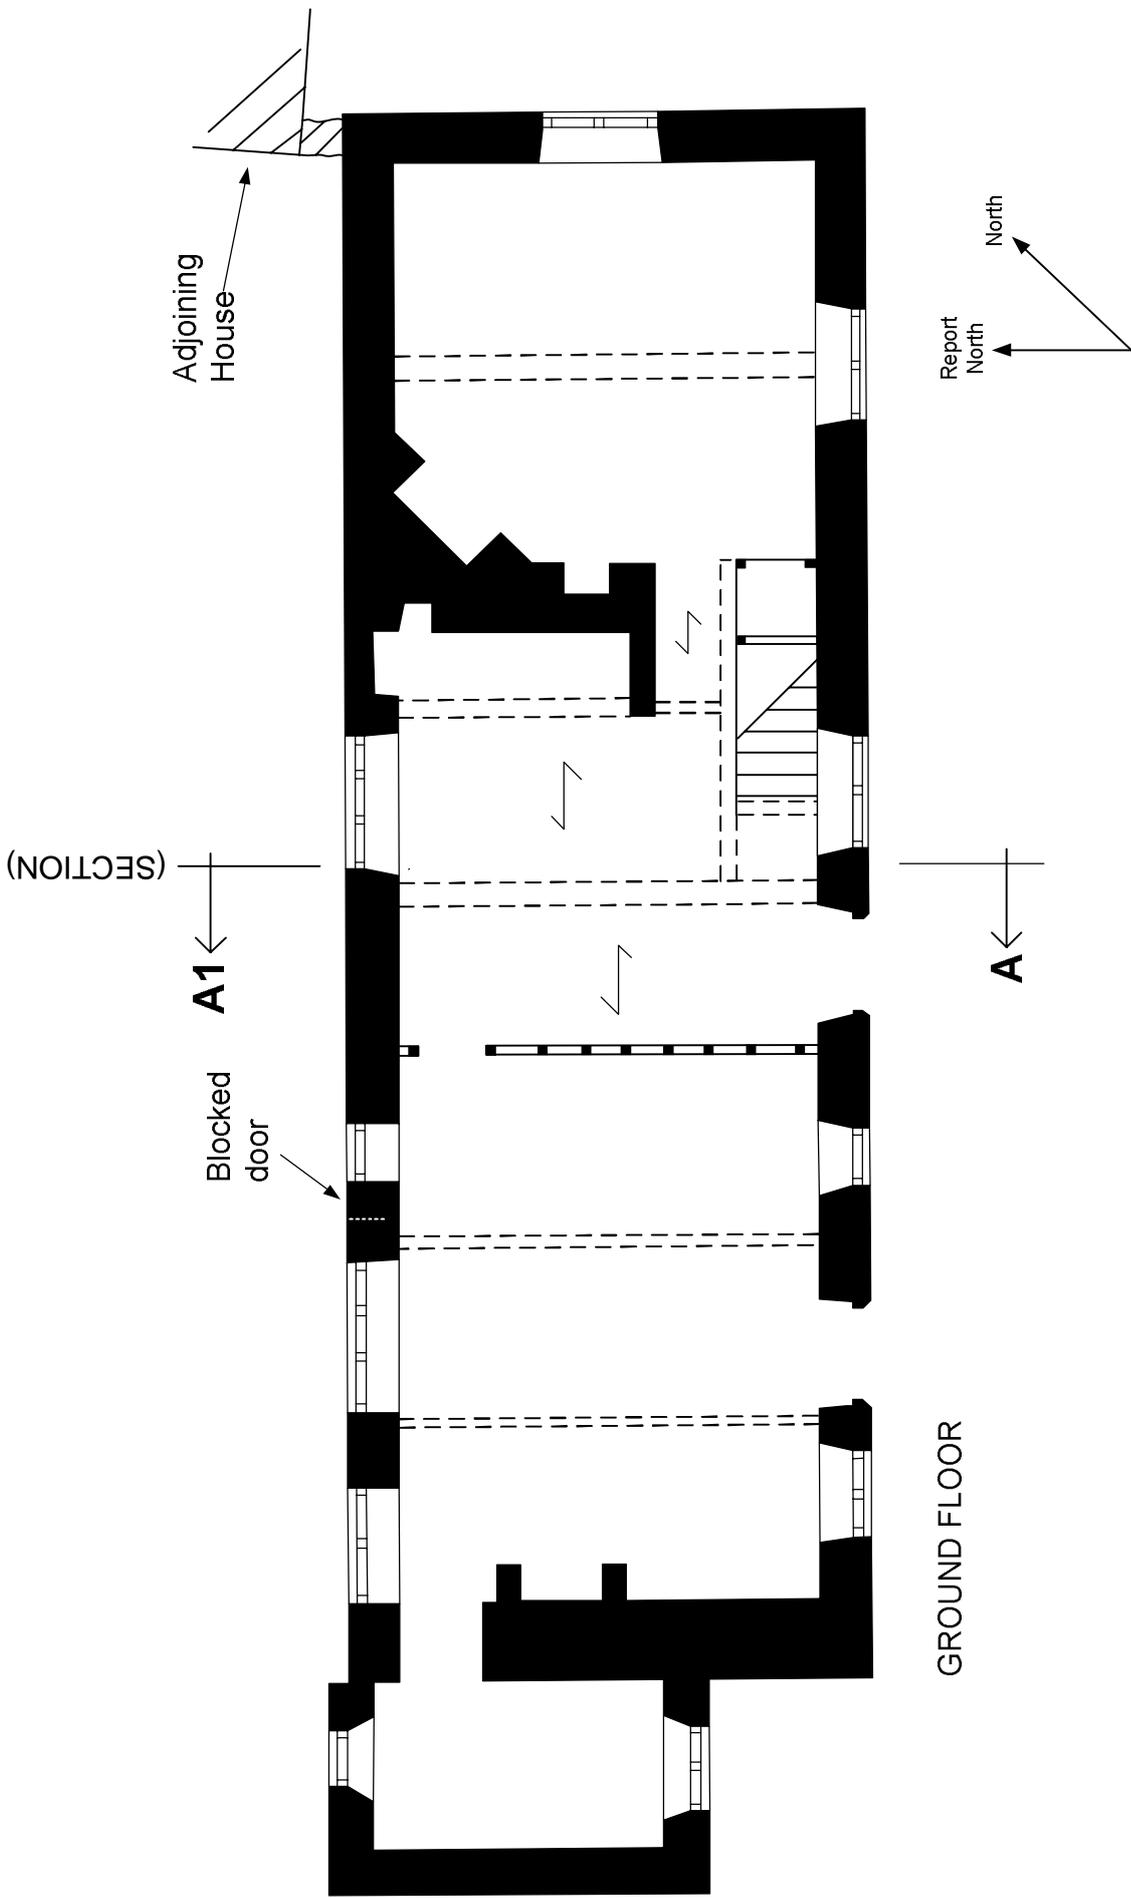
No 4 THORPE BY WATER

The main E block has a two-room plan, with central chimneystack heating both the central room (hall) and the E room (parlour). The entry doorway, however, is not set centrally to form a lobby-entry plan, but further to the W. The W end formed a large service block, with its own front and rear doorways, and separated from the main block only by a timber stud partition.

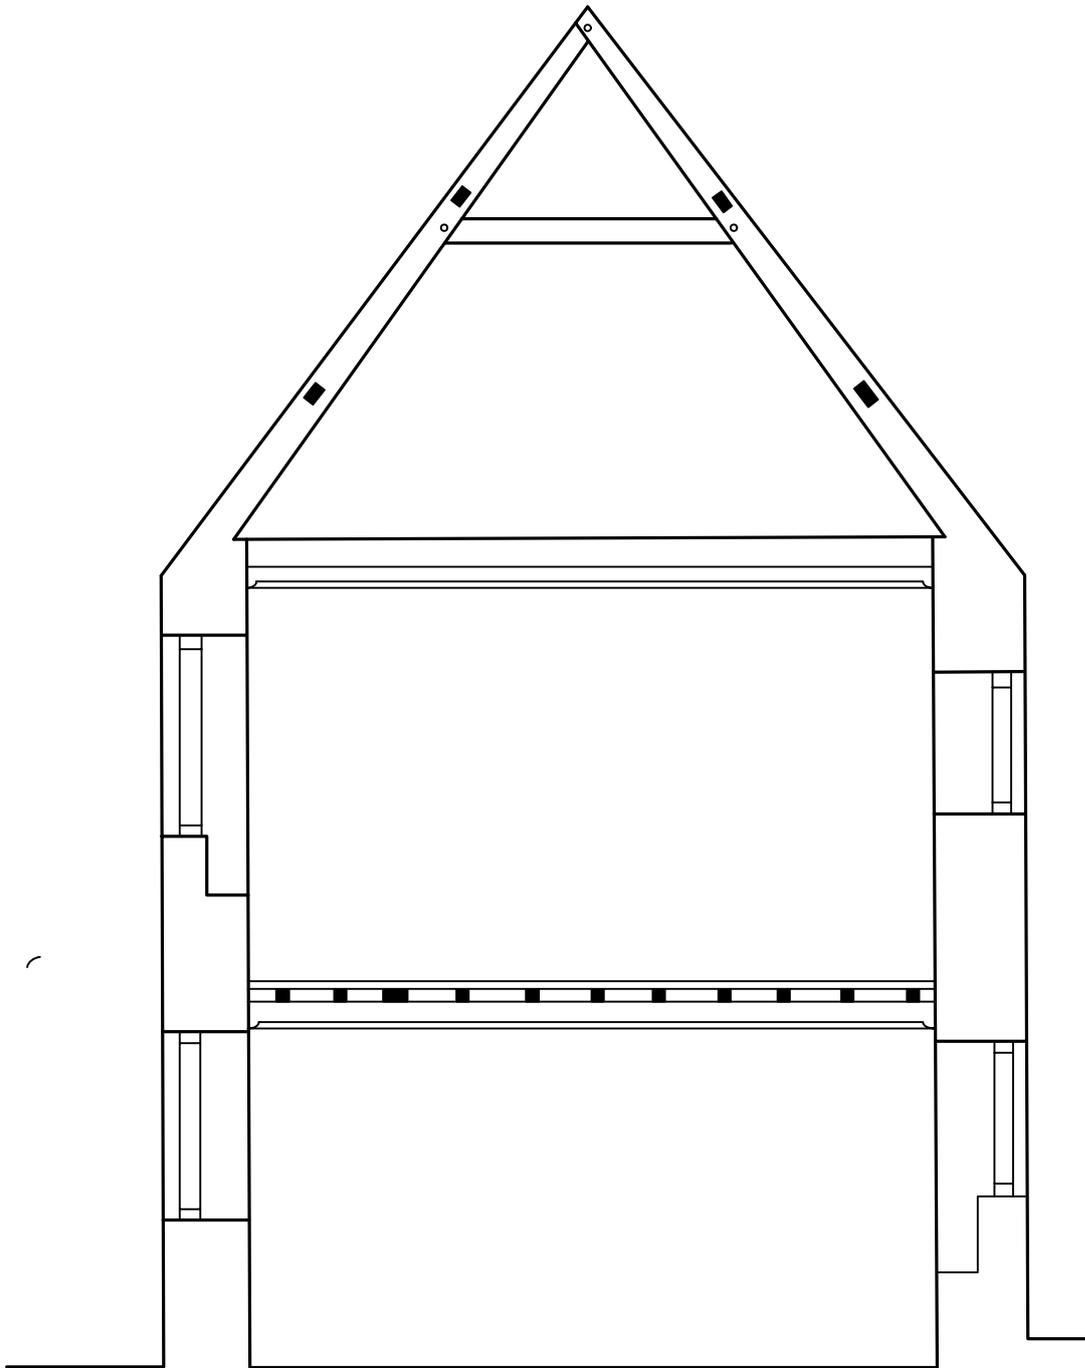
SECTION A – A1

The roof structure, all of oak, has 3 trusses: T 1 to E room, T2 to central room and T3 as the top part of the stud partition which divides the main block from the W block. The trusses have a tiebeam and principal rafters, with a high-set collar morticed and pegged. Two sets of tenoned purlins, and no ridge. The purlins have bridled scarf joints, twice pegged. The rafters are of square-cut oak, the protruding rafter feet visible to the N eaves. The E end has hip rafters and integral purlins, all of the same build. Timber is pit-sawn, but no carpenter's marks were noted, with only very small chamfers. The collar to truss T3 has V-grooving for mud infill both above and below.

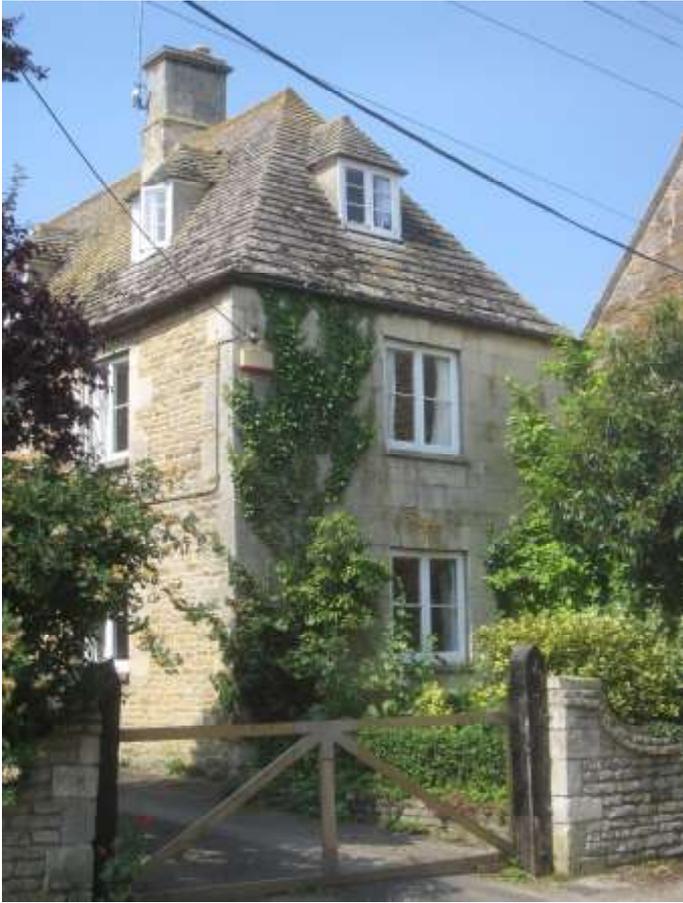
The front E gable is of finely jointed Ketton ashlar, with centrally placed windows to ground and first floor, both with limestone jambs, neat voussoirs and a projecting keystone. Square Ketton plinth course to base, set on rubble stone. The S (entrance) front has a symmetrical arrangement of window openings to the E block, with two windows to ground floor, two to first floor, and a central first floor window (now blocked). All windows have square limestone jambs and a single-piece stone lintel – designed for timber windows, though the current windows are of late date. Awkwardly placed to the left, disrupting the symmetry of the frontage, is a front doorway, with plain chamfered stone surround and single-piece lintel. Good 2-flue chimneystack of limestone ashlar, with chamfered plinth and moulded cornice. Collyweston roof, hipped to the E front, rather than the usual gabled form.

View from the east

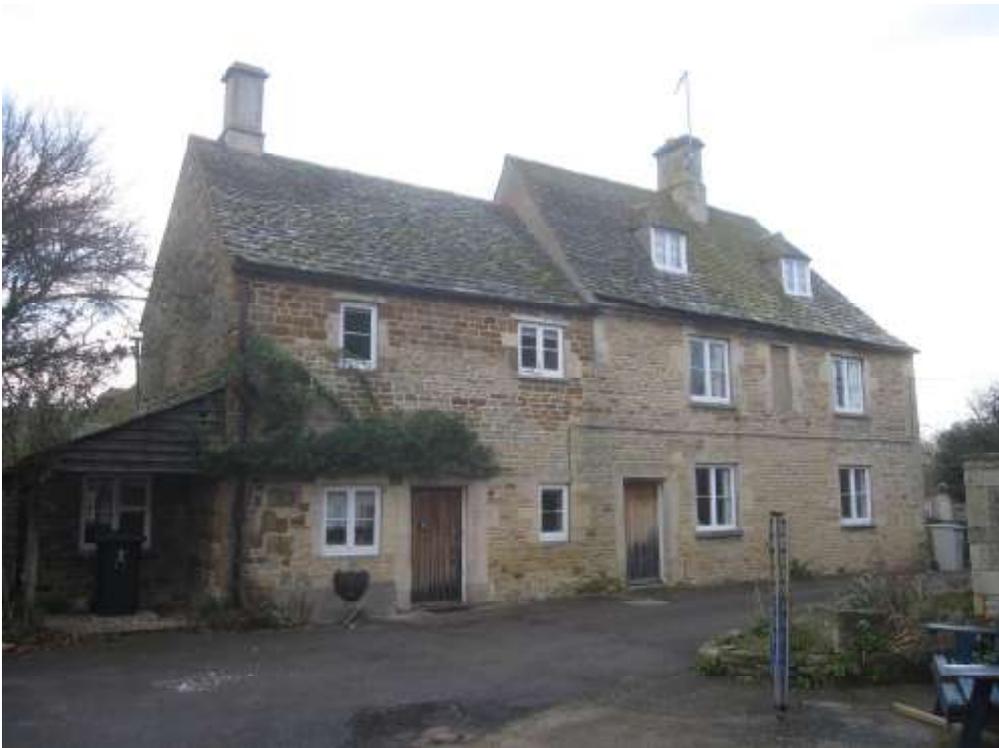
View from south-west

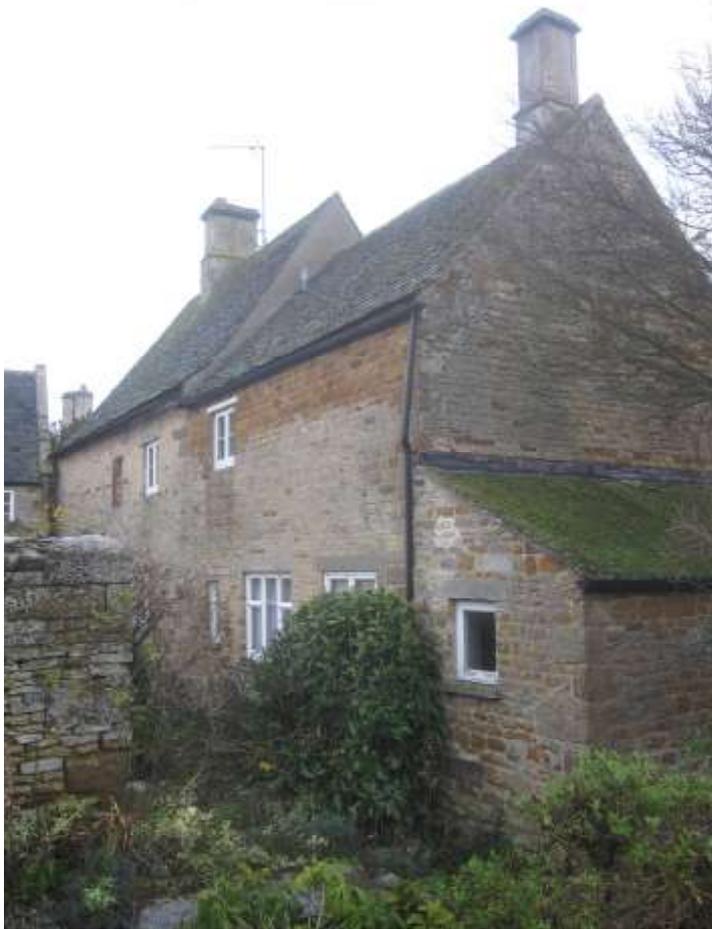
The W block has had its eaves raised by around 750mm, as can be seen on the W gable. There is no straight joint at the junction to the main block, with quoins only at the wall-top, where the main block originally rose higher than the W block. The S wall of the W block has a fine moulded doorway to the centre, of Ketton stone with a flat head, ovolo and cyma moulded jambs and high-set stops – a type normally found in the later 17th century. The two ground floor windows to either side have Ketton jambs and plain, quite deep stone lintels. The first floor eaves has been raised in ironstone, with window openings re-set. Some large ironstone blocks and disruption near the SW corner, no doubt connected to the odd dish-shaped wall face inside on the first floor. The gable end has a single-flue chimneystack of limestone ashlar, with chamfered plinth and moulded cap, though this has been rebuilt.

View from the west

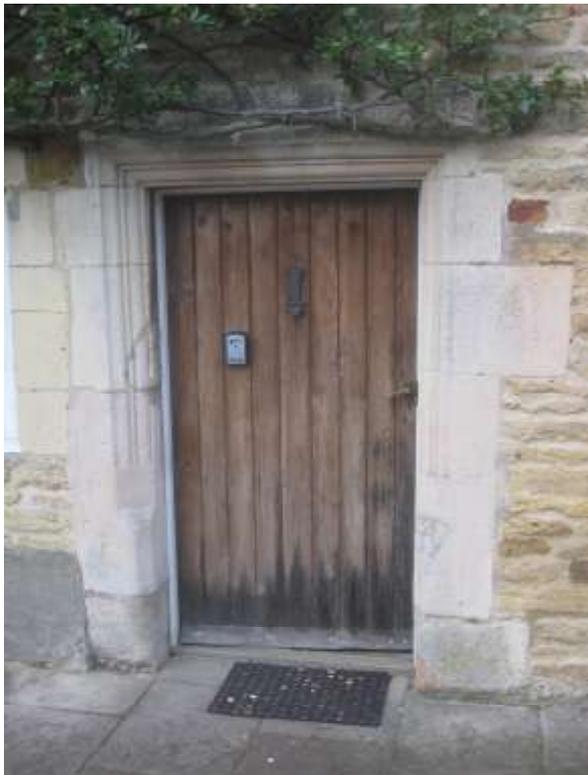
This is an unusual building, and its date is also puzzling. The moulded stone doorway to the west block suggests a date in the later 17th century. The ovolo-moulded single-light window to the rear wall indicates a date in the late 17th or very early 18th century, as do the fragments of other ovolo-moulded windows, now ex situ. The general structure, plan form, floor structures, timber partition and roof structure all suggest a date in the earlier 18th century. But the fine ashlar gable front to the street, with its keystone lintels, is very much of 18th century type. It might be that the moulded stone doorway is re-used from the previous house, though the Ketton masonry is all very consistent. The house was perhaps built, then, around 1700, with an elegant street frontage, but older-fashioned features elsewhere.

Moulded stone doorway to
the western part
